TRANSFER LINES - STABILITY AND OPTIMIZATION

L.Drosdal, V. Kain, W. Bartmann, C. Bracco, B. Goddard,
G. Le Godec, M. Meddahi, J.Wenninger, CERN, Geneva, Switzerland

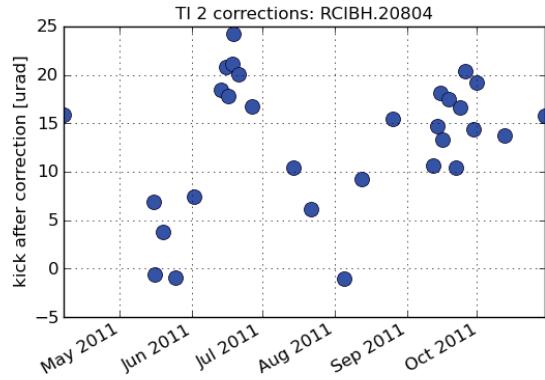
The transfer lines are drifting and need to be steered regularly. Frequently the same correctors are proposed. For TI 2 it is mainly RCIBH.20804 which is in phase with the MST and MSE (SPS extraction septa). The kick strength seems to be drifting back and forth, see Fig. 1. The cause of the drifts is still unclear and not further treated in this paper.

Figure 1: Applied corrections for the TI 2 corrector RCIBH.20804 during the 2011 proton run. This corrector was frequently proposed for correcting the line. It is in phase with the MST and MSE (SPS extraction septa).

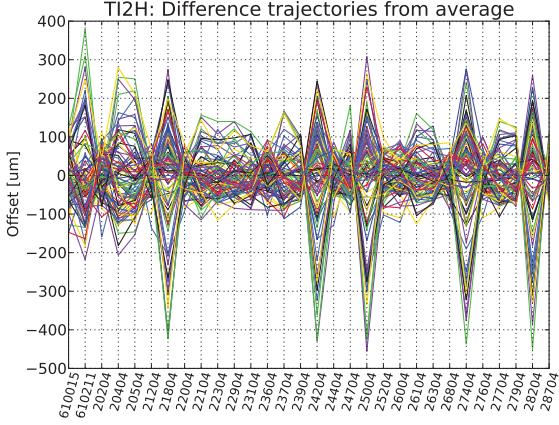
For TI 2 a dedicated stability study was done in June 2011. 82 shots were recorded and analysed using MIA. For the horizontal plane the variations from the average trajectory was up to $760 \mu\text{m}$, see Fig. 2. In the vertical plane the variations are smaller, up to $260 \mu\text{m}$.

Figure 2: Difference trajectories from average per BPM for TI 2 in the horizontal plane during a dedicated stability study in June 2011. The variations go up to $760 \mu\text{m}$.

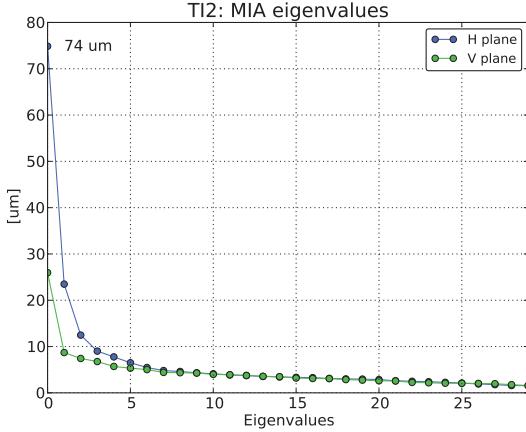
From this data set the MIA analysis gives one strong eigenmode of oscillation in the horizontal plane, see Fig. 3. All other eigenvalues are at an acceptable level and are not considered further.

Figure 3: Eigenvalues found by MIA analysis of the TI 2 stability data. The analysis gives 1 strong eigenvalue in the horizontal plane pointing to one strong source of instability.

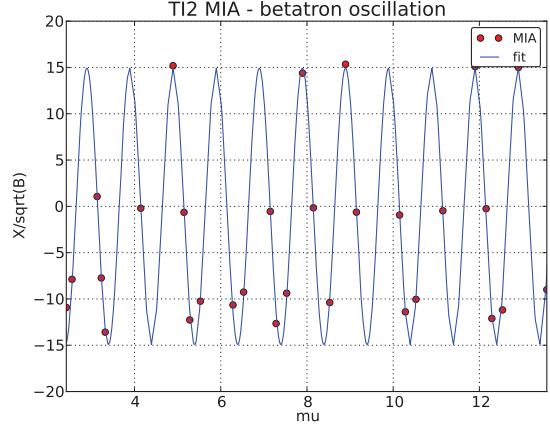
cillation beginning at the start of the line meaning that the source is a single kick before the start of the transfer line, see Fig. 4. To investigate possible sources MAD-X simulations of various errors were used. For the MSE the simulation matches the result of the MIA analysis. See Fig. 5 for a comparison of the trajectories.

Figure 4: The spatial eigenvector found by MIA corresponds to a betatron oscillation beginning at the start of the line.

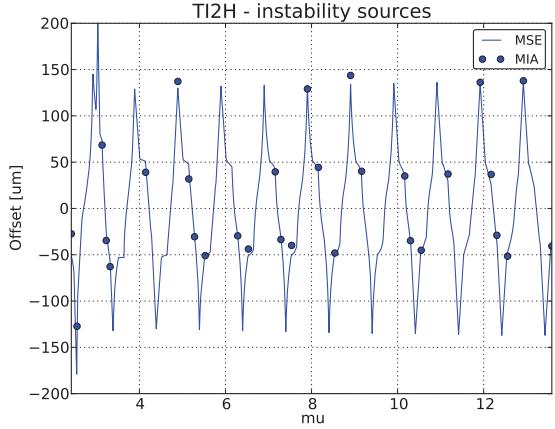
Figure 5: MAD-X simulations of an MSE error gives a good match to the trajectory found by MIA.

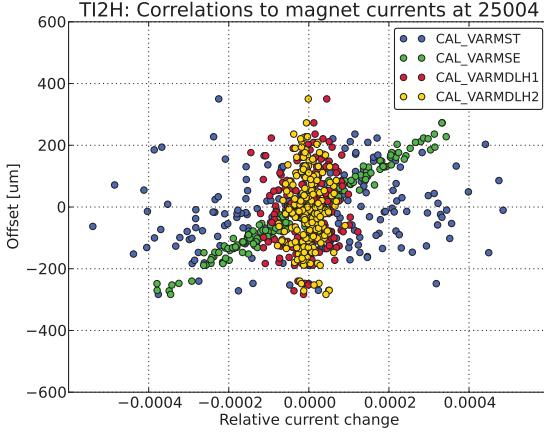
For the same period logged power converter currents of possible sources were investigated. The current variations were used as field errors in a simulation. The resulting excursions at a relevant BPM is given in Fig. 6. The MSE ripple correlates best with this BPM and its ripple is large enough to produce the variations observed. For the MST and other magnets investigated the observed current variations are not large enough.

Figure 6: Simulations of magnet field errors using logged current variations gives a clear correlation to the MSE at BPMI.25004. The observed errors are large enough to produce variations of 760 μm .

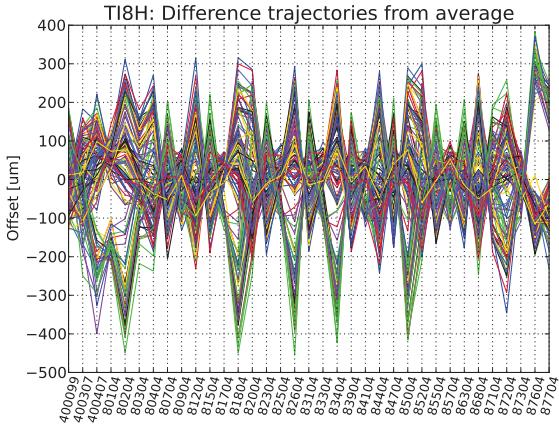
In November the same study was done for TI 8, giving 117 shots used in MIA. The maximum variations from average in the set were $770 \mu\text{m}$ in the horizontal plane and $260 \mu\text{m}$ in the vertical plane. See Fig. 7 for the full set of trajectories with respect to the average for the horizontal plane.

Figure 7: Variations from average trajectory in the horizontal plane of TI 8 during the stability study in November. The variations go up to 770 μm .

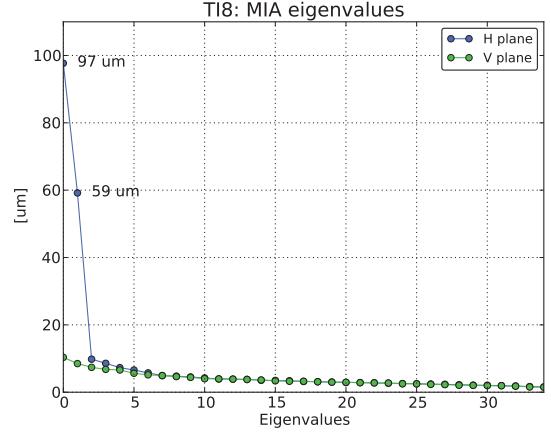
Using this data set in MIA, two strong eigenvalues were found in the horizontal plane, see Fig. 8. The corresponding eigenvectors are also betatron oscillations starting at the beginning of the line pointing to errors from the SPS extraction system or upstream of the line.

Figure 8: Eigenvalues found by MIA analysis of TI 8 stability data. Two strong eigenmodes give two sources of instability.

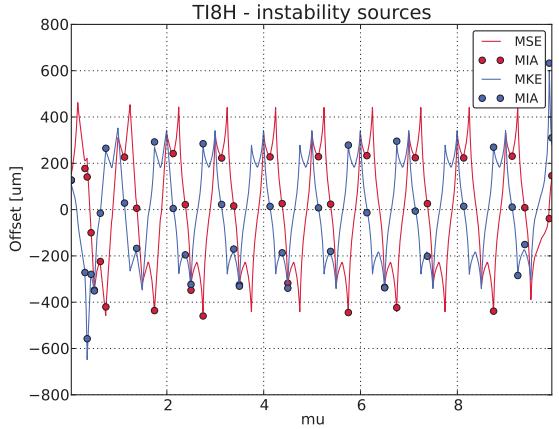
Possible sources are found simulating field errors by MAD-X. For the two largest spatial eigenvectors a good match is found with the MSE and the MKE (SPS extraction kicker), see Fig. 9.

Figure 9: The two sources found in the MIA analysis match MAD-X simulations of errors on the MSE and the MKE.

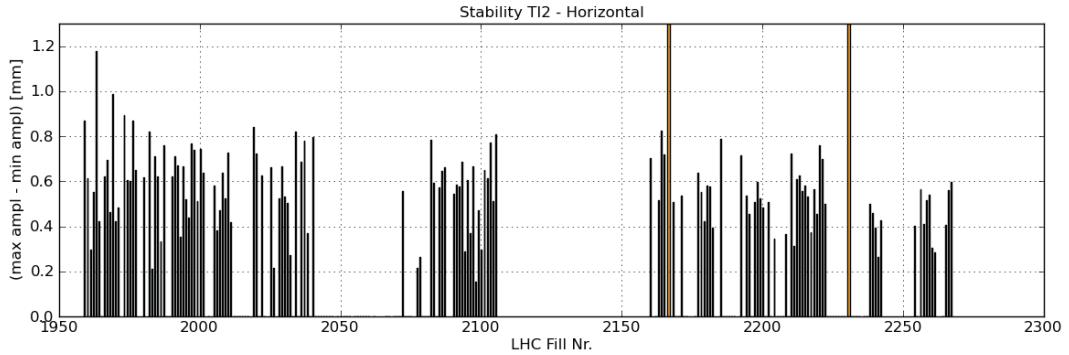
Figure 11: Stability of TI 2 for the 2011 proton run. Work was done to improve the MSE power convertors in two interventions marked by yellow lines. By the end of the run stability seemed to have improved.

The power converter team was informed about the MSE (TI 2) current variations and work was started to improve the stability. As a result the peak-to-peak ripple could be improved by a factor 2 by the end of the run. Variations measured using IQC data also seem to show a reduction, see Fig. 11. More statistics are necessary to confirm this. No further improvements have been done for TI 8.

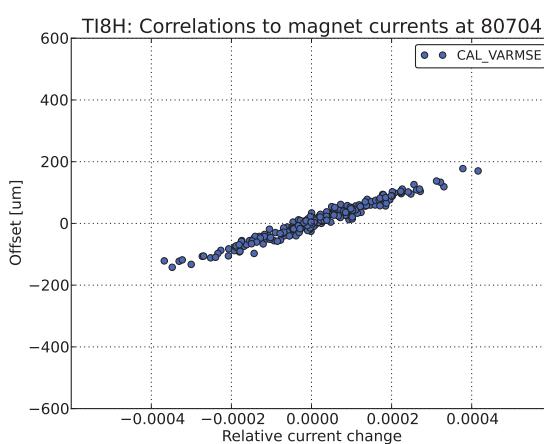
For the MSE this is confirmed by the logged current variations. The simulation shows that the observed cur-

rent variations are large enough to produce the observed trajectory variations, see Fig. 10. A similar study is still necessary for the MKE.

Figure 10: Simulations of logged current variations of the MSE gives high excursions at BPMI.80704.

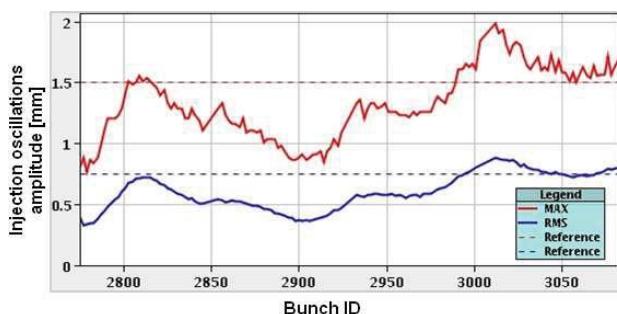
In the horizontal plane for TI 8 the injection oscillations analysis in the IQC indicated large bunch-by-bunch variations in the injected batch indicating problems in the low inductance MSE or the waveform stability of the MKE, see Fig. 12. A waveform scan was performed to investigate a possible ripple on the waveform.

Figure 12: IQC plot showing large variations for the bunch-by-bunch injection oscillations amplitudes of the injected batch in the horizontal plane for beam 2.

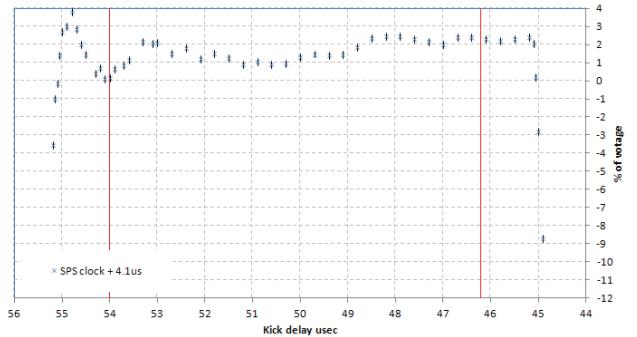
For beam 2, two separate scans were performed extracting pilot beams on the upstream TED varying the kick delay. For the waveform scan a strong ripple up to 4% on the waveform was observed, see Fig. 13. From specifications this should be no larger than 1%. Reviewing a previous measurement, the ripple was already present in 2009. For 2012 the delay will be adjusted to avoid the worst part of the waveform ripple.

Figure 13: Scan of the SPS extraction kicker waveform in TI 8 - MKE4. The scan was done extracting a pilot bunch and varying the kicker delay. The waveform has a large ripple going up to 4 %.
