FRONT END PHOTON SHUTTER WATER LEAK TO VACUUM AT THE CANADIAN LIGHT SOURCE

G. Henneberg*, G. Barkway, M. J. P. Adam, Canadian Light Source Inc., Saskatoon, Canada

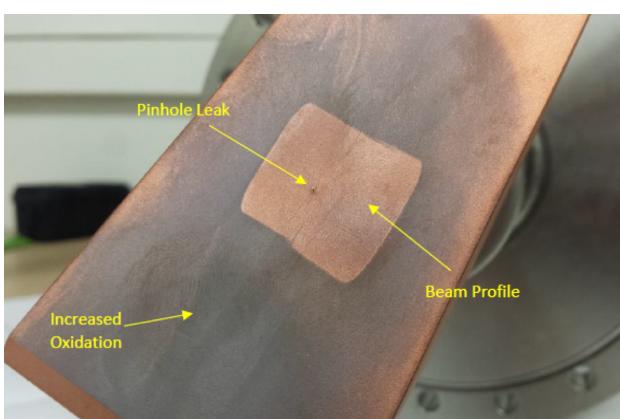
A collaborative decision was made to wait to find the exact location of the leak. The mechanical technicians first activated a scroll pump in an attempt to pump down the affected section. Water was discharged from the exhaust of the scroll pump, which indicated the water leak. After determining that the leak had originated in the HXMA FE, the technicians identified which components may have failed. By the afternoon, they had discovered a small pinhole leak on the absorber head of the first HXMA photon shutter (Fig. 1).

Figure 1: Illustration of the pinhole leak discovered on HXMA PSH1. Leak location is aligned precisely with water jet location of the tube in tube cooled absorber.

through the head of the absorber. The leak developed at (or very near) the centre of the absorber's face (Fig. 1). There are six other photon shutters that employ this exact same design currently in use at CLS. There are also 12 photon shutters that are derivatives of this design. Their cooling system and operational parameters are almost identical. Therefore, it is necessary to identify why failure occurred, how it can be prevented, and/or if other components are at risk to fail.

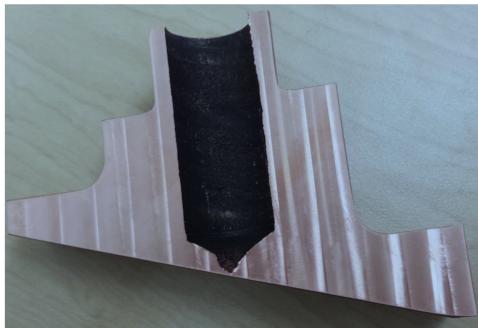
Figure 3: Section cut of failed PSH1, used to investigate extent of damage and location of erosion.

suspected to be degradation of the copper walls due to corrosion, erosion, or impingement damage. Operating conditions of HXMA PSH1 (at >7.12 m/s) exceeded CLS's maximum flow velocity standard of 2.5 m/s [1]. The typical maximum

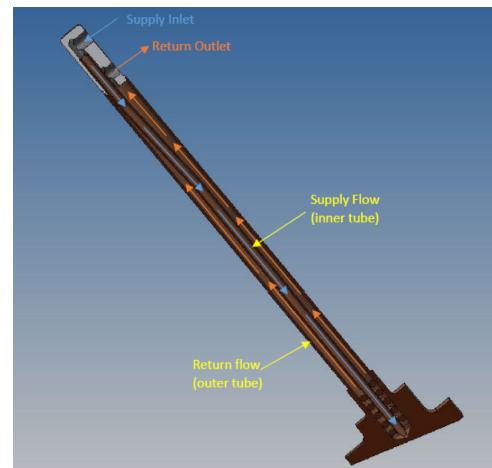
The HXMA PSH1 is based off of the APS design (Fig. 4). Jeffrey T. Collins, an APS employee, was contacted to determine if this style of photon shutter had a history of leaking. He was the lead author on a paper detailing the heat transfer benefits of using a coil insert for high heat load components [2]. APS has not dealt with such an issue before, but Jeffrey provided CLS with a report on a RF window that had suffered a pinhole water leak into vacuum [3]. The report explains that the RF window's cooling water caused large erosion-corrosion on the copper walls due to excessive flow rates (>5.3 m/s). The inner surface above the coil insert

Figure 4: Illustration of the tube-in-tube configuration of PSH1. Cooling water enters from the inner tube and exits the outer tube passage.

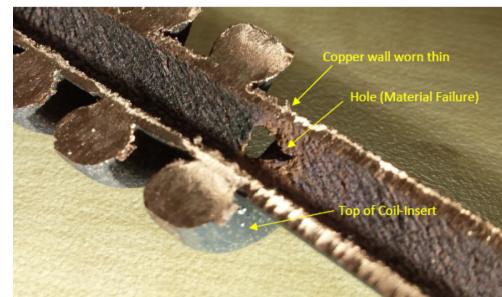
At the very top of the coil, a hole on the wall of the inner tube formed, allowing water to escape into the return flow without travelling to the base cavity. The hole is roughly 4 mm long and 3 mm wide. The hole sits directly beneath the end of the coil (Fig. 5). There is significant material degradation around the hole and the pipe wall is very thin.

Figure 5: Section cut of eroded inner copper tube.

The mechanism causing failure of the sidewall (Fig. 5) is not well understood. Its effect on the system is difficult to determine for the following reasons:

It is clear, however, that the location that the hole formed was unique. The hole sat right at the end of the coil, near a change in diameter on the outside of the tube. The pattern of erosion/corrosion on the inside surface changed abruptly on either side of the hole.

The hole may have formed for a multitude of reasons. There may have been localized turbulence as the fluid exited the spiral, increasing the rate of erosion-corrosion. Faulty brazing/soldering work between the coil insert and the tube may have weakened the tube wall. The hole may have formed along the edge where the tube diameter changed creating a larger stress concentration.

To prevent further degradation in similar photon shutters, flow rate should be evaluated to determine if a lower velocity is adequate (reducing the likelihood of similar HXMA PSH1 failures). Continuing to operate under current conditions may lead to further absorber failures, water leaks, and vacuum leaks. Due to damage they may have sustained operating under similar operating conditions, PSH of this design currently in service should be either examined or replaced at the CLS's earliest convenience. PSHs installed during the Phase II expansion are similar in design and operating conditions; flow velocity settings should be reviewed, but these absorbers may not need replacement.
