Lessons Learned from the Module Production for the First CMS Silicon Tracker

Alan Honma

Abstract: A personal view of some of the more important lessons learned from the module production for the CMS silicon tracker. This work took place from about 2002–2005. The focus is on areas where I had strong personal involvement; therefore, the tasks of hybrid production, hybrid assembly, and the wire bonding of modules and hybrids are emphasized. This article will first give a general description of the silicon tracker project and how the module production was organized. Then, there will be description of several of the key issues or problems during the production and how they were resolved. Some recommendations for future similar large-scale productions will be given.

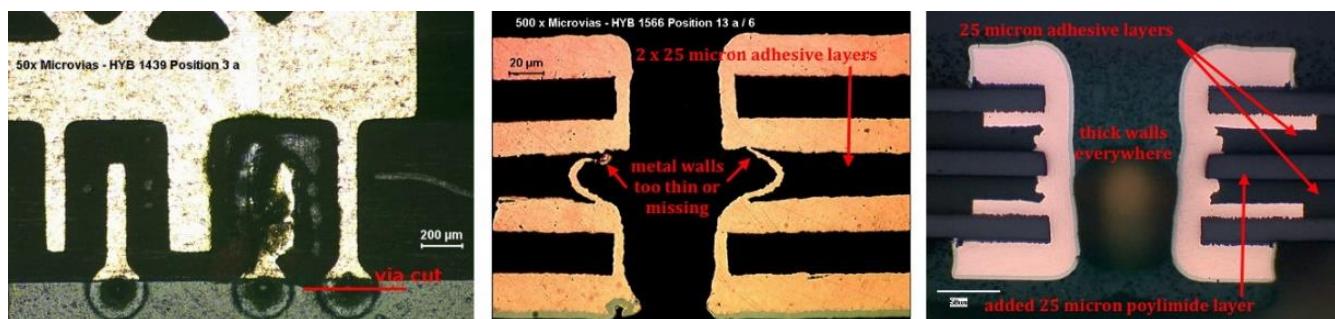
From the evidence of how the failure was seen in the electrical tests, the problem was found to be an open circuit that occurred in one key line in the hybrid. A simple electrical continuity test found this open circuit. The only likely reason for the open circuit was a failure in a via on that line, which had to connect one metal layer to another. Only a few lines on the hybrid that passed through vias were as critical as this one, without which one of the APV25 chips would not function correctly. Several of the hybrids with this problem were then sacrificed by being cross-sectioned to reveal the via's structure. What was found was quite surprising, there was very little metal in parts of the via. The metallization of the via hole should produce a cylinder of copper on the circuit's surface where the hole was made. This cylinder should be around 5 μm thick (or more) at all points on the cylinder surface. Cross-sections were made through the vias in the PCBs in many locations such as the one indicated in the right photo of Figure 8. As can be seen in the middle photo in Figure 8, the cross-section showed that the metal skin was not at all uniform and in many places the thickness was much less than 5 μm and in some places there was no copper at all. It was clear that such vias were not correct and could easily fail with time and especially with thermal cycling, which would stress the metal cylinder and cause already thin zones to crack and fail. Since in most of these poorly metallized vias there was still a thin amount of metal such that it would still conduct properly between the layers, the bare PCB would pass the open/short electrical tests. After assembly (which meant some mechanical stress and a large thermal one from the solder reflow process), a small number of electrical failures occurred on completed hybrids but up until then these were thought to be due to more random faults such as ASIC chip failures, line breaks, and poor soldering. A more careful examination revealed that many of the electrical failures were due to these vias going open circuit.

Figure 8. Left: Location of via cross-sectional cut. Middle: Original poorly plated via walls. Right: Improved solution giving correctly plated walls.

meanwhile, the PCB manufacturer tried a number of modifications in order to try to solve the problem even though they did not understand the actual cause. As it turned out, the studies to understand how the problem occurred concluded that the drilling of the vias caused an uneven hole wall to be made such that the adhesive layers in the stack-up were more abraded than the polyimide layers, giving the concave-like metal shape along the adhesive layers seen in the cross-sections. The solution that was chosen was to add a polyimide layer between the two adjacent adhesive layers in the center of the stack, thus reducing the adhesive thickness from 50 to 25 μm (all other adhesive layers were only 25 μm). It was observed that the very poor metal thickness in the cross-sections occurred only at this thicker adhesive layer. In addition, the metallization process was modified to deposit more copper into the vias. The combination of these changes resulted in vias with much better metal thickness and uniformity, as can be seen in the right photo in Figure 8.

There is an ironic post-script to this issue: the via failure cause was, in fact, not diagnosed correctly, although the solution was effective, nevertheless. I worked on another CMS silicon detector project just following the tracker construction, the CMS pre-shower detector. It involved the building of about 4400 modules of what one could call silicon pad detectors (or a silicon strip detector with very wide strips, 2 mm compared to 100 μm). However, it also used a complex multi-layered hybrid for its front-end electronics that used a combination of flex and rigid layers in its build-up. It also had many via structures similar but slightly larger in size to the tracker hybrids. It also had some thick adhesive layers and it was found that some of the vias were failing in a similar way to the tracker case. Cross-sections showed nearly the exact same concave cavities in the adhesive layers. The flex manufacturer (a different one than for the tracker) conducted an even more extensive study and learned that these cavities were not due to the drilling of the vias but rather the plasma etching step used to “clean” and prepare the vias prior to the copper plating step.

The plasma etching ate away the adhesive much faster than the polyimide, thus creating the concave cavities in those layers. The solution was quite similar to that of the tracker, minimizing the thickness of the adhesives and increasing the thickness of the copper plating. However, since they knew that the problem was from the plasma etching, they could also try modified etching parameters that would reduce the size of the cavities while preserving the quality of the cleaning and hole preparation. It was satisfying, however, to finally understand the true cause of the via failure in both projects.

The above modification addressed only points 1 and 2 above. To address points 3 and 4, it was decided to add a “test coupon” to each PCB panel, which contained via “daisy chains”. The via daisy chain consisted of a very large number (several hundred) of all the types of vias used in the real circuit where a signal line passed in series through all of these vias such that one could see clearly if any of the several hundred vias went open-circuit using a single continuity test. Several of these via daisy chain structures were placed in different locations on the PCB panel. The test coupons could be removed from the panel and thus were subjected to several passes through a solder reflow cycle, giving them even more stress than the circuit would see during the soldering of the SMD components. In addition, we required that these test coupons see cold thermal cycles as well since the operational temperature of the CMS tracker was expected to be about -20°C at the later part of the detector lifetime (needed to minimize the radiation damage to the silicon sensors). Then, each coupon would have the via daisy chain tested for continuity and also a resistance measurement performed since this could reveal a weakening or reduction in the amount of metal in the vias even though it was still conductive. Finally, we required that all assembled circuits be subjected to five passive thermal cycles of -20°C to $+30^\circ\text{C}$ and an electrical test be performed after those thermal cycles.

There were multiple lessons from the via failure problem. One was not to assume a company had mastered a difficult technical feature simply because they claimed to have performed something similar (but not identical) to what you require. Second, for vias and other delicate PCB structures, test coupons with via daisy chains and copies of the other delicate structures (such as very fine lines or small bond pads) should be included on the PCB panels. They should be electrically tested (if possible) and, in many cases, cross-sectioned if there is a risk of incorrect metal plating or non-conforming shape or thicknesses.

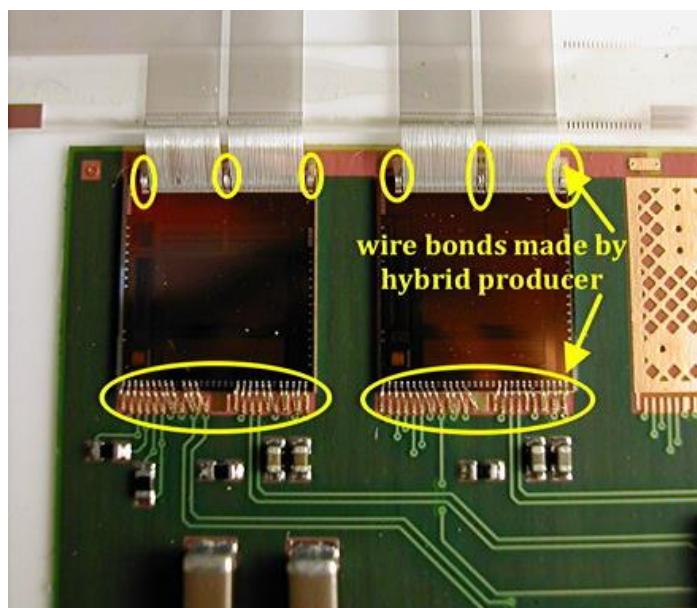
The first problem occurred in the front-end hybrids, where the assembly company performed the wire bonding from the readout ASICs to the PCB bond pads (see Figure 10). We had (fortunately) decided to ask the company to make “dummy” hybrids (electrically bad but mechanically good) with dummy chips so the soldering, gluing, and bonding steps could be tested without wasting good parts. One out of twenty hybrids assembled was a dummy. Both the company and CMS conducted wire-bond pull tests on the bond wires they placed on the dummies. A pull test is when you take a dynamometer with a very tiny wire hook and pull up on a bond wire to measure how much force it can take before it either breaks or the wires detach from one of the end weld points (called the bond foot). The problem that occurred was that CMS started to get very poor results on the pull tests of some of the hybrids that the company had also tested but with good results. The difference

was very substantial in some cases: the company got nominal results (which was a pull test strength of about 10 g) whereas CMS would get values of 2–3 g (the required value was a mean of 8 g for a set of 10 wires).

Figure 10. Location of wire bonds on a hybrid assembly made by the hybrid producer.

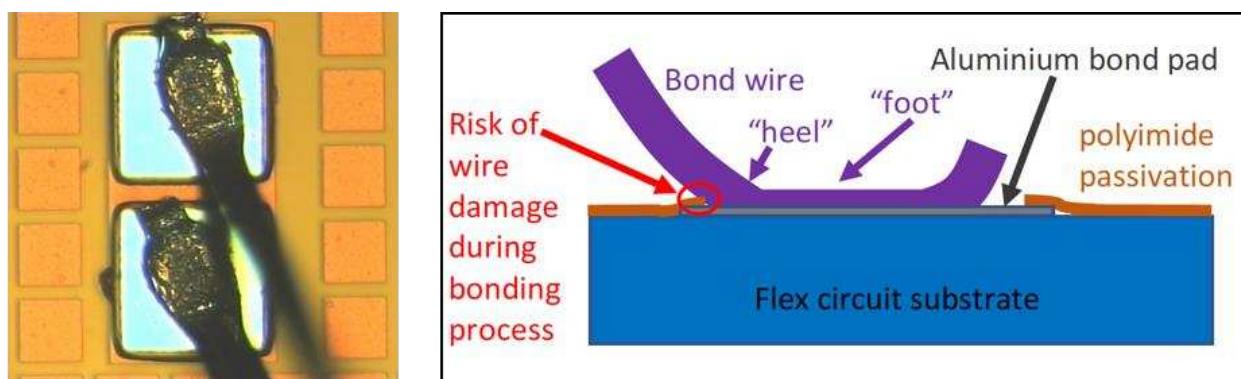
After several heated discussions about whether the company or CMS was conducting the test correctly, it was found that the result depended very strongly on precisely where the wire hook was placed when conducting the test. The company had chosen to pull very near the apex of the wire loop whereas CMS was pulling closer to the central point mid-way between the ends of the wire (a difference in distance of perhaps 0.3 mm out of the typical 3 mm length of a wire). However, this very small difference in pull location could lead to very large differences in the result. There were good reasons for choosing either position; the company's choice would result in the least change in position of the wire during the pull test (moving the wire will generally weaken it) whereas the CMS choice would result in the force applied to the two ends of the wire to be nearly equal, thus testing both ends fairly.

There were more heated discussions as to which was the correct method to use in order to apply the pull test criteria and decide if the wire bonding passed or failed those criteria. As CMS was the client and because we wanted the wires to be able to survive the handling and thermal changes over the long lifetime of the detector, we insisted that if a wire is slightly moved during this test, it should not lose 90% of its strength. In fact, a more careful analysis of why this weakness occurred after such a small flexing of the wire showed that because of the design of the ASIC, the wire was developing a crack at the point where the wire rose upward from the ASIC bond pad. This crack developed because there was a "passivation" (protection) layer of polyimide, which was about 7 μm thick and surrounded the ASICs' wire bond pads. Because the bond pads were very small (95 $\mu\text{m} \times 95 \mu\text{m}$), the bond weld foot (which was about 75 μm long) often would run into the edge of the polyimide, which could create a dent in the soft aluminium wire and the local stresses and further movements of the wire during the bonding process caused a crack to form near this point (see Figure 11). If the wire was not much stressed further (as for the company's method of pull testing), the strength of the wire was close to normal. If the wire was moved physically (as was the case for the CMS method of pull testing), the crack would quickly propagate through much of the rest of the intact wire material and cause a failure with very little (or even no) pull force.

Figure 11. **Left:** Photo of wire bonds on an APV25 chip made by the hybrid assembler. **Right:** Drawing of a side view of one wire bond on an APV25 chip indicating the location of the probable cause of weakening of the wire.

The solution was to use a wire bonding tip that reduced the length of the bond weld foot and to position the placement of the foot to avoid hitting the edge of the polyimide. These solutions did work but prior to that one large batch of about 500 hybrids was rejected because of weakened bond wires. The problem could have been easily avoided if the bond pads had been made a bit larger and the polyimide passivation window had also been made larger. Unfortunately, the chip design was created years before the production and could not be changed. In prototype testing of wire bonding to the chip, this was performed by CMS and the problem of hitting the edge of the polyimide had not occurred, so the potential danger was not identified. It is true that the bond pad size was marginal and could have been made slightly larger without a major re-design of the chip. We note that future chip designs should allow for more space for the bond foot or a thinner passivation layer should be used (which is now the case, 1–2 μm is more typical of recent ASICs). It was also important to realize that if there is a chance of wires being moved, a pull test that minimizes wire movement may not reveal crack damage that could lead to severe weakening and potential failure in the future.

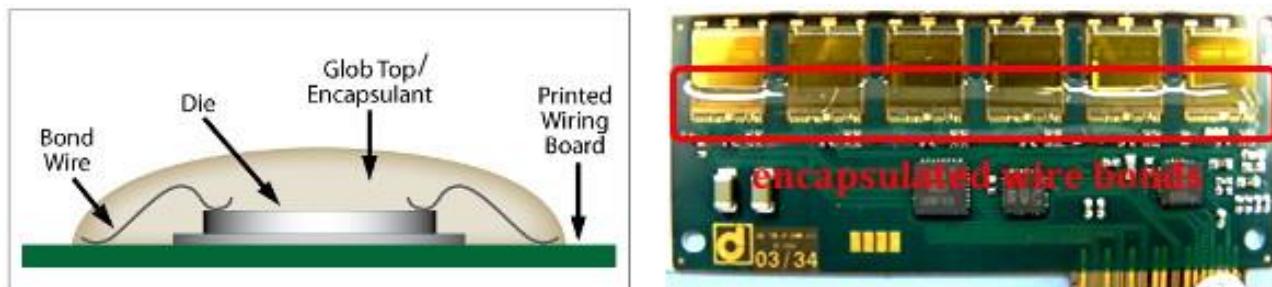
In an early two-sensor prototype module that was built in the United States and transported by air to CERN by a CMS collaborator, it was found to have nearly all its bond wires connecting the two sensors and connecting the sensor to the pitch adapter broken or severely weakened. The module was carefully handled during the whole transport process (it was in the person's hand baggage) and it was certain that it was never subjected to severe shocks such as what one might expect if the baggage was dropped or hit hard by another object. The hint that this damage might have been caused by vibration came from the fact that the broken wires were the ones in the center of the row of wires and not near the edges, where the sensors were glued to the module frame. The sensors were only glued to the support frame at the four corners and thus the central parts of the sensor edges were unsupported and could thus be moved more easily. However, the sensors were 500 μm -thick silicon, which is quite rigid, and thus it did not seem like they could bend sufficiently to cause movement damage to bond wires.

In order to study the possible cause of the damage, test modules were taken to a lab at one of the collaborating institutes where they had vibration test equipment. It was found that there were a number of resonant modes of a sensor held in the way it was held in the CMS modules but the most important one was the primary mode where the center of the sensors moved up and down. Since the fixed points were the corners, the unfixed edges would also move up and down at that resonant frequency although with a smaller amplitude than the center of the sensor. However, the amplitude of movement at the midpoint of the edges could reach millimeters, even with a very small driving amplitude of the vibration system. The frequency of resonance was around 500 Hz. In studying the

Figure 12. Left: Principle of encapsulation of wire bonds. Right: Photo of encapsulant on hybrid.

Since the modules would be bonded in 14 different sites in both the US and Europe, they would be seeing quite a lot of transport before being finally installed in the CMS pit in the LHC. Therefore, a solution was needed to avoid any such transport damage. One solution to this sort of damage has been used in industry for nearly as long as wire bonding has been used for chip attachment to its package. This solution is called potting or encapsulation and consists of encasing the chip and its wire bonds in a material that is applied as a fluid and then polymerizes or cools to become a solid (see Figure 12). Quite often the material used is a type of epoxy adhesive which hardens to something very tough and robust. However, this was not a good solution for the CMS modules as there was evidence that large surface coverage of epoxy adhesives on the active face of silicon sensors could damage or change the behavior of the charge collection of the sensor, thus degrading its use as a particle detector. It would not have been such a problem had the detector been intended for room temperature use only. However, the CMS silicon modules would need to operate at -20°C and, because of the large coefficient of thermal expansion (CTE) of these adhesives (typically 100 ppm/K compared to 3 ppm/K for silicon), there would be a very large stress on the silicon surface caused by the adhesive shrinkage when cold. Thus, it was decided to use a flexible silicone-based adhesive instead. This still had a large CTE but, because it remained flexible even at low temperatures, it would not create a large stress on the silicon surface. Many tests were performed to check that this material did protect the wires from vibration damage and yet did not overly stress the sensor at ambient or when cold. It also had to be tested for radiation hardness since it would receive a significant amount of radiation during the lifetime of the silicon tracker in LHC. In addition to this encapsulation, the sensor-to-sensor and sensor-to-pitch adapter edges were glued to a bridging piece of ceramic (which had a low CTE) in order to prevent these parts from moving with respect to each other. It was decided to apply the flexible encapsulant only for the modules made in the US, since those were the ones to experience air transport. The modules made in Europe had the extra support but not the encapsulation. There was no known transport damage to bond wires in any of the modules made during the production phase, so these solutions did work well.

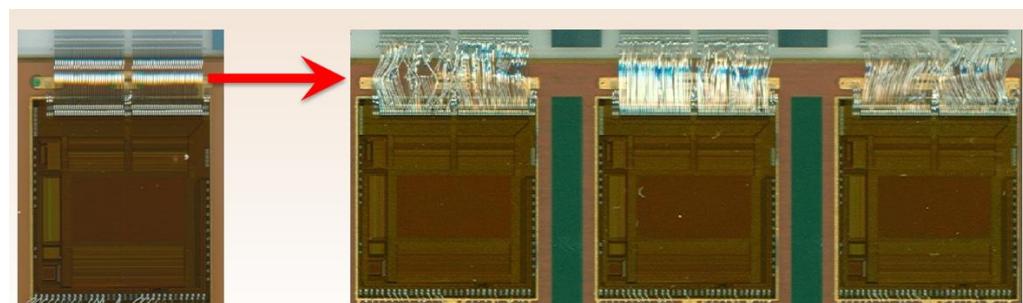
During the endcap module mounting work at CERN, a very large number of modules (about 400 in total) had their bond wires either damaged or broken. Several modules had the sensor broken and were thus non-repairable. However, those with only the bond wires damaged were usually repairable and could be re-installed in the endcap structures. The bond wire damage (an unrepairable example is shown in Figure 13) was mostly to the wires going to the ASIC chips, either the signals coming from the sensors (via the pitch adapters) or those coming from the PCB (control, power, monitoring). In all but a small percentage of modules, the damaged bond wires were able to be repaired, thanks to the CERN wire bonding lab, which had excellent technical experience with very difficult bonding situations. It was clear from the way the wires were damaged that the operators had difficulty avoiding touching the area during the mounting of the module. The location of the mounting screws was very close to the wire bonds in many cases. Given that the mounting of the modules in other facilities resulted in much less damage, it was made clear that either a lack of training, a less safe method of mounting, or the need for performing the job very quickly led to this massive damage. If the CERN wire bond lab had not been nearby (it was downstairs in the same building as the module mounting) and available for these often-difficult repairs, there would not have been enough spare modules to complete the endcap installation on time. However, another lesson learned from this was that the encapsulation of those wires that could be safely encapsulated could have prevented much (but not all) of the installation damage described above.

Figure 13. Left: Normal row of bond wires. **Right:** Damaged wires on three chips during installation.
