# ELONGATION OF LED LIGHTING LIFETIME UNDER X-RAY DOMINANT RADIATION ENVIRONMENT

T. Fukui<sup>†</sup>, T. Inagaki, H. Tanaka, RIKEN SPring-8 Center, Hyogo, Japan

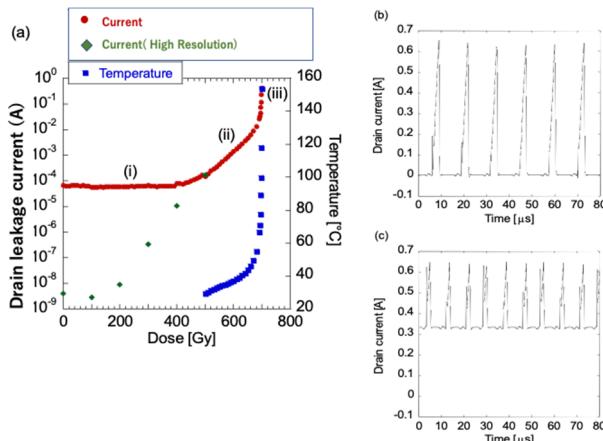
Figure 3(a) shows the turn-off leakage current ( $VG = 0$  V) as a function of the total dose to the MOSFET. The LED driver circuit was kept on during irradiation by the X-ray tube. The drain current was recorded continuously during the in-situ measurements as red circles. The current started to exponentially increase above 500 Gy and increased sharply above roughly 700 Gy. As seen in Fig. 3(c), a clear increase of the turn-off leakage occurs during stage (iii). The leakage current measured by the high-resolution setup are shown in Fig. 3(a) as solid green diamonds, and agreed well with that measured by the in-situ measurement more than 500 Gy dose.

The solid blue squares in Fig. 3(a) show the temperature of the MOSFET. The temperature gradually increased as a function of dose during stage (ii). When the total dose reached around 700 Gy (air kerma), the current and temperature increase sharply (stage (iii)), and finally the MOSFET was destroyed in a short period. This indicates that the sharp increase of current was caused by breakdown of the MOSFET in which temperature increase causes a decrease of the gate threshold voltage of the MOSFET, resulting in a further increase of the current. We expected that the increase of current was caused by the accumulation of holes near the Si/SiO<sub>2</sub> interface by applying voltage to the MOSFET. The detail of discussion is described in a reference [6].

Figure 3: (a) leakage current (red circles and green diamonds) and temperature of the MOSFET (blue squares) as a function of dose (air kerma). (b) Typical waveform of IDSS during stage (ii). (c) Typical waveform of IDSS during stage (iii).

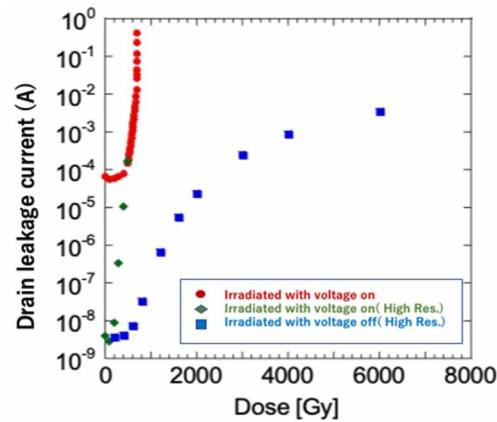
We measured the current with power off at each 200 Gy increment in dose until the total dose reached 800 Gy, as shown by the solid blue squares in Fig. 4. We found that the increase current was slow compared with power on, as represented by the red circles and green diamonds in Fig. 3(a). The measurements were repeated for each 400 Gy increment in dose until the total dose until 2000 Gy, and at 3000, 4000, and 6000 Gy. Although the leakage current increased as a function of dose. The increase rate was clearly suppressed compared with the case of power on.

Figure 4: The leakage current as a function of cumulative dose (air kerma) when MOSFET is voltage on (red circles and green diamonds) and voltage off (blue squares).

This is interpreted as follows; accumulation of holes near the gate due to radiation is caused by the voltage between source and drain, which is unlikely to occur when the power supply is turned off. This result suggests that it may be effective for elongating the lifetime of LED lightings to minimize the net time that LED lightings are turned on during irradiation. The leakage current increased as a function of dose.

We evaluate the LED lightings radiation damage process at SPring-8 tunnel and X-ray irradiation by an X-ray tube. It shows enabled to use an inexpensive commercial LED lighting at the large synchrotron radiation facility. The radiation damage to the MOSFET is dramatically suppressed by switching off the LED power supply in the X-ray radiation environment, and the LED lightings can be used even after the total dose of 6000 Gy (air kerma). A separate power supply outside the storage ring tunnel is also useful for preventing the failure of LED lightings.
