Analysis of MQXFA07 Test Non-Conformity

US-HiLumi-doc-4293

Date: Sept. 12, 2022

US HL-LHC Accelerator Upgrade Project

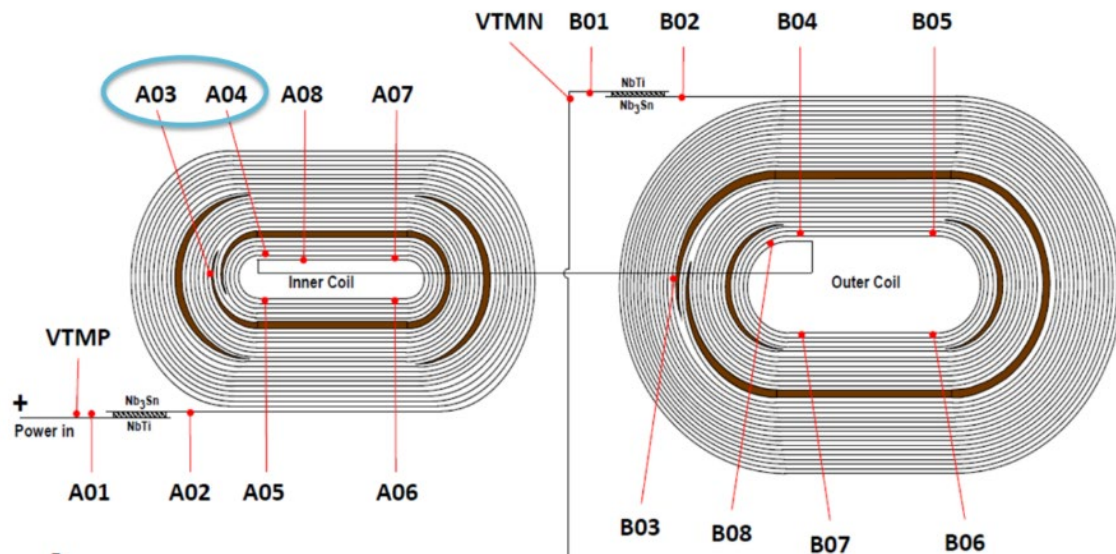
All limiting quenches in coil 214 started within segmented A3-A4 on the inner layer. As shown in Fig. 2.2, this is a multiturn segment including turns 2 to 6 counting from the pole. Turns 2-5 are included in the pole-block multiturn, whereas turn 6 is the first turn outside the wedge.

Figure 2.2: Voltage taps in MQXFA pre-series coils. All limiting quenches in coil 214 started with the multi-turn segment A03-A04.

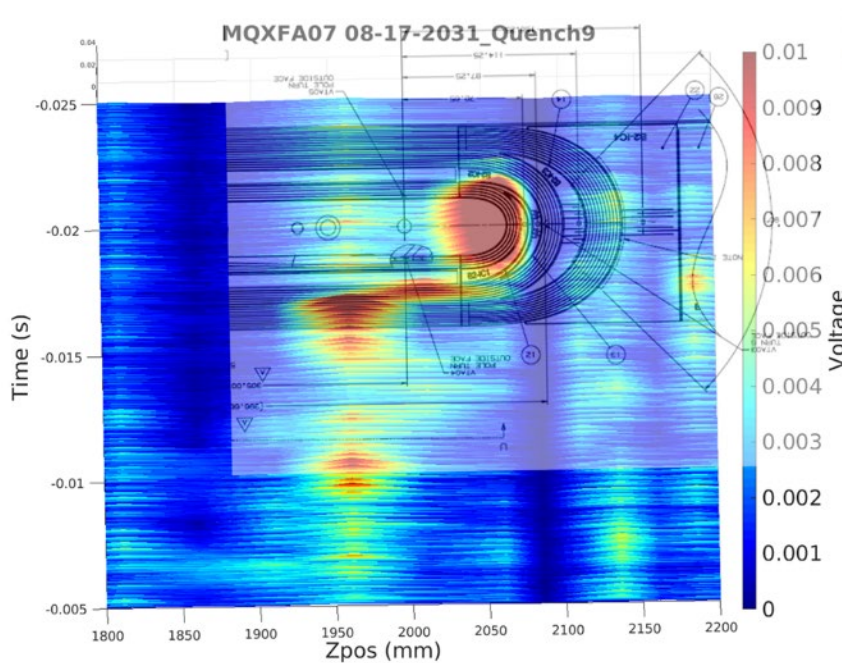
Figure 2.4 shows quench antenna signals (of quench #9) overlapped to a coil drawing. The quench starts at about -23 ms (from quench detection) at the longitudinal position where the turns of the pole-block go around the pole tip. The raw data are shown in Fig. 2.5 for quench 9. The contribution of the last 10 channels of the antenna is displayed. The quench start is detected by channel 95.

Figure 2.4: Signals of the quench antenna and localization along the coil axis for quench 9 (1.9 K, 20 A/s)

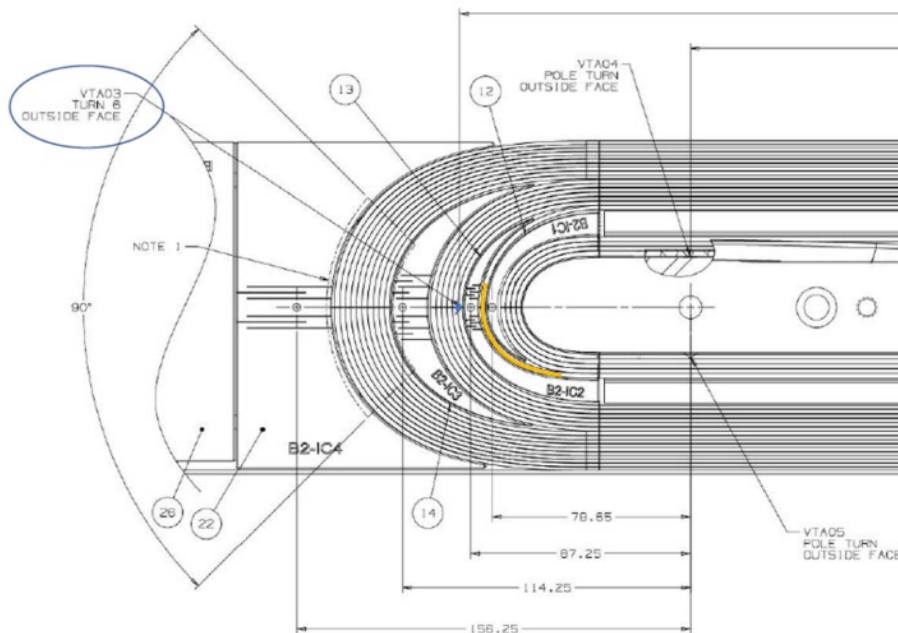
DR AM-164 describes that “during winding of layer 1, approaching turn 6, the cable collapsed”. The cable was repaired following standard practice (see details in Fig 3.2), and winding was resumed. “The next morning it was noted that some strands were out of position at the lead end.”

Figure 3.3: Inner layer coil drawing showing in yellow the position of coil-214 cable affected by DR AM-164

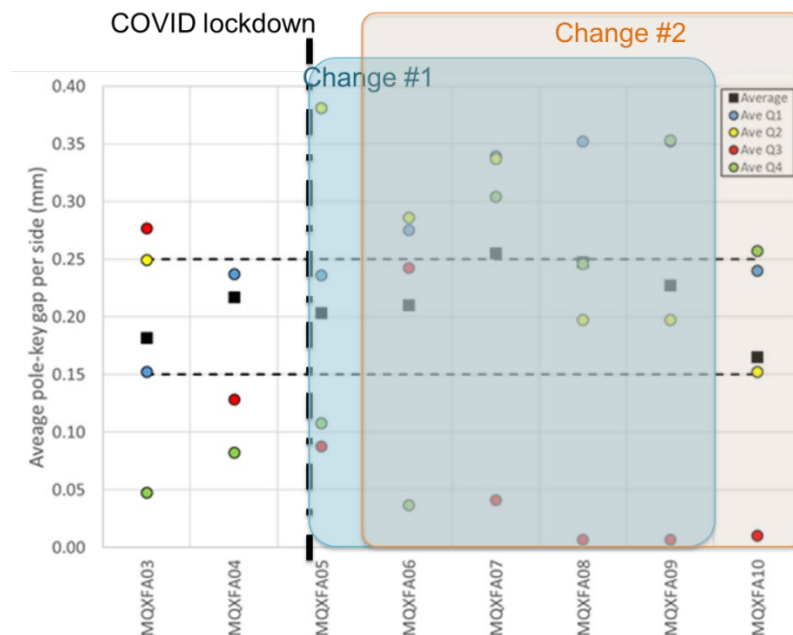
Figure 3.8: Average pole-key gaps (per key side) in magnets MQXFA03 to MQXFA10.

Figure 3.8 shows the average pole-key gap in each quadrant and for each magnet from MQXFA03 to MQXFA10. It can be noted that the minimum pole-key gap had a positive trend in magnets MQXFA03-MQXFA05, whereas it showed a negative trend starting with MQXFA06 (i.e. when change #2 was implemented). Therefore, it is our understanding that the changes due to Covid requirements contributed to small pole-key gaps in quadrant 3 of MQXFA07 and MQXFA08, which did not meet test requirements. Magnets MQXFA09 and MQXFA10 were disassembled before test, and MQXFA10 met test requirements after it was re-assembled with uniform pole-key gaps.

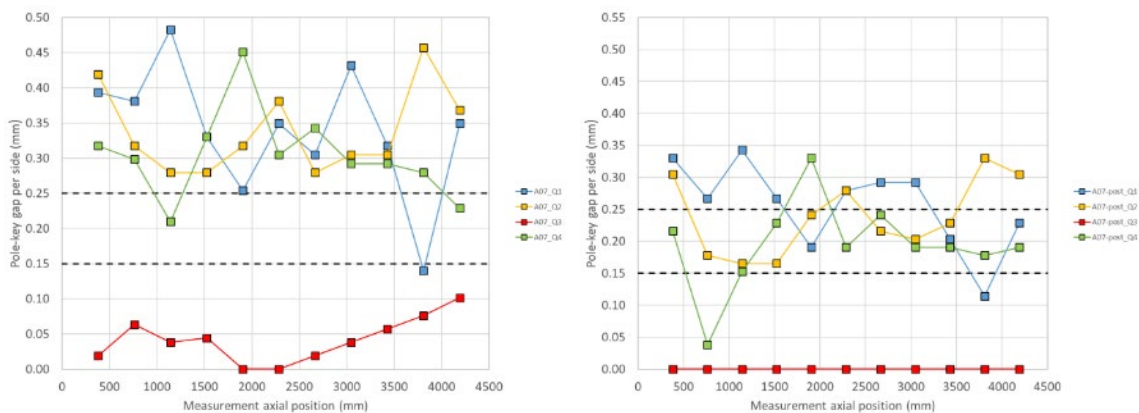
Consistently with the trapezoidal shape of the coil pack, a non-uniformity in the distribution of the pole key gaps was observed, both before and after the test. In Fig. 4.3, the pole key gap measurements in each quadrant as a function of the axial position, before the test (A07) and after the test (A07p), are shown. The specifications for the pole gaps, indicated by the dashed lines in the figures, state that the average pole key gap (per side) among the four coils on each longitudinal location shall be $+0.200 \pm 0.050$ mm. It can be seen that the average among 4 quadrants is on spec, both before and after the test, but a significant variation among quadrants is present. In particular, in Q3 an extremely low gap is observed before the test, and it becomes null after the test. The measurements before and after the test show that the gaps decreased by about 0.100 mm, but the same profiles among the quadrant is maintained, demonstrating the neither the room temperature loading, nor the cool-down or the test, corrected the non-uniformities in the pole key gaps.

Figure 4.3: Pole key gap measurements in each quadrant as a function of the axial position, before the test (A07) and after the test (A07p). The dashed lines indicate the spec values of the average of among the four quadrants on each longitudinal location.

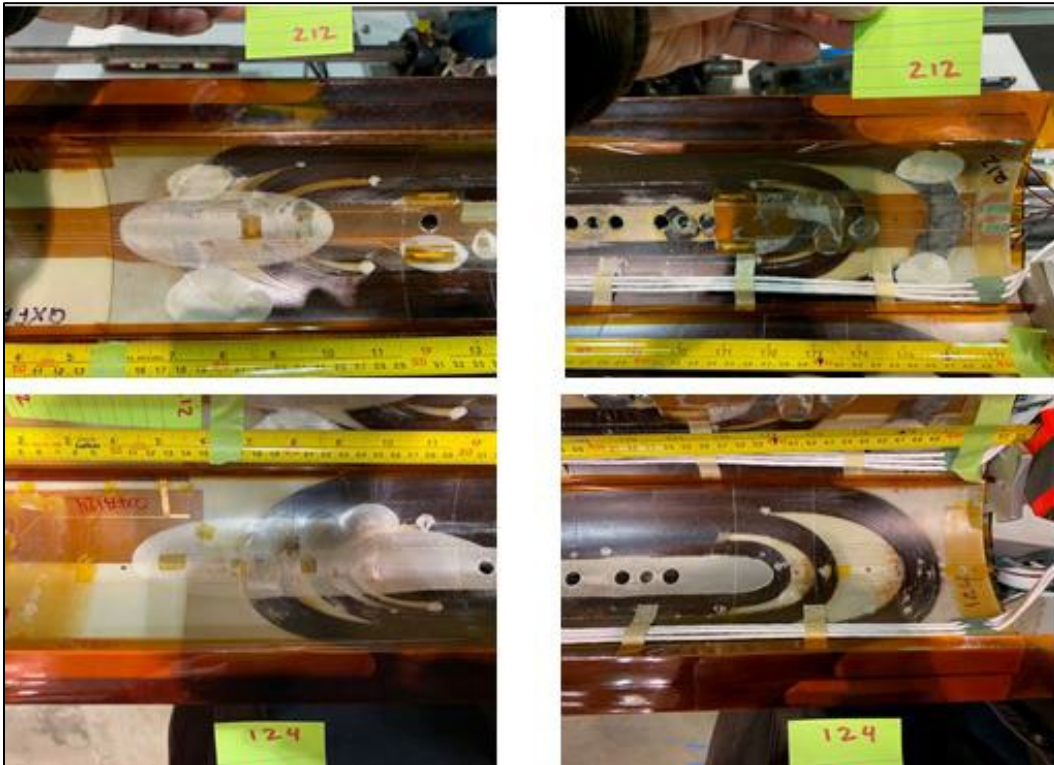
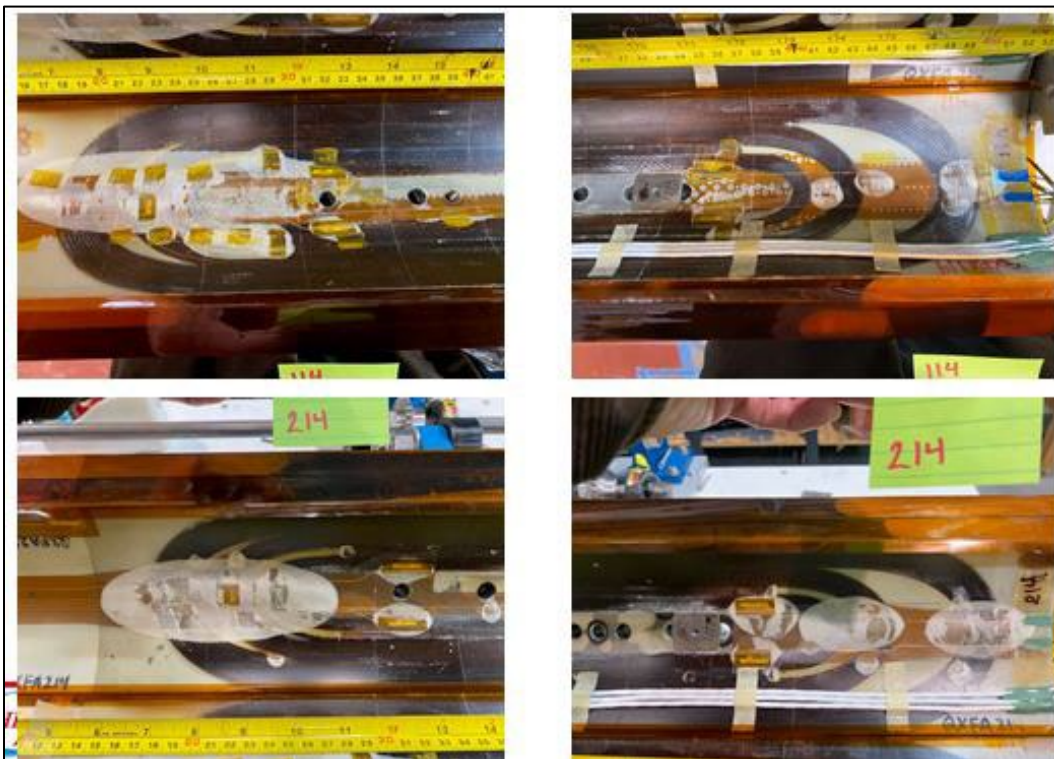
The coil inner surface was characterized by many bubbles/blisters, predominantly on the LE (Fig. 4.6 and 4.7). More observations and comments may be found at section 6.1 “Coil 214 Visual Inspection”.

Figure 4.6: Inner surface of coil 212 and 124 in the end region after test.

Figure 4.7: Inner surface of coil 114 and 214 in the end region after test.

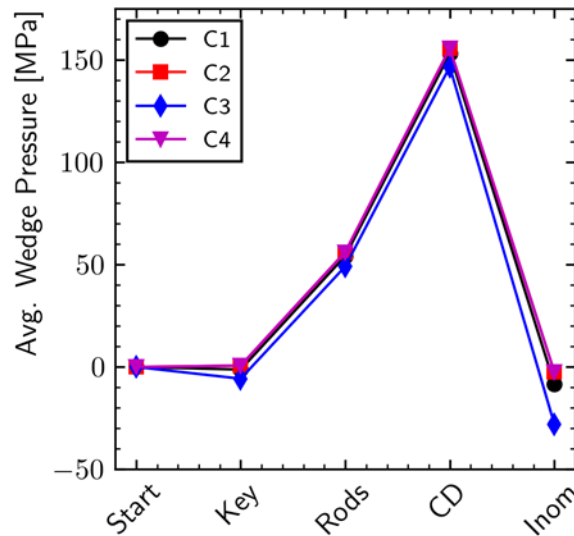
If now we focus on the contact area between the wedge and the end spacer in layer 1, we see that, if we assume that all the coil surfaces are bonded, a tension occurs in quadrant 3 during excitation, as shown in Fig. 5.5. More precisely, when Lorentz forces are applied, the average tension between wedge and end-spacer is about 30 MPa in quadrant 3, while it remains close to zero in the other quadrants.

Figure 5.5: Average contact pressure (negative in tension) between wedge and end-spacer in the bonded case.

In summary, a higher tension between the spacer and end-shoe is observed in the Q3 due to the lower azimuthal and axial pre-load caused by the closed pole key gap. The higher tension results in a higher possibility of epoxy cracking between the wedge and the end-spacer.

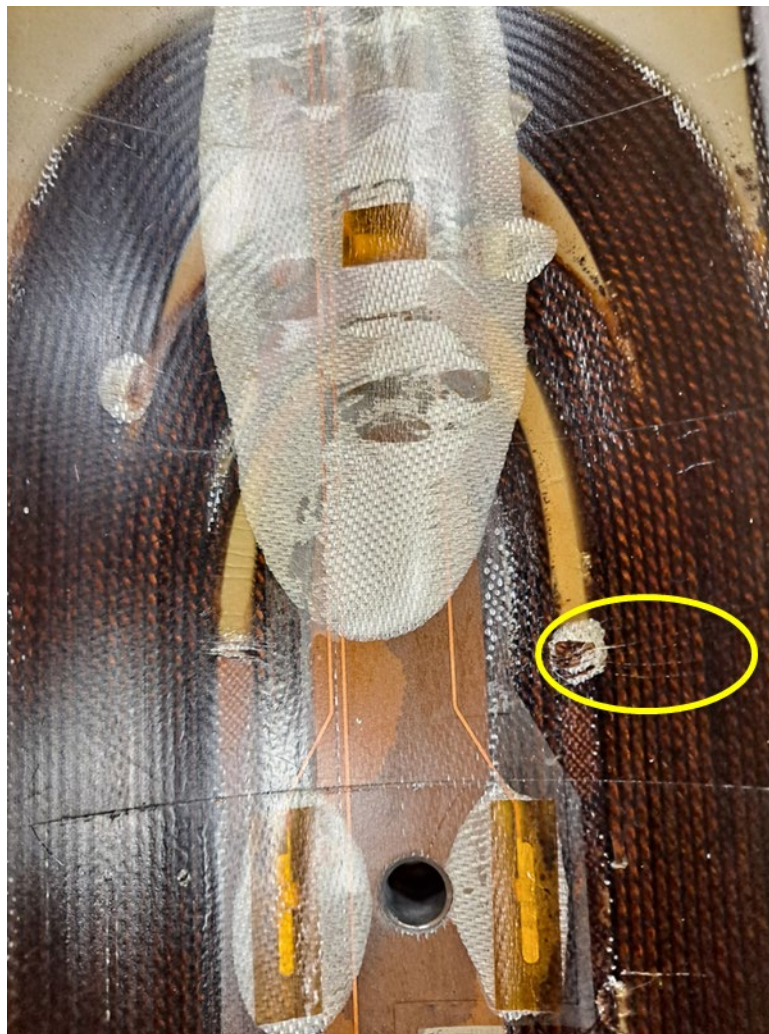
Figure 6.2: detail of coil 214 Lead End. The yellow box shows the position of “scratches” starting from the wedge to end-spacer transition

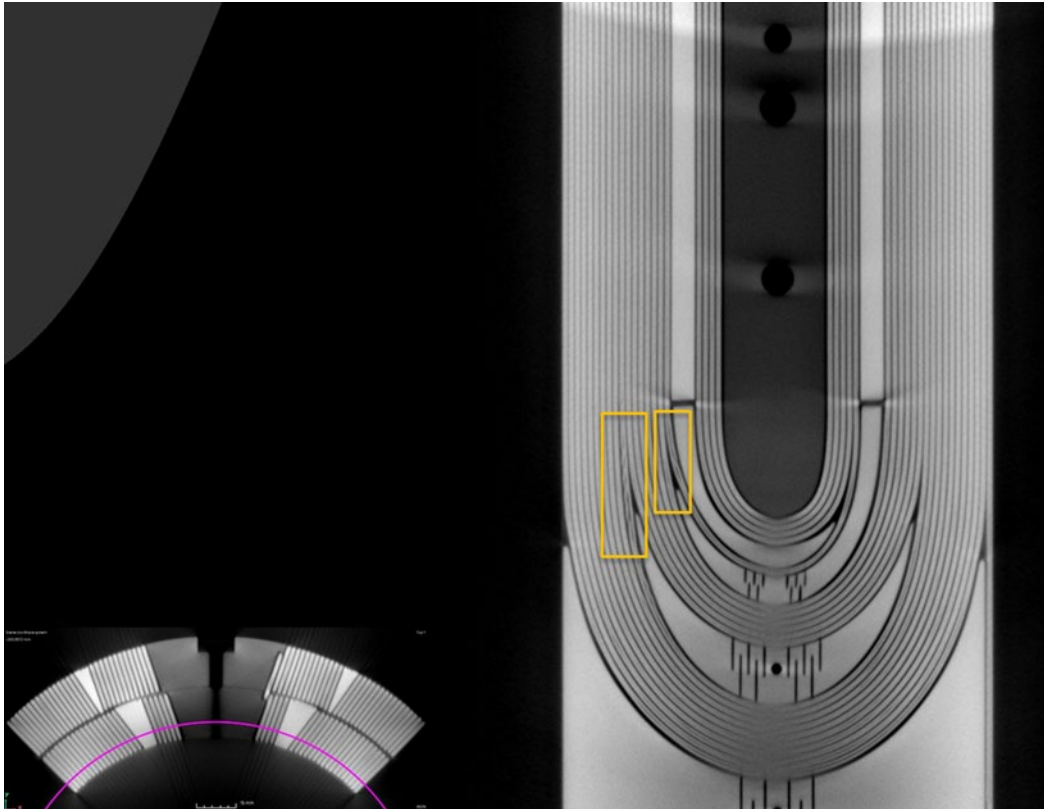
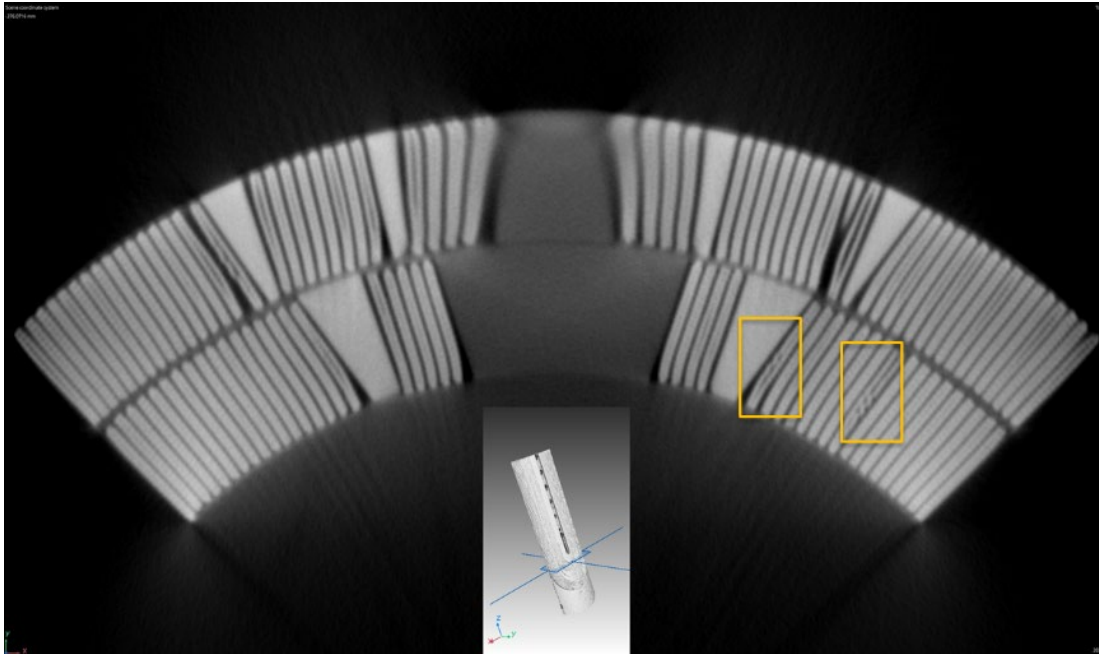
Figure 6.3 (Top): Image reconstruction of CT-scan through the Inner Layer of coil 214 Lead End. The purple line on coil cross-section shows the radial position. The yellow boxes highlight the location of two popped strands. The innermost one is within A3-A4 segment. (Bottom): Image reconstruction of coil radial cross-section at the location of the popped strands shown in the top picture.

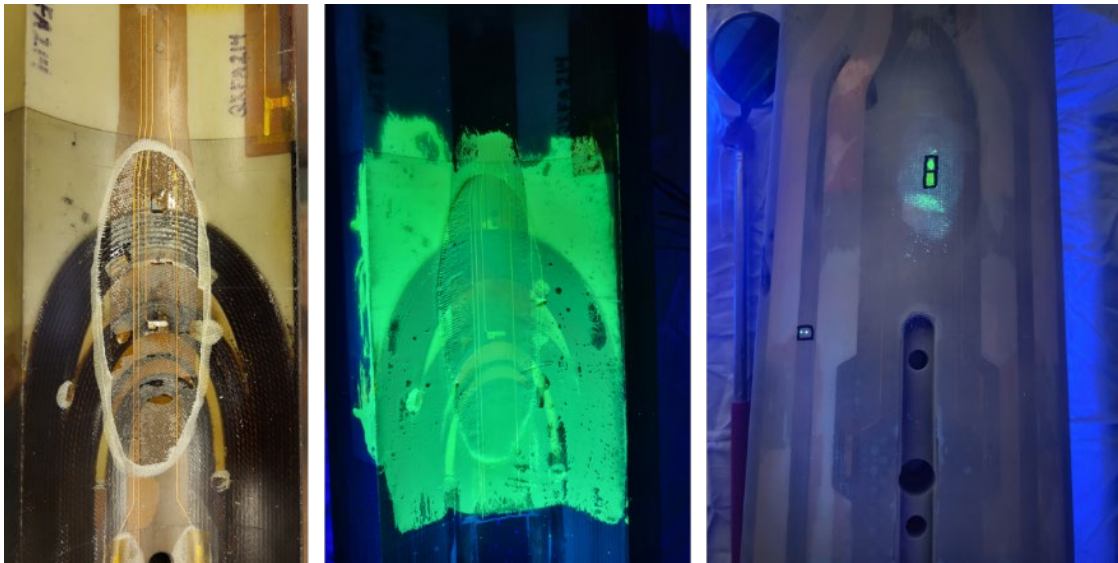
After the CT-scan dye-penetrant test was performed in order to check bonding among coil components. The large bubbles on coil ends were removed by cutting the delaminated insulation (Fig 6.4, left). The dye was applied to the inner radius surface of the coil (Fig 6.4, center) and the outer surface was subsequently examined for signs of paths through the coil (Fig. 6.4, right). Only two small paths were found on the Lead End (Fig 6.5).

Figure 6.4: Procedure and results of dye penetrant test on coil 214 Lead End. The large bubble was removed by cutting the delaminated insulation (left); the dye was applied to the inner surface of the coil (center); the outer surface was subsequently examined for signs of paths through the coil (right).

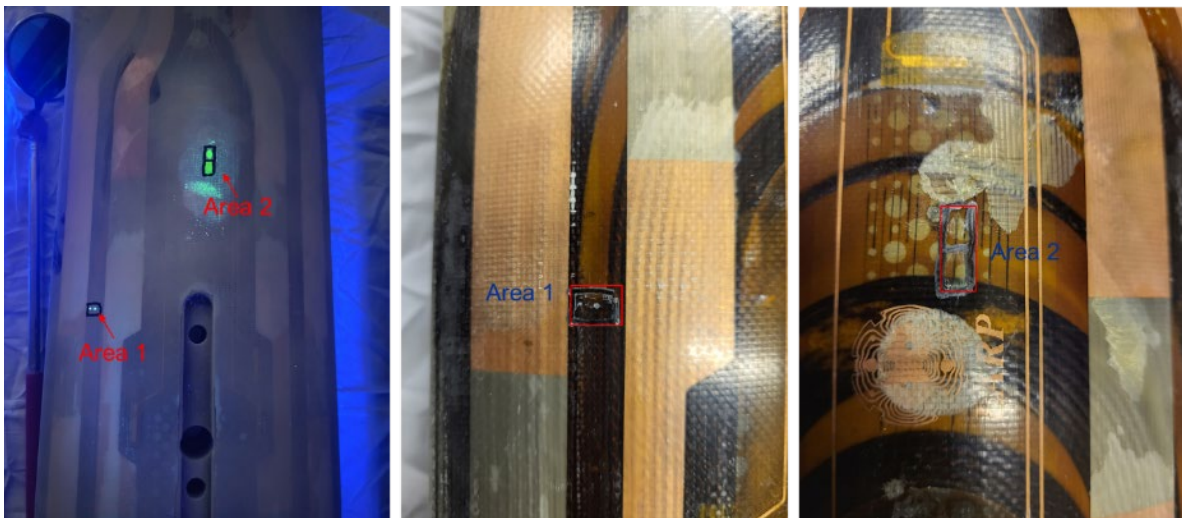
Figure 6.5: Areas where dye emerged on coil 214 outer surface in the Lead End

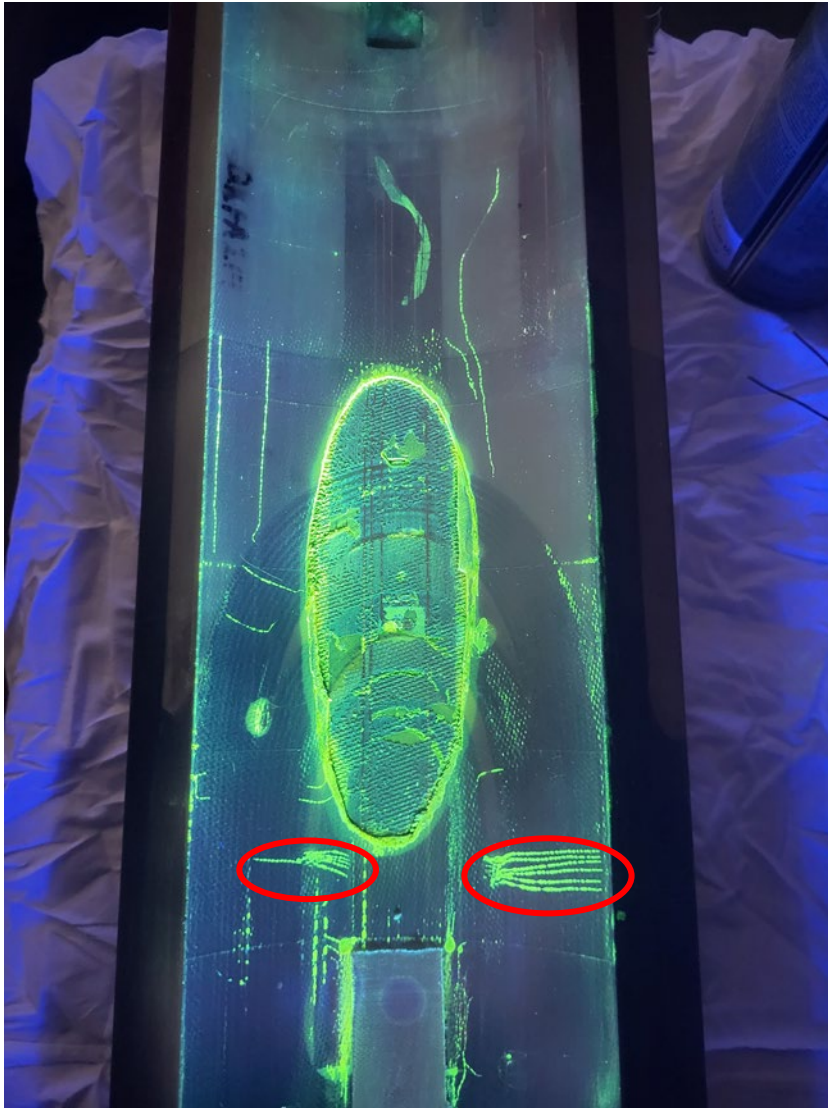
After the go-through inspection, the dye penetrant was cleaned on the inner surface and revelator was applied on the same surface. Some cracks on the surface of the impregnated insulation layer were detected. These areas are signs of superficial cracks and can be seen in Figure 6.6. This test highlighted the surface cracks at the wedge to end-spacer transition (red ovals in Fig 6.6) identified during the visual inspection (Fig. 6.2).

Figure 6.6: Inner surface of the Lead End showing some cracks on the surface of the epoxy-impregnated insulation layer. After the go-through inspection, the dye penetrant was cleaned on the inner surface and revelator was applied on the same surface to get this picture. The red ovals show the marks located/starting at the interface between wedges and end-spacers.

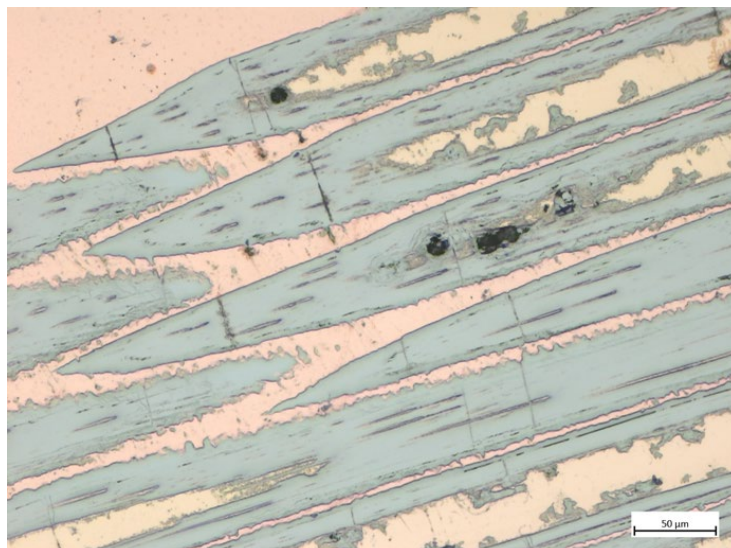
Figure 6.13. Example of some cracks shown in Fig. 6.12.

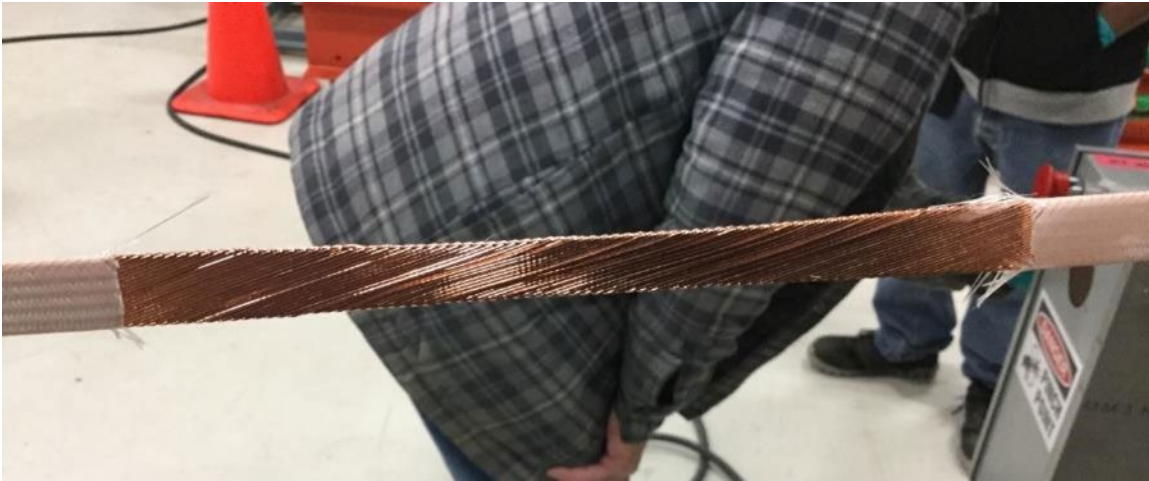
Figure 9.5: Coil 123 roped cable after insulation was removed, and before cable was fixed
