RHIC Au-Au OPERATION AT 100 GeV IN RUN 23*

Abstract

The Relativistic Heavy Ion Collider (RHIC) Run 23 program consisted of collisions of 100 GeV gold beams at two collision points for the first time since 2016; the sPHENIX collaboration used the beam to commission their new detector systems while the STAR detector took physics data. Completion of sPHENIX construction pushed the start of the run to May, forcing the collider complex to operate over the summer months and incurring lower than normal availability due to heat and power dip related problems. Issues with dynamic pressure rise during acceleration through transition resulted in a slower ramp up of intensity compared to prior years. Finally, a failure of a warm-to-cold current lead interface in the valve box for the Main Magnet power supply forced the run to end. This paper will discuss the progress made by each experiment and the failure mode, repair and mitigation efforts in preparation for Run 24.

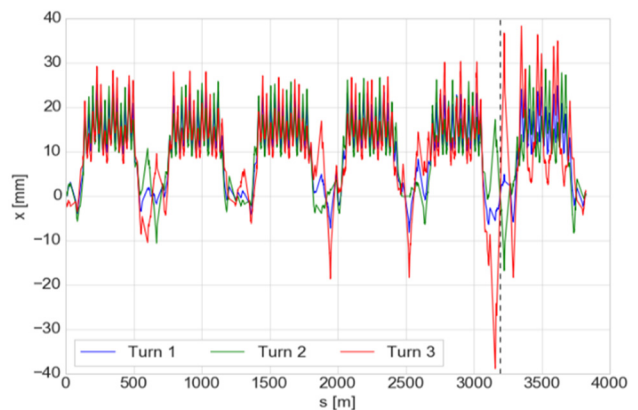
Shortly after collisions were established STAR reported an unusual asymmetry in their experimental backgrounds. Several beam experiments were carried out in an attempt to understand this. Ultimately a tracking simulation indicated that Au⁷⁸ generated by bound-free pair production in collisions in IP8 was responsible [1]. In the direction of the blue beam these particles would circulate for 3 turns before being lost in the high-beta triplet, creating particle showers in the detector.

Figure 2: Au⁷⁸ orbit tracking. After 3 turns the beam ends up in the triplet beampipe outside of IR6.

Unfortunately, there was no way to deposit this beam into one of the collimators or masks in RHIC, so work began to modify the optics to provide a distributed loss of this beam. The run ended before this work was completed; it will need to be implemented in Run 24.

Optics modifications to address the Au⁷⁸ will be used in the lattice for gold operations scheduled for late in Run 24.

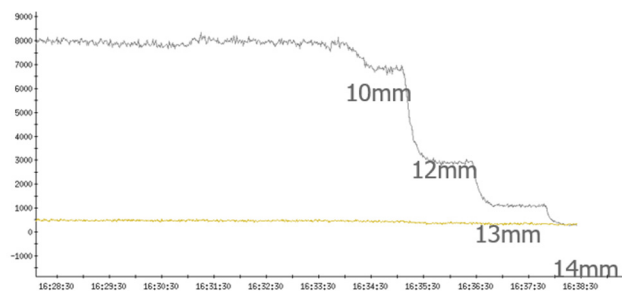
This suspicion was confirmed when a series of increasing amplitude orbit bumps were introduced further upstream, crashing the particles away from the detector.

Figure 3: STAR blue (grey trace) backgrounds reduced to those of yellow (yellow trace) as an arc bump was added to crash the Au⁷⁸ beam.

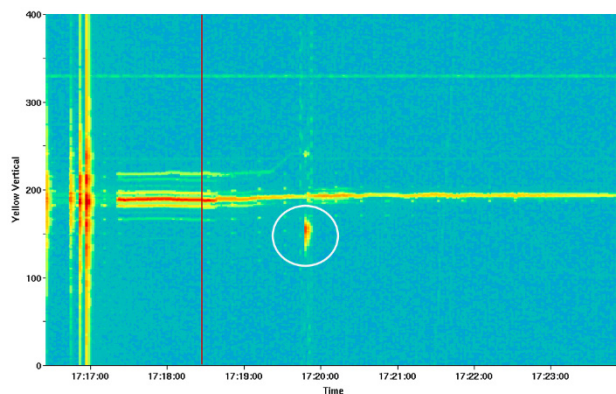
During the intensity ramp up phase of the run an unexplained excitation peak was seen in the broadband tune (BBQ) system in the yellow vertical plane approximately .1 unit away from the beam tune. This very quickly became a limiting factor in the beam intensity for ramping, causing large emittance growth. This growth could initially be compensated for by the stochastic cooling system of RHIC at store, but eventually made the beam large enough that the stochastic tanks could not close due to losses when the beam reached flattop.

Figure 4: Unexplained BBQ excitation (circled) seen in the yellow vertical pickup away from the beam tune (yellow horizontal line) at transition crossing.

Up to this point it had been several years since the machine had run at full energy with high intensity; sources of secondary emission yield were investigated but nothing stood out. Ultimately this intensity limit was avoided by moving the yellow vertical tune away from the peak seen in the signal.

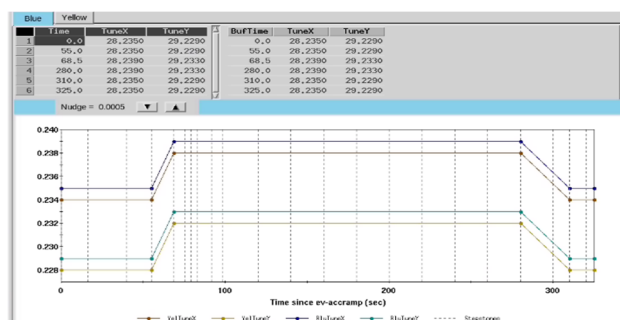
Figure 5: Target tunes for the ramp. To avoid the resonance a tune bridge was added to raise the vertical tune at transition crossing.

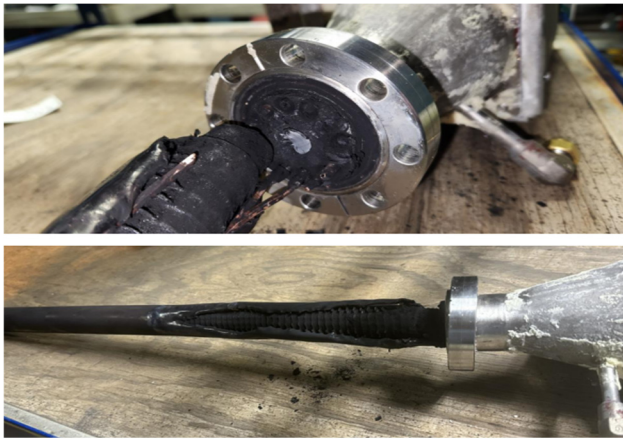
Each lead pot contains several groups of connections referred to as 'terminal boards'. The failure occurred in terminal board D (TBD) that contained 12 connections each rated up to 150 amps. An arc developed across two of the gas-cooled leads which then expanded to engulf 10 of the 12 pins, destroying them and rupturing both the TBD feed-through wall and the bellows that separate the insulating vacuum from atmosphere.

Figure 7: Site of arc on 10 of 12 pins in TBD

The postmortem investigation found several issues with the design and fabrication of the terminal board, mainly from dissecting the two pins that were not involved in the failure. The solder connections at the failure were done in blind cups with no weep hole, causing very incomplete solder joints. There was no mechanical connection of the copper pins to the cups, the solder was used for that as well as electrical connection. The copper pins are cooled by liquid helium flashing to gas and flowing up around the pins via a helix of plastic; the plastic was an interference fit with the pins, not allowing for any level of expansion. Several pieces of the helix fell out of the assembly when the insu-

lation was removed. The primary culprit leading to the failure is the control mechanism for the valve that determines the gas flow over the pins.

The 4 o'clock DX magnet was replaced with a spare since the time needed to check for damage within the original magnet would exceed the shutdown time between runs. A spare terminal board was installed into the failed location and the ruptured bellows were replaced.

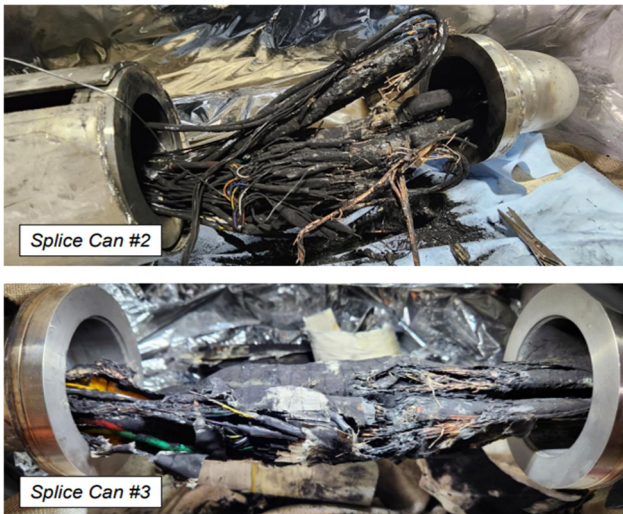
Most of the connections on the terminal board involved shunt supplies for the main quadrupole circuit, but one of them was an unused (but connected) circuit for the main dipole. When the arc occurred the dipole circuit became involved, firing the heaters for the 12 DX magnets around the ring. The combination of the arc in the valve box connection along with the warm gas flowing from the heaters firing led to a failure of the wiring connections on the upstream and downstream ends of the nearest DX magnet in the tunnel.

Figure 8: Wiring failure of 4 o'clock DX magnet

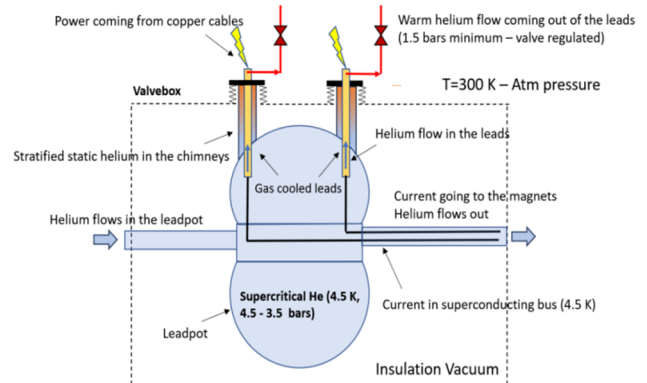
Figure 9: Helium gas flow for terminal board cooling controlled by red valves at the top of the diagram.

The flow control was set up in a very coarse way when RHIC was commissioned and wasn't specifically tuned for the currents involved in each terminal board when ramping. Analysis of logged voltages for each lead was used to calculate temperature in the leads and some temperature swings were seen to be over 200 degrees on every ramp.

Control of the gas valves for each terminal board were upgraded and a new algorithm will be used to tune up each valve throughout the ring based on the currents within that specific terminal board during ramping [3]. Time will be added to the startup period in Run 24 to check out and commission both the new DX magnet and the new gas flow calculations.
