# RADIATION DAMAGE OF UNDULATORS AT PETRA III

P. Vagin\*, O. Bilani, A. Schöps, S. Tripathi, T. Vielitz, M. Tischer, DESY, Hamburg, Germany

## Abstract

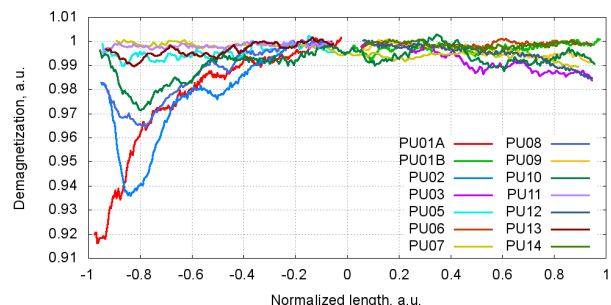
Figure 1: Demagnetization of PETRAIII undulators, horizontal axis is normalized to the length of a straight section.

There are 9 straight sections in the rededicated PETRAIII octant with 14 undulators installed. Some devices are paired in a straight section. The first ones of these show a stronger demagnetization, mainly from upstream part. The second devices show less demagnetization, mainly on the downstream end (Fig. 1).

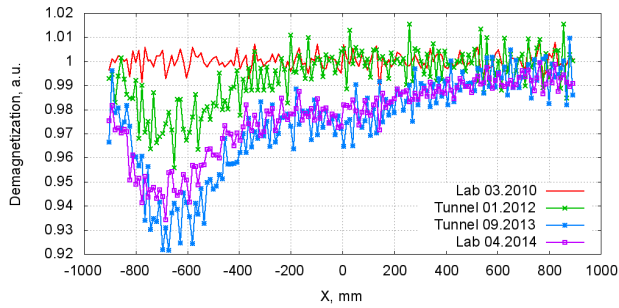
The sensors were mounted on a carriage that used the bottom magnet module as a reference for the vertical position. The assembly was manually moved along the undulator and the Hall probe voltage was continuously digitized in time. The data had no longitudinal coordinate reference, however only the peak amplitude was required to be measured. The position information could be extracted from the measured data by finding positive and negative extremum positions. Although this setup did not allow to measure the absolute field amplitudes and field integrals, in order to compare directly to the results of measurements in the lab performed before installation into the tunnel, still it was well suited to determine relative field changes along the magnet structure. The reproducibility of the measured data over several repetitions is 0.1%. However because of measuring both girders separately, and because absolute fields level could not be determined due to poor vertical and transverse positioning, the total accuracy is only 1% (Fig. 2). Which is significantly worse than in the lab.

Figure 2: PU02 undulator demagnetization progress.

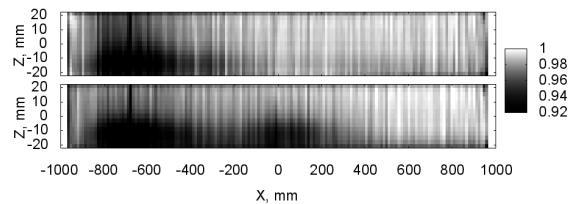
Figure 4: PU02 undulator demagnetization fieldmap measured for top and bottom modules separately at open gap.

During the current shutdown a few devices were removed from tunnel and properly remeasured in the lab. Measurements show a transverse non-uniformity of the demagnetization (higher field decrease at "ring-outside", negative Z), which is also different for top and bottom magnet modules (Fig. 3, 4). The demagnetization is highly localized longitudinally around X=-700mm and does not have its maximum

in the beginning. That would indicate a localized source of radiation, close to the undulator entrance, for example where the decreasing aperture of the vacuum chamber could cause additional beam losses.

The damage to the magnets is localized to the part which is close to the beam axis, therefore flipping of the magnets upside down could, for some time, fully correct field errors due to demagnetization, since the field contributions from the magnet parts far away from the beam axis is much lower.

For this particular device it was decided to refurbish the magnets. The magnets will be remagnetized, the coercivity will be enhanced by a rare earth diffusion process to strengthen the grain boundaries and after all an additional coating will be applied to prevent them from corrosion by exposure to synchrotron radiation.

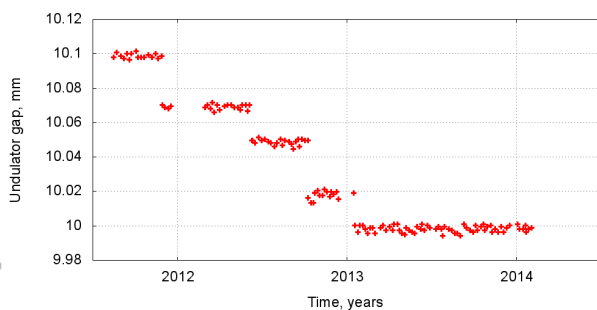
Figure 5: PU02 gap setting to reach 60keV on 7<sup>th</sup> harmonic is decreasing over time to compensate demagnetization, till it reaches minimum gap defined by vacuum chamber size.

In order to compensate for the demagnetization of the PU02 undulator, gap settings to reach the same wavelength were decreasing over time until reaching the minimum value defined by vacuum chamber. Therefore it was decided to refurbish the magnets during current one-year shutdown for building PETRA III Extension. After that, further improvements in beam lifetime and more careful machine operation should reduce beam losses and therefore radiation damage to the insertion devices.

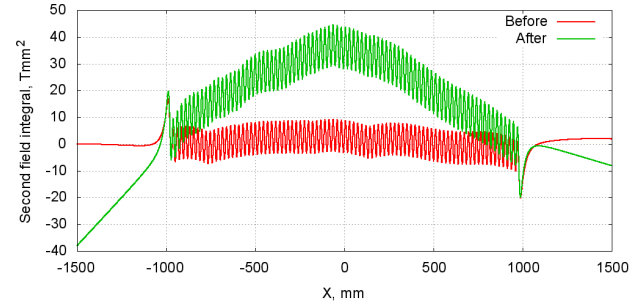
Despite the strong field losses of ~6%, the trajectory straightness was not really affected, as a significant number of poles were demagnetized. Thus field changes on neighbouring poles with opposite signs were similar, having only minor impact on field integrals (Fig. 6).

Figure 6: PU02 trajectory before and after demagnetization.

In contrast to that, the effects of demagnetization on the phase error is much more severe, since different parts of the undulator have different field amplitude and thus different emitted wavelength, causing the phase error increase even to the values over  $\pi$ .

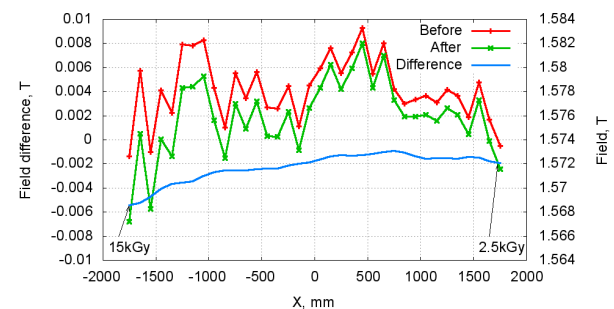
Figure 7: DW05 peakfields after 5 years of operation.

A review of one of the damping wigglers in the lab showed only slight demagnetization mainly on the upstream end. Since this is the first wiggler in a long straight damping

wiggler section, the full dose measured by TLDs can be attributed to the particle losses, and not to synchrotron radiation. The total accumulated dose measured is 15kGy at the upstream side, and 2.5kGy downstream. This is more or less consistent with the magnetic measurements, showing a demagnetization of 5mT (0.3%) at the upstream and only 1mT at the downstream end, which however is only slightly above accuracy level of these magnetic measurements.

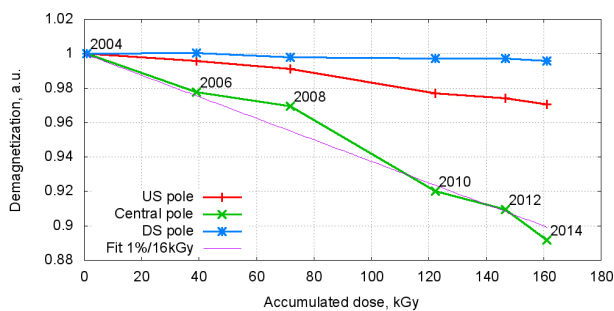
To study radiation damage effects at FLASH, a special 3-pole undulator (with +0.5;-1;+0.5 poles) is installed right before the SASE undulator section. Correlating the periodically remeasured magnetic field of this device with the TLD data for the accumulated dose shows that the magnetic field degradation is 1% per 16kGy of accumulated dose.

Figure 8: Sacrificial undulator demagnetization.

The up- and downstream poles show less demagnetization as they have smaller magnets. Therefore demagnetization fields are lower than for the normal magnets in the center. In addition to that the downstream magnets are shielded by preceding poles.
