# TWENTY YEARS OF OPERATION OF THE ELETTRA RF SYSTEM

C. Pasotti, M. Boccai, P. Pittana, M. Rinaldi,  
Elettra - Sincrotrone Trieste, 34149 Basovizza, Trieste, Italy

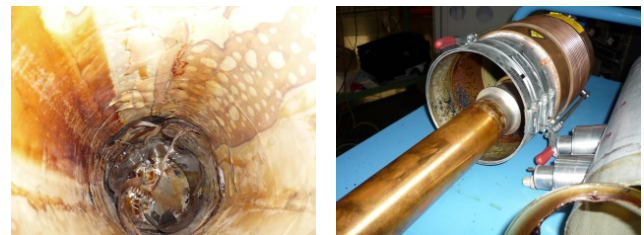
Figure 2: Klystron based transmitter ageing: damaged insulation of the linear HV transformer laminated core and burnt klystron output coaxial line.

The full energy injection and top up operation has greatly helped the RF system, relaxing the requested performances. Nevertheless first evidences of aging troubles arose from the increasing operating hours mainly on the klystron based transmitter. Several failures happened in 2010 and 2011, for example burnt part of a power coaxial output line and of the linear high voltage transformer, shown in Fig. 2. Those have been replaced during user time.

The extraordinary servicing is also triggered by the failure's incidence. A renewal campaign of the aging klystron transmitters was performed from 2010: high voltage capacitors and cables, electronics components if available and HV transformers were replaced to extend their lifetime. This operation has been made possible because of the large spare parts made available at the transmitter's purchasing stage. Today's replacements are running out and the klystron production has been discontinued. The transmitter failure rate is almost cleared for the next few years, but it is not anymore worth to invest budget and effort in these aging transmitters.

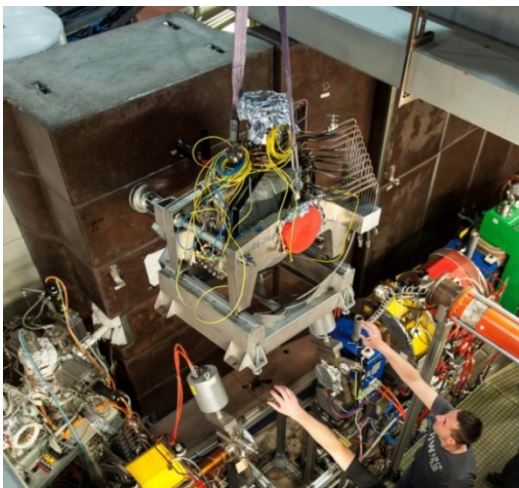
In 2003, 2009 and 2013 respectively, three among four cavities have been replaced having an improved copper losses capability of 60 kW as shown in Fig. 3.

Figure 3: Cavity installation in the Elettra storage ring.

Each cavity replacement time (the new cavity ready for acceleration) is around 15 working time but it should be recalled that the cavity is already conditioned at full RF power in the laboratory.
