# THE FACILITY FOR RARE ISOTOPE BEAMS SUPERCONDUCTING CAVITY PRODUCTION STATUS AND FINDINGS CONCERNING SURFACE DEFECTS\*

C. Compton<sup>†</sup>, H. Ao, J. Asciutto, J. Craft, K. Elliott, W. Hartung, S. Kim, E. Metzgar, S. Miller, E. Oswald, J. Popielarski, L. Popielarski, K. Saito, T. Xu  
Facility for Rare Isotope Beams, Michigan State University, East Lansing, MI, 48824, U.S.A.

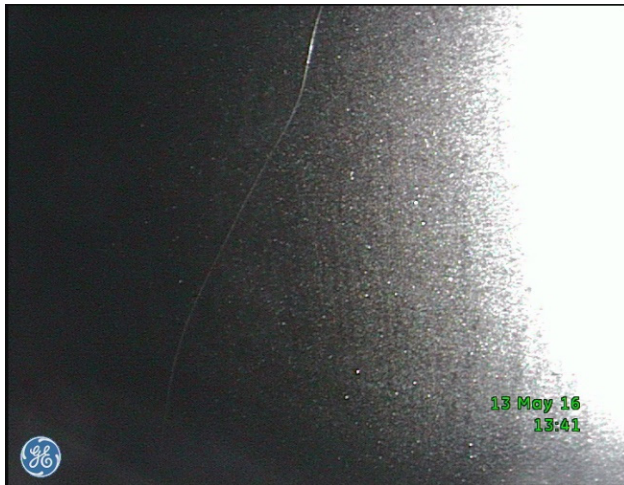
Figure 4: Scratch along the inner conductor observed after the first Dewar test ( $\beta = 0.085$  QWR, S85-952).

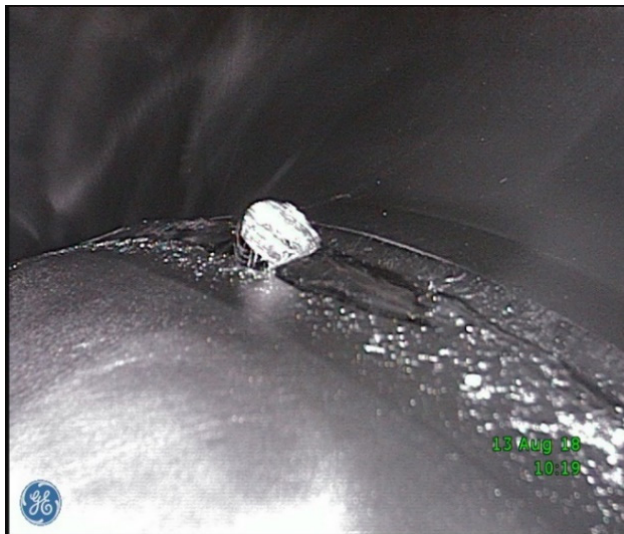
Figure 5: Electron-beam weld repair of inner conductor to short plate blow-through with plug not fully melted, observed during incoming inspection ( $\beta = 0.53$  HWR, S53-125).

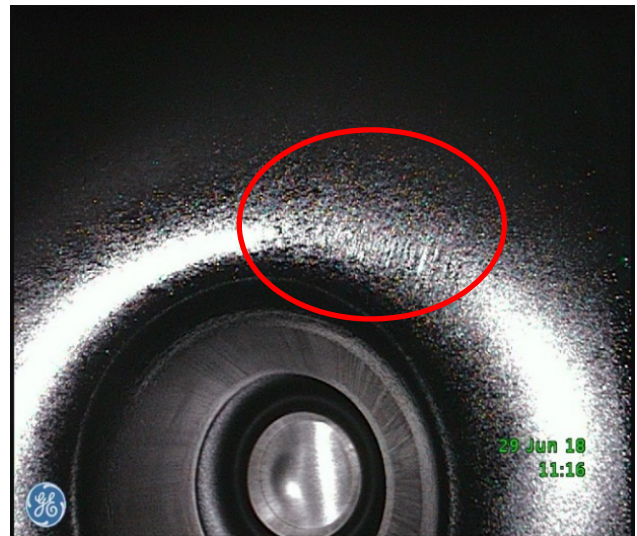
Figure 6: Surface scratches/ledges on the drift tube, possibly due to acid erosion, observed after the first Dewar test ( $\beta = 0.53$  HWR, S53-113).

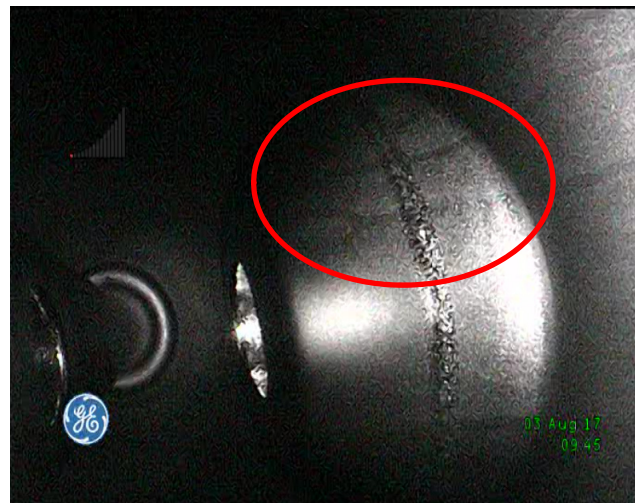
Figure 7: Acid vapour marks on outer conductor observed after first Dewar test ( $\beta = 0.085$  QWR, S85-951).

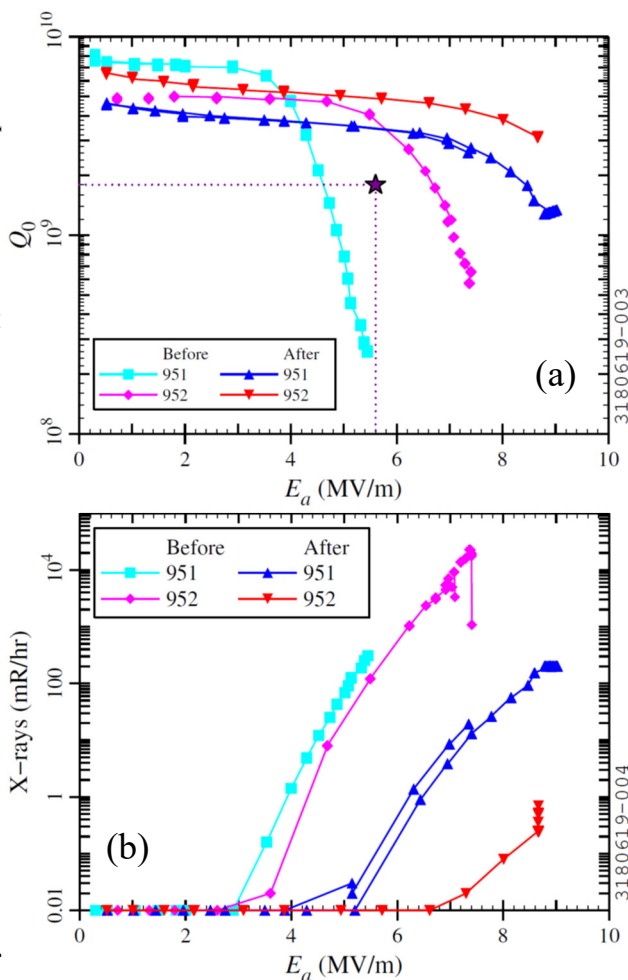
Figure 8 (cyan and magenta) shows an example: two cavities which had heavy field emission in the first Dewar test, as seen by X-ray levels increasing rapidly with field and corresponding decreases in the quality factor. In the borescope inspections after Dewar testing, features were observed on the inner conductor (see Figure 4) and drift tube. These features were mechanically polished, and the cavities were reprocessed and retested. The post-polishing tests show a significant improvement in the quality factor at high field and a corresponding reduction in field emission X-rays (Figure 8, blue and red).

Figure 8: Dewar test results at 2 K for two  $\beta = 0.085$  QWRs before and after mechanical polishing: (a) quality factor and (b) X-rays as a function of accelerating gradient ( $E_a$ ). Purple star: FRIB operating goal.

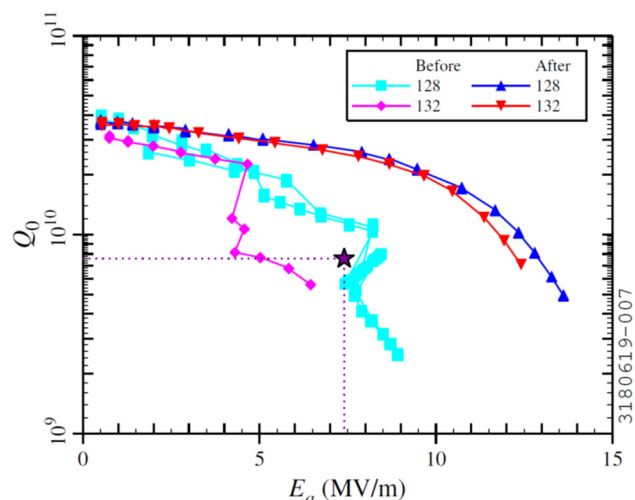
Cavity S53-128 ( $\beta = 0.53$  HWR) showed marginal performance in the first certification test and had a  $Q$ -switch behaviour, as shown in Figure 9 (cyan):  $Q_0$  and the field jumped downward at  $E_a = 5$  MV/m and dropped further at about 8 MV/m. The incoming borescope inspection had shown a surface feature on the beam cup to outer conductor weld (Figure 10a). The initial thought was that the feature was residual oxide from acid etching or a weld inclusion; hence a polishing rework was implemented.

Cavity S53-132 (another  $\beta = 0.53$  HWR) did not meet the certification requirements in the first Dewar test, and also had a  $Q$ -switch near 5 MV/m (Figure 9, magenta). The borescope inspection revealed a feature on the outer conductor to short plate weld, as indicated by oxide coming from the weld, shown in Figure 11. The vendor’s report indicated that a weld blow-through occurred in the suspected area, and that a repair was done using a niobium plug.

Figure 9: Dewar test results at 2 K for two  $\beta = 0.53$  HWRs before and after mechanical polishing.

After polishing, the cavity was reprocessed and Dewar tested again. In the second test, it met the FRIB certification requirements with good margin for field and quality factor (Figure 9, blue).

After polishing, the cavity was reprocessed and retested. The post-polishing test showed considerable improvement in performance (Figure 9, red), such that the cavity met the requirements for  $Q_0$  and field.

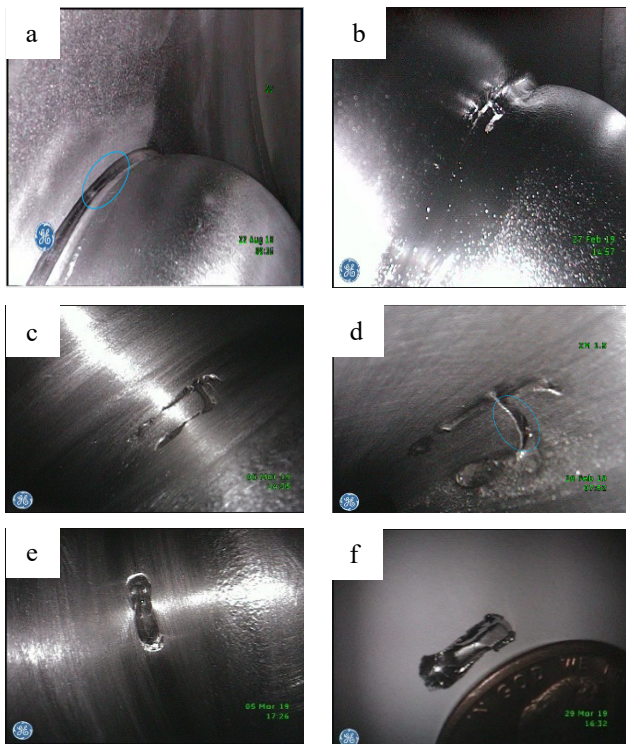
During the initial stages of polishing, the feature “opened up” revealing additional voids in the weld and along its edges (Figure 10c). Further material removal showed the area was a weld overlap with a void underneath, producing a small pocket (Figure 10d). The material over the pocket was polished away and the remaining pocket was blended into the adjacent sides (Figure 10e). Partway through polishing, a piece broke away (Figure 10f).

Figure 10: Polishing of S53-128 feature: (a) as received, before etching; (b) after etching and test; (c) after initial polishing, “opening up”; (d) shelving with void underneath; (e) top material removed, blending void area to adjacent surface; (f) fragment broken off during polishing.

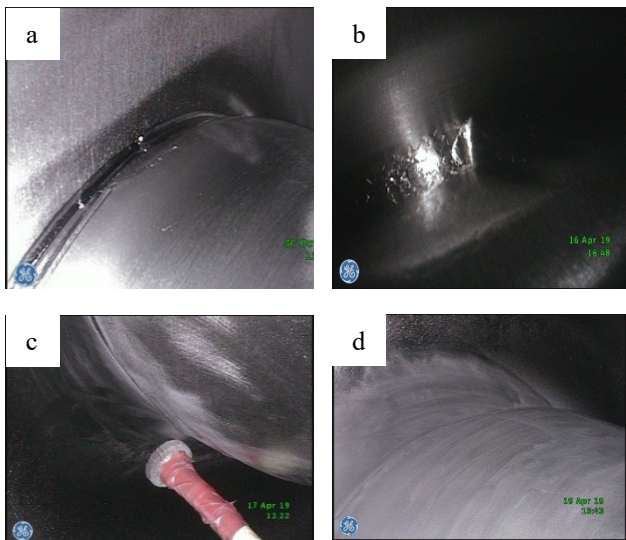
Initial polishing caused the feature to “open up” revealing more dark, oxide-like material (most likely foreign material). Polishing was continued until no traces of foreign material were visible. Salt-water soak and inspection were repeated after mechanical polishing, with no foreign material observed.

Figure 11: Polishing of S53-132 feature: (a) as received, before etching; (b) after etching and test; (c) during polishing; (d) after polishing.
