## How to upgrade a pixel detector: lessons from Phase-1 being applied to Phase-2 CMS Pixel Upgrade

**Rachel Bartek<sup>a,\*</sup> for the CMS collaboration**

*42nd International Conference on High Energy Physics (ICHEP2024)  
18-24 July 2024  
Prague, Czech Republic*

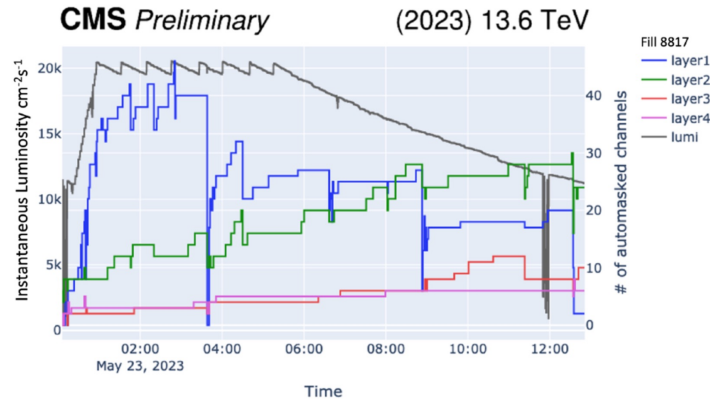
**Figure 2:** Plot showing a soft error recovery storm during May 23, 2024 for each of the 4 pixel barrel layers. The number of automasked channels in layer 1 (blue) can be seen climbing with luminosity (black). The dip in automasked channels just before 4 hours into the run is due to a pause and resume sent by global DAQ. The number of automasked channels from layer 2 (green) can be seen climbing the entire fill. These are due to stuck TBMs which accumulate during the run and are only cleared via a power cycle [6].

To recover stuck parts of the detector, a soft error recovery (SER) mechanism was created. This is a way to recovery from SEU (single event upset) or SEU-like events by only briefly interrupting data taking. SER recovers port cards and front end chips by refreshing the configurations of stuck parts. A full configuration would interrupt data taking for a much longer time. If the SER is not successful after several attempts, the channel is then automatically masked or "automasked". In Run 2 CMS started to experience SER "storms" when pileup exceeded 60. These were events during a run where the pixel would continuously go into SER and data taking would be interrupted very frequently for a few minutes. As seen in Fig. 2, the number of automasked channels in layer 1 is high until the pause and resume sequence is issued just before 4 hours into the fill, clearing the list of masked channels and allowing for reprogramming of devices at a lower PU near the end of the luminosity leveling phase of the fill. It was found that by adjusting the working point of the layer 1 channels these storms could be minimized but not entirely solved. Stuck channels in layer 2 continue to climb the entire fill and is not reduced by a pause and resume due to a vulnerability in the TBM. These stuck TBMs are how the DC-DC problem was discovered in 2017.

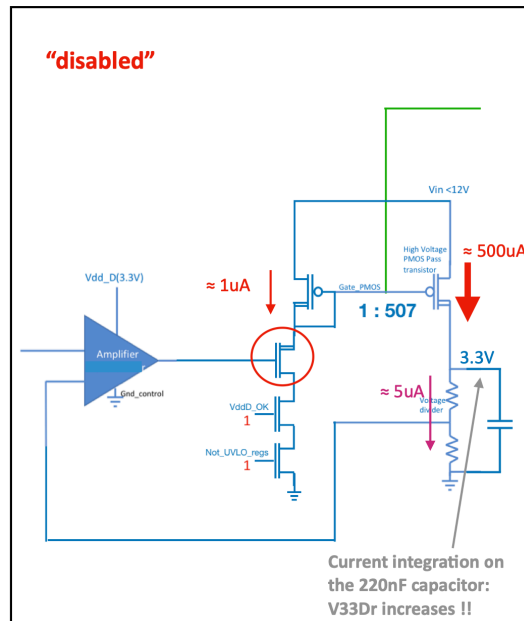
In order to provide power to many more modules in Phase-1 than the original CMS pixel detector consisted of, the CMS pixel detector uses DC-DC converters to step from 10 V to 3 V. As this was an upgrade scheduled to be installed during an extended year end technical stop, the number of cables was fixed. 1184 converters based on the radiation-hard FEAST2 ASIC developed at CERN were needed for the Phase-1 upgrade. The pixel operations team used the enable/disable function in the FEAST2 chip to power cycle stuck TBMs in 2017. However after about  $30 \text{ fb}^{-1}$ , DC-DC converters started to break. By the end of 2017 data taking, 5% of the converters were broken. While problems in the CMS Phase-1 pixel system are unfortunate, its design allows it to be extracted and reinstalled quickly. There was however large concern for the LHC community because many less accessible detector systems were planning on using the FEAST2 DC-DC converters for the HL-LHC. Hence, there was much interest from the community. These converters have now been substituted with the bPOL converters because the FEAST production fab closed.

All DC-DC converters were replaced during year end technical stop 2017/2018. This allowed for detailed testing where it was found that 65 were broken and 333 exhibited high current. It was thought that the high current mode might be an initial sign of deterioration, but it is now understood that there were actually two failure modes, both related to trapped charge in the chip. In the disabled state, the current on the 220 nF capacitor increases as seen in Fig. 3. This causes voltage spikes well beyond the 3.3 V this part of the chip can handle. This part of the chip provides current to the drivers of the power transistors, so after a voltage spike the chip is dead and will not turn on. Similarly increase leakage current after irradiation damages the current mirror, causing high current DC-DC converters. During 2018, a workaround was developed to power cycle the stuck TBM modules from the power supply and also to reduce to 9 V so there were smaller currents during the power cycle sequence. The problem was permanently resolved with new DC-DC converters equipped with a new version of the FEAST2 ASIC that were installed during long shutdown 2 (LS2).

There is an unfortunate addendum to the DC-DC converter saga. Some modules were permanently damaged during running with their low voltage off due to broken DC-DC converters, but their high voltage on. A running configuration, coming about due to a mismatch in the LV and HV powering granularity, was not considered nor studied before. The turned-off readout chips could not drain the leakage current off the sensor efficiently, this damaged the preamplifier. Most damage can be seen in the modules where there were high particle rates, so in the affected forward pixel modules, the readout chips nearest the beam line are almost dead, but the readout chips furthest

**Figure 3:** Diagram showing a section of the FEAST chip in disabled state. In this state, leakage currents are amplified and lead to a charge-up of a capacitor up to the input voltage (11.4 V in 2017) instead of the specified 3.3 V. The discharge when the converter gets enabled can damage the connected electronics irreversibly. Alternatively, a new ohmic path to ground can form. The latter case explains the occurrence of converters with higher power consumption in the disabled state. [8].

away from the beam line on the same module still provide good data for physics. Fortunately with the planned replacement of layer 1 during LS2, few enough modules were damaged so that the physics performance of the pixel was preserved.
