# High Voltage Performance Degradation of the 14UD Tandem Accelerator

**Abstract.** The 14UD at the Australian National University's Heavy Ion Accelerator Facility (HIAF) operated at a maximum voltage of 15.5 MV after the installation of tubes with a compressed geometry in the 1990s. In recent years, the performance of the accelerator has shown a gradual decline to a maximum operation voltage of  $\sim$ 14.5 MV. There are some fundamental factors that limit the high voltage performance, such as SF<sub>6</sub> gas pressure, field enhancement due to triple junctions and total voltage effect. In addition, there are non-fundamental factors causing high voltage degradation. These are: operation with faulty ceramic gaps; operation at inappropriate voltage and SF<sub>6</sub> pressure combinations; SF<sub>6</sub> leaks into the vacuum space; use of SF<sub>6</sub> and O<sub>2</sub> as a stripper gases; poor electron suppression in the high energy stripper and frequent use of highly reactive ions such as sulphur and fluorine. In this paper we will discuss factors that limit the high voltage performance. The main outcomes of a preliminary investigation of titanium (Ti) electrodes removed fro

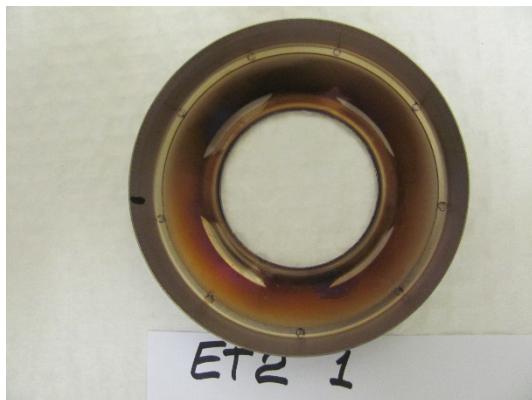
Figure 1 and figure 2 show the top of the first titanium electrode in unit 19, acceleration tube 2 (exposed to the ion beam) and the bottom of the last electrode in the same tube (chiefly exposed to electron flux). SEM images of the same electrodes are shown in figure 3 through figure 6. These images show varied but common features observed, such as porosity, metal vaporisation and material build up. Titanium sheet samples were also analysed as a comparison (figure 7) and the surface was shown to be relatively pure, with sparse embedded particles with a high oxygen and carbon content.

**Figure 1.** Top face of electrode 1 in unit 19, acceleration tube 2 after over 40 years of operation.

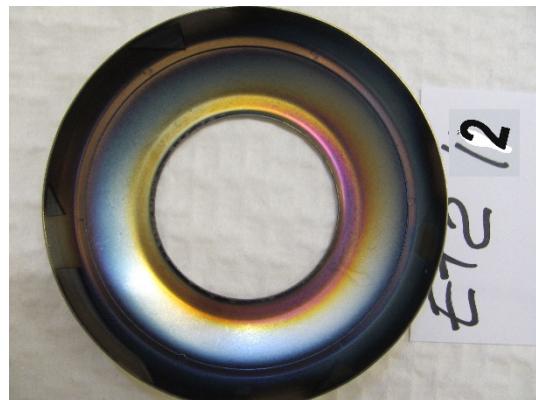
**Figure 2.** Bottom face of electrode 12 (last) in unit 19, acceleration tube 2 after over 40 years of operation.

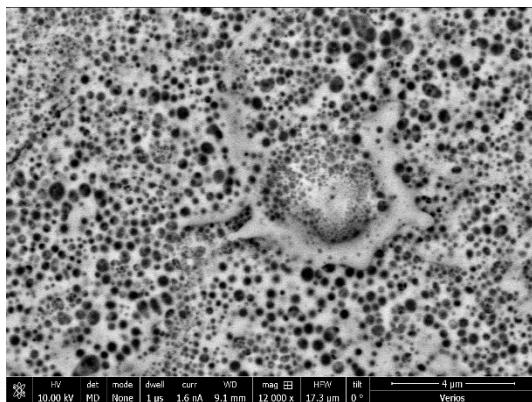
**Figure 3.** SEM image of the bottom of electrode 1 in unit 19, acceleration tube 2, showing metal vaporisation and surface porosity.

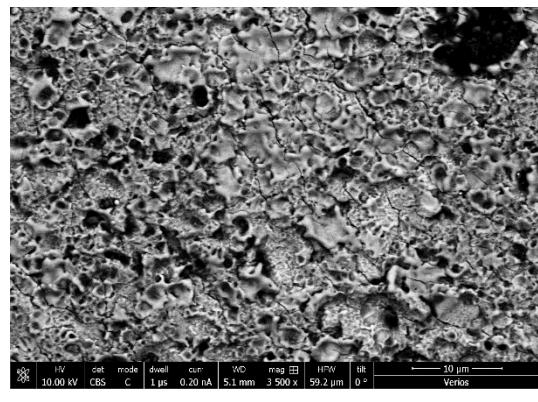
**Figure 4.** SEM image of the top of electrode 12 (last) in unit 19, acceleration tube 2 showing re-crystallisation of the surface layer of the Ti electrode.

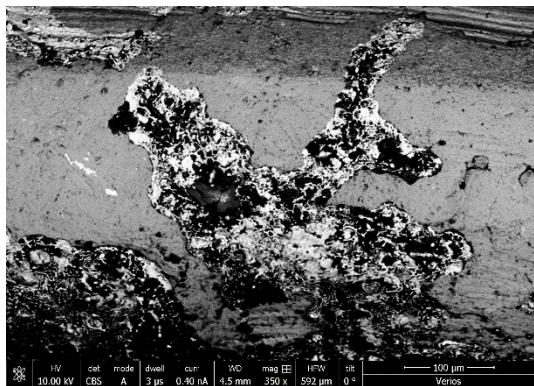
**Figure 5.** SEM image of the bottom of electrode 12 (last) in unit 19, acceleration tube 2, showing metal vaporisation.

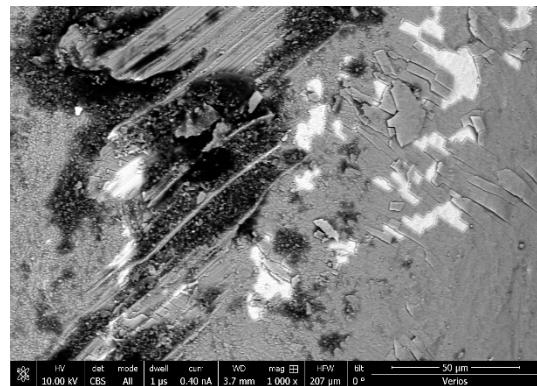
In combination with the SEM images, the oxygen and carbon content suggests a build-up of oxide and carbon layers, which aside from impacting the voltage gradient, would provide particulate material for increased initiation of vacuum breakdown. The supply of oxygen comes from residual gas in the acceleration tubes and oxygen gas that was historically used as a gas stripper media. Most of the carbon contamination is likely to be from broken carbon stripper foils.

**Figure 6.** SEM image at the inner edge (toward the beam axis) of the bottom side of an acceleration tube electrode showing severe layer build up and subsequent possible flaking. The black regions are carbon rich layers and the white areas are pure Ti. The grey areas are loose films contaminated with O, F, S.

From the observed conditions of the accelerator tube insert electrodes, their remediation through cleaning or replacement should be a priority. However, even new electrodes may need processing. New tubes and electrodes installed during the compressed geometry upgrade of the 14UD were

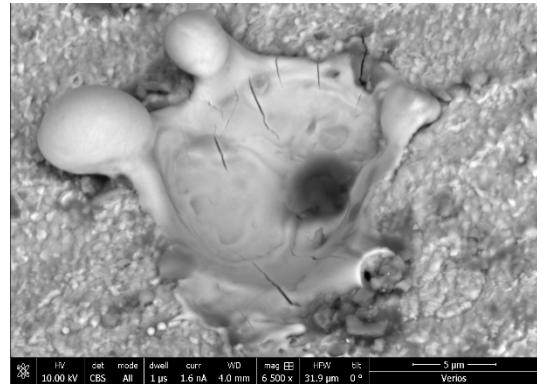
**Figure 8.** SEM image at the inner edge (toward the beam axis) of an acceleration tube electrode showing severe metal vaporisation.

Other features were also observed upon disassembly of the acceleration tubes. Pure physical damage to electrodes was observed, with craters in electrode surfaces and sputtering of titanium. This then creates protrusions that then act as a trigger for the release of electrons. An example of cratering is shown in figure 8.
