# REPORT ON COLLIMATOR DAMAGED EVENT IN SuperKEKB

S. Terui<sup>†</sup>, T. Ishibashi, M. Shirai, Y. Suetsugu, K. Shibata,  
K. Kanazawa, H. Hisamatsu, Y. Ohnishi, Y. Funakoshi, M. Tobiyama  
High Energy Accelerator Research Organization (KEK), Tsukuba, Japan

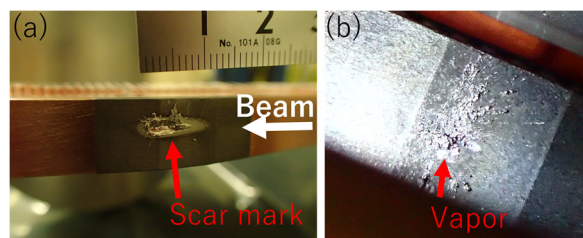
The jaws damaged by the abnormal beam hitting are shown in Fig. 1. A scar-mark can be observed (Fig. 1 (a)) on the tip of the top jaw. When a beam passed through tungsten, it caused pair creation. Owing to its energy deposit, tungsten was sublimated as the temperature rose sharply. Then, a protrusion was formed by the vapor deposition of tungsten on the jaw on the opposite side (Fig. 1 (b)).

Figure 1: (a) Damaged jaw, (b) protrusion by vapor deposition on the opposite side of the damaged jaw.

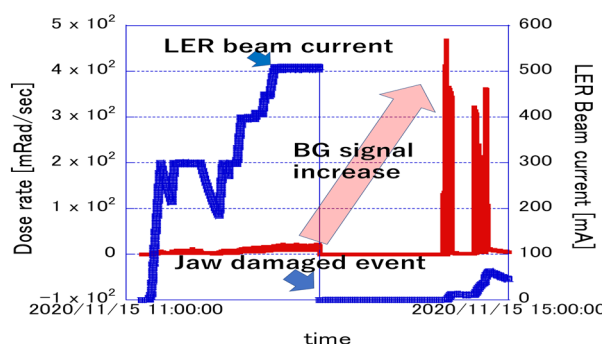
Figure 2 shows the LER beam current and the value of the BG observed using the VXD in Belle II before and after the jaw damage event. The peak value of the BG after this event was approximately 200 times higher than that before it. As the accelerator operation was difficult after this event due to the high BG, we replaced the damaged jaw with a new one during the 2020c run (from 10/14/2020 to 12/18/2020).

Figure 2: BG signal before and after the event of the damaged jaw.

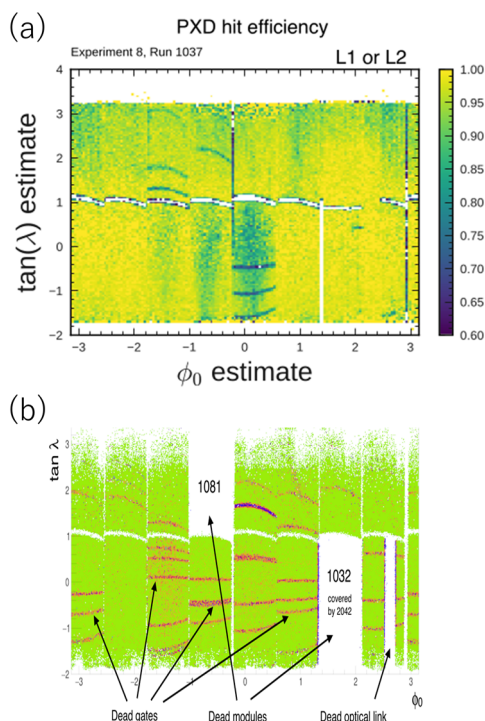
When a jaw damage event occurred, a large beam loss was observed in Belle II. The soundness of the DEPFET pixel detector (PXD) in Belle II before and after the jaw was damaged during the 2019b run (from 4/1/2019 to 7/1/2019) is shown in Fig. 3. The white part in Fig. 3 (b) indicates that the modules in the PXD are no longer functioning [4]. It was revealed that an event during which the current collimator could not protect Belle II occurred.

Figure 3: Soundness of the PXD (a) before and (b) after the jaw damage event that occurred during the 2019b run.

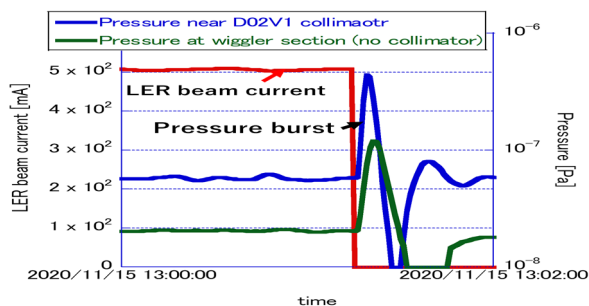
In this event, the pressure burst near the collimator (blue line) with the beam abort is shown in Fig. 4. In addition, a smaller pressure burst (green line in Fig. 4) was observed at a location different from the location at which the collimator was installed. The beam abort during this event was mainly triggered by the beam loss monitor. It is believed that the pressure burst at the green line was caused by the beam interacting with the dust. We consider that these events were triggered by a sudden change in the beam energy because the beam collided with the dust. We consider dust to be the cause of these events because of two reasons.

Figure 4: Pressure burst when a jaw damaged.

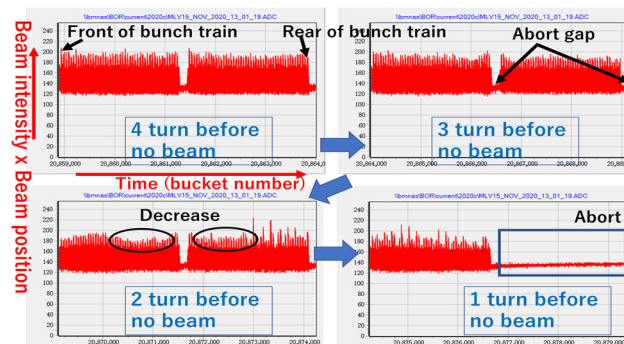
Next, we describe the second reason. We illustrate the data obtained using the bunch oscillation recorder (BOR) (Fig. 5), where the horizontal axis represents the bucket number, and the vertical axis represents the product of the beam intensity and vertical beam position.

Figure 5: Plot observed using BOR when a jaw was damaged.

In conclusion, when this event occurred, there was no sign of oscillation indicating beam instability, and the data indicated that the intensity of the part of the bunch train suddenly decreased a few turns before the abort. We consider that part of the bunch train was abnormal upon interacting with the dust particles.

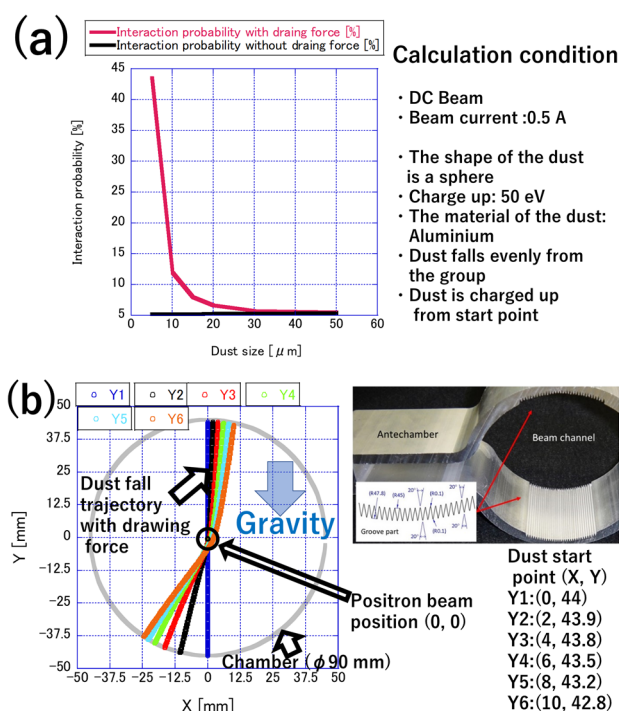
though the beam size in SuperKEKB is very small. When the dust falls out of the groove, it almost does not interact with the beam if it is not attracted to the beam. Assuming that the beam has a circular transverse cross-section with a diameter of 2 mm and the material of the dust particles is aluminum, the probability of interaction between the dust falling from the groove and the beam is very low (see the black line in Fig. 6 (a)). We believe that the electron cloud may cause an increase in the probability of interaction between the dust and the beam. The mechanism is believed to be the charging of the free-falling dust when it passes through the electron cloud. Thereafter, the charged dust is drawn to the positron beam. Figure 6 (b) shows the orbit of the dust with the drawing force caused by the electron cloud, assuming that the energy of the charged-up dust is 50 eV [8] and the dust radius is 10  $\mu\text{m}$ . If the above process occurs, the probability of interaction between the dust and the beam increases dramatically (see the red line in Fig. 6 (a)).

Figure 6: (a) Probability of interaction with/without the drawing force, (b) orbit of the dust (radius = 10  $\mu\text{m}$ ) with the drawing force caused by the electron cloud.

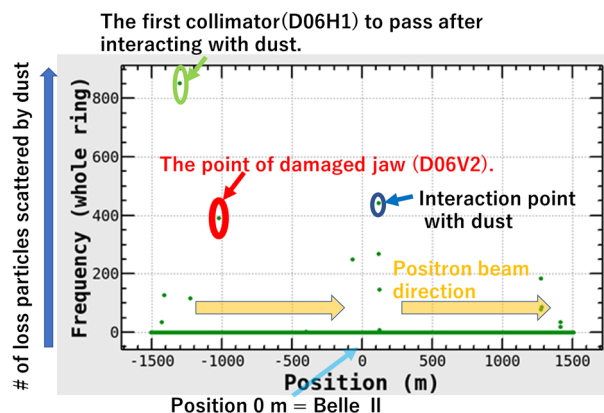
using PHITS [9] and Strategic Accelerator Design (SAD) [10]. Figure 7 shows the results of beam tracking when the D06V2 collimator jaw was damaged. See reference [1] for the collimator location. Figure 8 shows a comparison of the scatter plots of particles that collided with D06H1 and D06V2. We observed that the particles were concentrated within a narrow range in D06V2. If high-density particles hit the jaw, the jaw may be damaged.

Figure 7: Result of tracking the scattered beam that interacted with dust using PHITS and SAD.

Thus, we developed a low-Z collimator as a countermeasure for these events. This development has been reported in other studies [11].

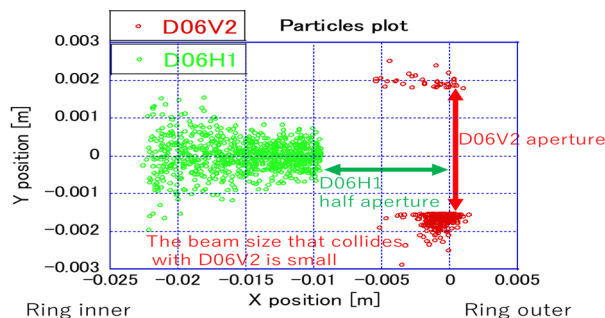
Figure 8: Comparison between the sizes of beams that collided with D06H1 and D06V2.
