THE RECORD OF RF TRANSMITTER POWER SUPPLY MODULE MAINTENANCE IN NSRRC

Abstract

The RF group constructed a second radio frequency (RF) system for the Taiwan Photon Source (TPS) RF system. This RF system employs a high-power RF transmitter to deliver RF energy to the cavity. The RF transmitter is composed of multiple power supply modules (PSMs) that are installed in series. PSMs are critical and fragile components of the RF transmitter.

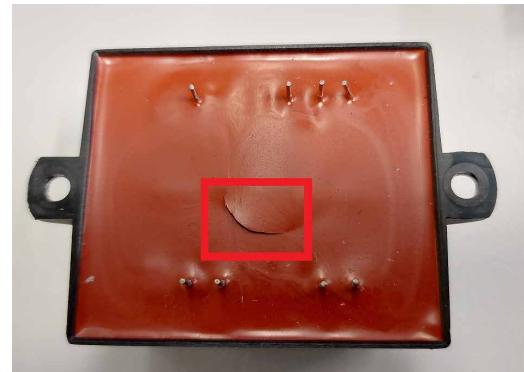
It is crucial to gain a comprehensive understanding of the causes of device malfunction. Therefore, fault analysis was performed on the transformers. As a part of this analysis, all damaged transformers from the modules were disassembled and their appearance was observed. Figure 1 illustrates that some transformers have a crack at the bottom.

Figure 1: The bottom of a damaged transformer.

As previously mentioned, we discovered that the originally designed transformer had insufficient capacity. Therefore, we reformulated the specifications by increasing the rated capacity of the transformer from the original 6 VA to 12 VA. After developing the new specifications, it was entrusted with production. The new version of the transformer is depicted in Fig. 4. As the pin position of the new version of the transformer was incompatible with the original one, we used an adapter board for conversion.

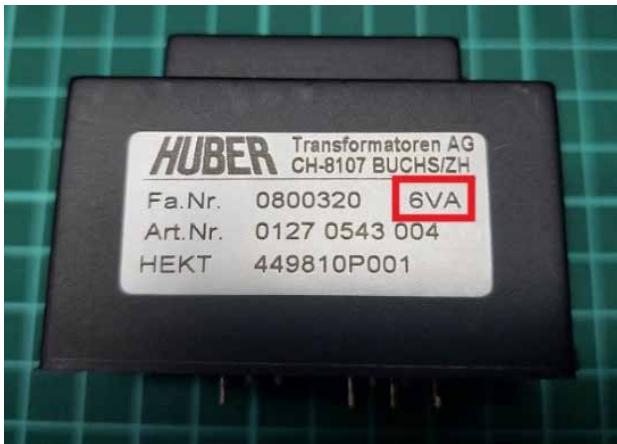
The original power transformer specification, which has a rated capacity of 6 VA, is illustrated in Fig. 2. We measured the input current value of the primary side of the transformer on the module, and the results are shown in Fig. 3. The input voltage value for the primary side is 570 V, and it can be calculated that the apparent power of the transformer is approximately 7.2 VA using Equation 1. The operational power was identified as being higher than the specification values for the transformer.

Figure 2: Transformer specification.

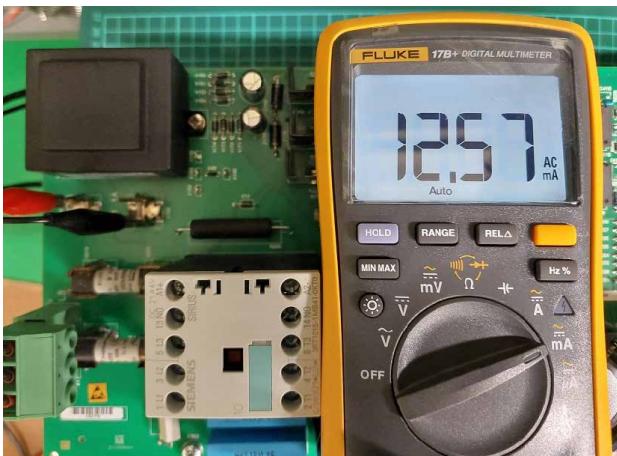
Figure 3: Measure the input current on the primary side.

$$S_{\text{original}} = V * A = 7.2 \text{ VA.} \quad (1)$$

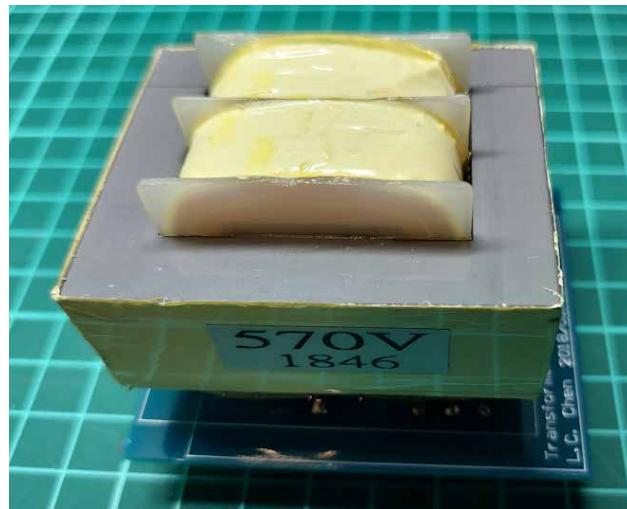
Figure 4: New version of the transformer.

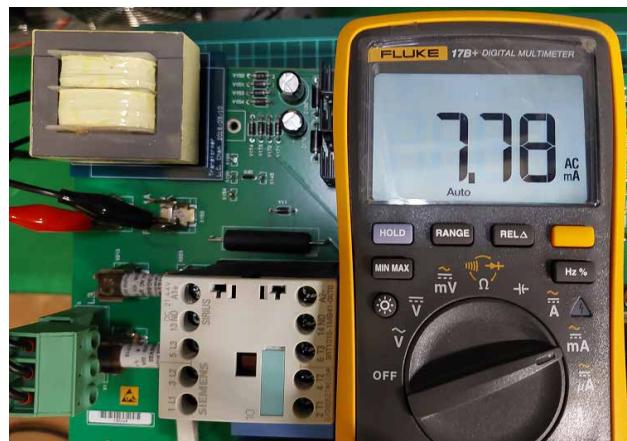
After replacing the damaged modules with the new version of transformers, they were tested in practice. The input current value of the primary side of the transformer is displayed in Fig. 5. The input current value is 7.78 mA, and it can be calculated that the apparent power of the transformer is approximately 4.4 VA using Equation 2. The actual operational value of the apparent power is within the newly established specification.

$$S_{\text{new}} = V * A = 4.4 \text{ VA.} \quad (2)$$

Figure 5: Measure the current on the primary side of the new transformer.
