# High Gradient SRF Research at DESY

Sebastian Aderhold<sup>1</sup>, Detlef Reschke<sup>1</sup>

Gradients exceeding 40MV/m have been multiply demonstrated in 9-cell SRF cavities that are foreseen for the International Linear Collider. The mass production of such cavities however remains a challenge. A new, in situ method for optical inspection, developed at KEK/Kyoto University allows to correlate surface features with e.g. quench locations. This and other tools are presented that enable a systematic approach to understanding the gradient limiting features in SRF cavities. Results from the large sample investigated at DESY are shown.

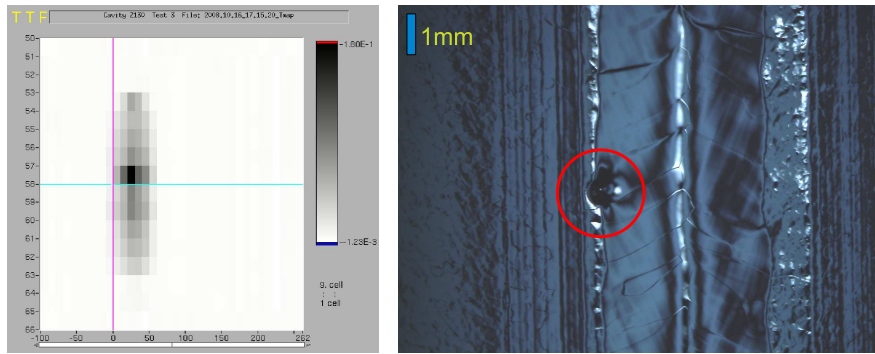
Figure 2: Heating of quench detected by T-map in Z130 (left) and defect in optical inspection picture of corresponding area (right)

During the RF measurement in the vertical test the surface temperature of the cavity can be monitored by an array of thermo-sensors (T-map) [6]. In case of a local breakdown of superconductivity (quench) the position can be identified by the increase in temperature at the outer surface. In several cases subsequent optical inspection of the corresponding areas on the inner surface revealed visible defects, e.g. in the welding seam. One example for such a correlation is shown in Fig. 2. The cavity Z130 was limited at 17.3 MV/m by quench in the first vertical test and was cut out of its He-vessel for further investigation. The second test was done with T-map. The  $3\pi/9$ -mode was limited at 22 MV/m and heating of the quench was observed on the equator of cell 5 (left part of Fig. 2). Optical inspection of the corresponding area revealed a circular pit of about 700  $\mu\text{m}$  diameter on the edge of the welding seam (right part of Fig. 2).

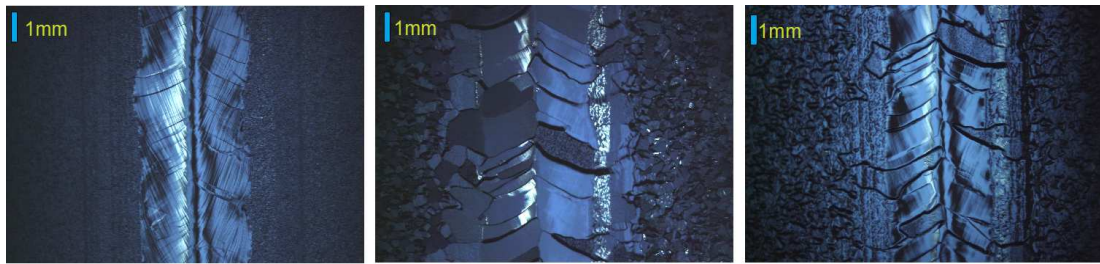
Figure 3: Equatorial welding seam of cell 1 in Z137: before EP (left), after main-EP (center) and after final-EP (right)

Optical inspections in consecutive stages of the surface treatment process allow the study of formation and evolution of surface defects. The series of pictures in Fig. 3 shows the evolution

of an area on the equator of cell 1 in the cavity Z137. The left picture is taken after welding before any further chemical treatment of the surface. The welding seam looks normal and similar to all the other eight welding seams. After the main surface removal of  $108\ \mu\text{m}$  by electro-polishing (EP) (center picture) rough areas and steep edges at the grain boundaries are visible on the equator and in the heat affected zone of cell 1, in contrast to the other eight cells. The final EP has smoothened out the edges a bit (right picture) and the equator is shinier, but the steep grain boundaries remain. The accelerating gradient of Z137 was limited by quench at  $25.2\ \text{MV/m}$  in the vertical test. Heating of the quench was located by T-map next to the equator of cell 1. It is not yet understood why cell 1 reacted differently under EP.
