Use of Acoustic Emission to Diagnose Breakdown in Accelerator RF Structures ^{*}

J. Nelson, M. Ross, J. Frisch, F. Le Pimpec, K. Jobe, D. McCormick, T. Smith
Stanford Linear Accelerator Center, Stanford University, Stanford CA 94309

Contributed to Particle Accelerator Conference 2003

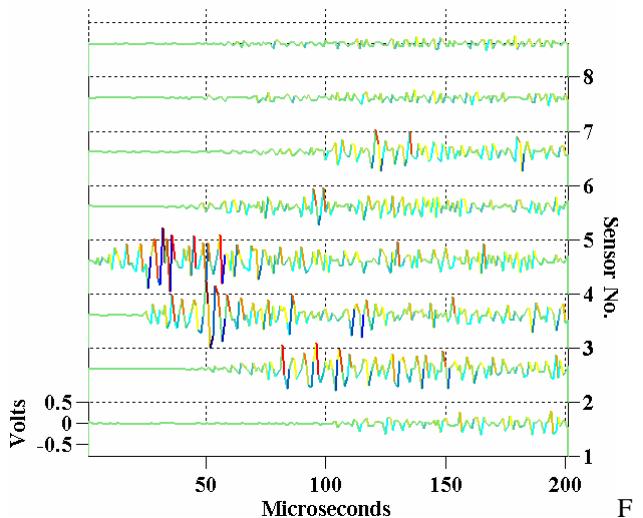
Figure 1: Recorded voltage signals from TTF gun acoustic sensors from a single breakdown event.

In Fig. 1, the breakdown signals that are largest and arrive earliest (sensors 3 and 4) are around the waveguide coupler iris. Those that are small and arrive later (sensors 7 and 8) are attached to the gun's cavity coupler cell and close to the cathode, respectively. The shapes of the envelopes of the signals are not understood.

Eight sensors were attached to the copper gun cavity and waveguide with cyano-acrylate glue. The sensors' signals were locally amplified then recorded with oscilloscopes outside the tunnel housing. Figure 1 below shows sensor signals from a typical breakdown event. The breakdown signals are up to 100 times larger than the signals produced on a non-breakdown pulse.

For the TTF L-band gun the breakdowns were isolated to the input waveguide coupling iris, not the cathode as originally suspected. Typical signals from the 3 sensors on this iris are shown in figure 1 as signals 3, 4, and 5. Using the t_0 technique and given the distance between the sensors and the potential breakdown sources, one can pinpoint the breakdown location between sensors 4 and 5, as well as calculate the speed of the signal's propagation: 3520 ± 810 m/s. This speed is between the p and s wave speeds. The sensors probably see both waves with differing sensitivities.

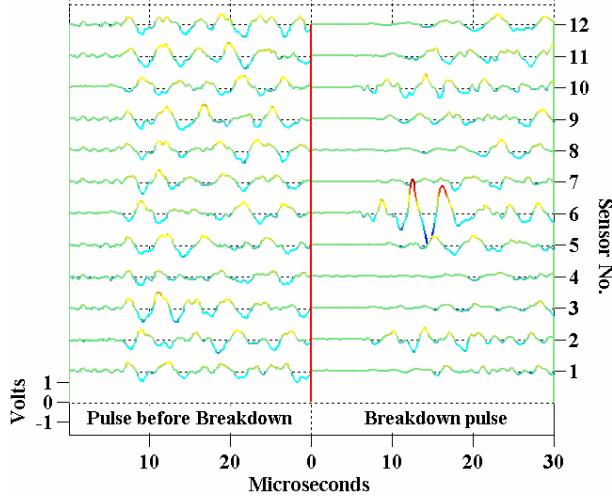
Figure 2 shows two consecutive pulses for 12 sensors (3 cells, 4 sensors per cell). Sensor 6 shows the largest signal, about 30 times larger than the non-breakdown pulse. Adjacent sensors 2 and 10 have relatively small signals, indicating very localized energy deposition at sensor 6.

Figure 2: Two consecutive RF pulses in NLCTA. The amplitude of the non-breakdown pulse has been increased 10x.

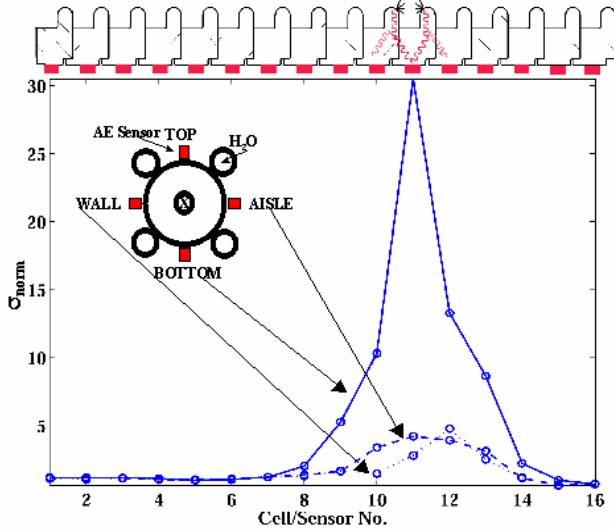
This selected 15 of the 400 events in the body of the structure. Figure 3 shows a typical event of this type.

This figure shows that the sensors' resolution is less than the distance between the sensors around the cell and about equal to the cell spacing. Using the t_0 technique, we found that the signals from sensors $i \pm 1$ arrive at the same time, approximately 1 μ s later than the signal from

sensor i . Given that the sensors are mounted between the irises, the breakdown can only be coming from both irises, not just one. This result is consistent with the theory proposed in [1,2].

Figure 3: σ_{norm} for a typical multiple-iris event. The solid line connects data from 16 sensors, one per cell, in a row. Along the top is a schematic of the structure, showing the placement of the sensors between the irises as well as a possible path for the sound from the breakdown to travel. The inset shows the sensors mounted around a cell. Of note is the vertical scale: more than 30 times the energy deposited on a non-breakdown pulse is seen by one sensor.

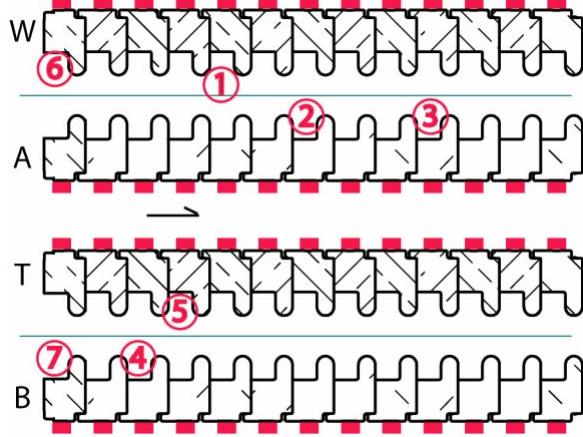
Another phenomenon seen during processing of the X-band structures in NLCTA is the so-called spitfest –when breakdowns are rare, but clustered in time. For example, there will be no breakdowns for more than 30 minutes, followed by many breakdowns in quick succession, less than two minutes apart. Some of these breakdowns occur at very low voltage. From a two week, steady-state running period with 288 breakdowns, 141 happened within two minutes of the previous event in 62 spitfest groups. Figure 4 below shows the locations of seven breakdowns that happened in one spitfest sequence.

This figure shows that subsequent breakdowns aren't confined to the same location as the first breakdown and actually vary their locations by more than just a few cells. This is inconsistent with the assumption that subsequent breakdowns happen near the surface damage caused by the first breakdown.

Figure 4: Sketch of a section of a 60-cell X-band structure showing the location of a series of breakdowns in a spitfest. The rows correspond to the rows of sensors on the structure: on the wall, aisle, top and bottom sides.
