Redesign of Water-cooling for the IPA

UPGRADE OF THE TRANSMISSION LINE

The current upgrades involved many critical components of the TRIUMF Cyclotron's RF system: replacement of pentode with the SS driver, improvements of water-cooling for PA and IPA, TL upgrade with new components and water interlock. Those upgrades should provide more reliable operation of the 520 MeV cyclotron.

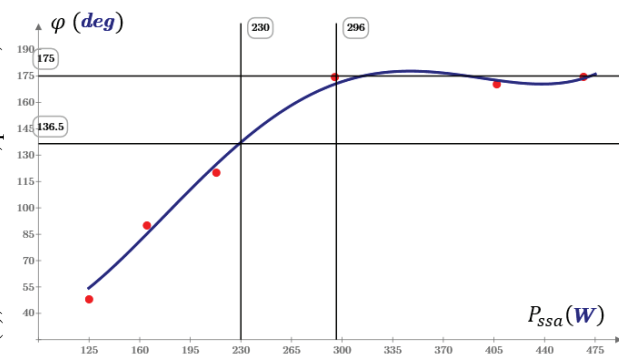
Figure 4: The dependence of the phase shift between input and output on the output power of the 2 kW SS driver.

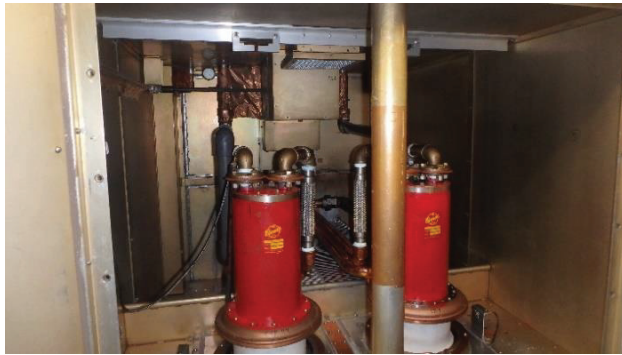
One of the essential causes of a water leak in the PAs is a crack in the metal bellows that provide water-cooling for power tubes, caused by water cavitation in those bellows. The original bellows were made of beryllium copper (BeCu). To avoid these problems, we installed stainless steel bellows that should sustain against water cavitation (see Fig. 9).

Figure 9: PA2 with stainless steel bellows.

Cold measurements showed that Q-factor of the output resonator of the PA was less than the original one by about 3 % due to the change of BeCu to SS. We successfully tested upgraded PA in regular operation at 200 kW power.

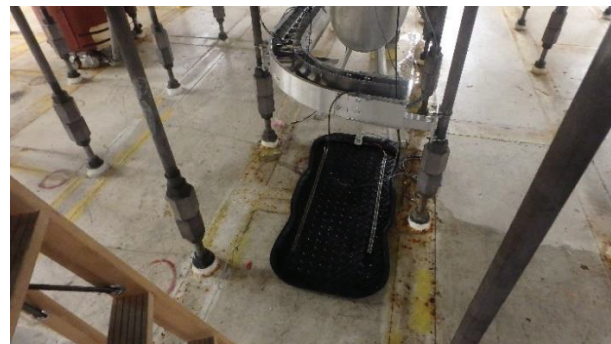
To protect RF TL from water leak damage, we built the water interlock system that is based on water sensors placed underneath all critical parts of the TL (see Fig. 12). Those sensors trigger this interlock.

Figure 12: Photo of water leak sensors tray.
