IMPEDANCE OF THE FLANGE JOINTS WITH THE RF CONTACT SPRING IN NSLS-II*

A. Blednykh[†], B. Bacha, G. Bassi, C. Hetzel, B. Kosciuk, V. Smaluk, T. Shaftan, G. Wang
BNL, NSLS-II, Upton, NY, USA

Abstract

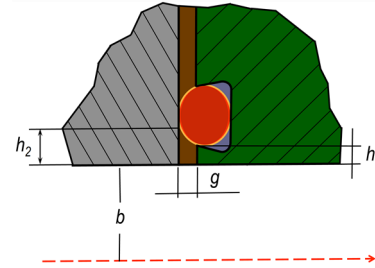
Figure 1: The RF contact spring placed between flanges.

The RF contact spring (Fig. 1) has been designed for installation in the area between two flange joints to eliminate the large cavity effect generating wakefield/impedances. To stay securely, the RF contact spring is placed in one of the flanges with trapezoidal groove. Due to the RF spring installation procedure and a bit larger gaps between two groups of flanges, the local overheating appeared at different locations of the NSLS-II storage ring, predominately in the straight sections. The local overheating has been measured by the thermal Infrared (IR) camera (Fig. 2) and the Resistance Temperature Detector (RTD) sensors (Fig. 3), installed on the surface of the flange joints.

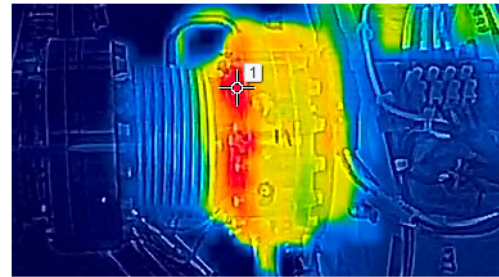
Figure 2: Thermal image of the attached bellows to the flange of the vacuum chamber made by the FLIR AX8 infrared camera, where the local overheating appeared.

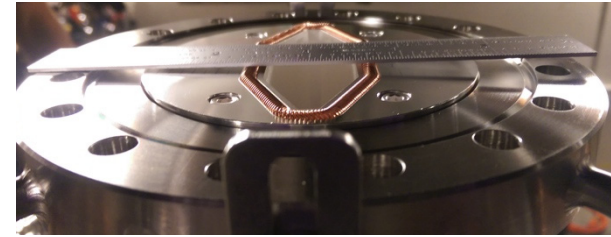
Figure 4: Flange image of the bellows with trapezoidal groove and the RF contact spring at place after disassembling.

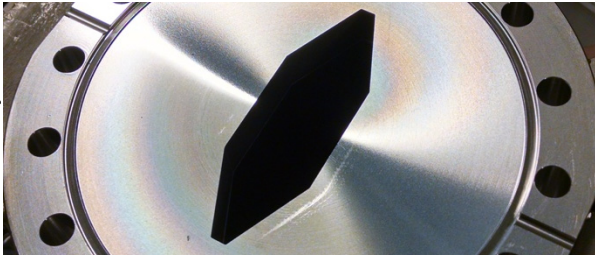
Figure 5: Surface image of the flange, which was attached to the bellows flange. There is a scratch on the surface, where the RF spring has a good contact.

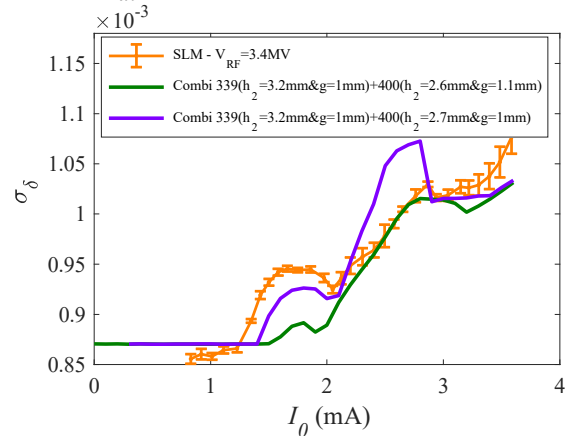
Figure 6: Energy spread change vs. single-bunch current for 739 RF shielded flange joints at $V_{RF} = 3.4MV$. The purple and green traces are numerically simulated data. The σ_δ measured data (orange trace) at $V_{RF} = 3.4MV$ are shown for comparison.

Despite the good agreement shown in Fig. 6 between measurements and simulations of σ_δ a discrepancy has been observed in the comparison of the bunch length (σ_τ), as shown in Fig. 7 at $V_{RF} = 3MV$. The blue dots correspond to the streak camera measurements for the regular 3DW

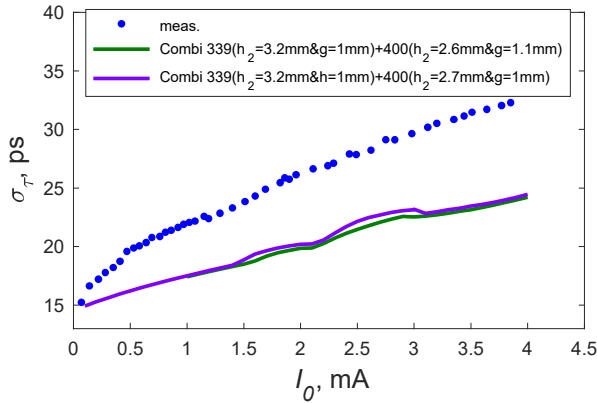
Figure 7: Bunch length dependence on the single bunch current. The experimental data are shown with blue points. The purple and green traces are the numerically simulated results.

lattice and the purple solid trace corresponds to the numerically simulated results by the SPACE code. We are presently investigating the reason why we can reproduce well the energy spread behaviour while, the bunch lengthening slopes differ by a factor of 1.4. The low-frequency part of the longitudinal impedance, especially the imaginary part needs to be further investigated and analysed in detail to resolve and understand the difference between the results. We believe that with a streak camera resolution better than $0.5ps$ we will be able to detect changes in bunch length, where the beam becomes unstable, especially at high enough RF voltage.

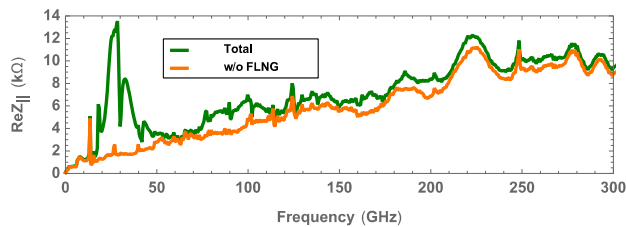
Figure 8: The real part of the longitudinal impedance up to $300GHz$ frequency range. Green trace is the total NSLS-II longitudinal impedance. Orange trace is $ReZ_{||}$ without contribution of the RF sealed flanges.

The frequency spectrum of the total NSLS-II longitudinal impedance is presented in Fig. 8 (green trace) and Fig. 9 (purple trace) up to $300GHz$. There are several observable broad-band peaks at different frequencies, $\sim 25GHz$, $\sim 90GHz$, $\sim 180GHz$, $\sim 220GHz$,... . The main spectral peak at $f \sim 27GHz$ has the highest magnitude, $ReZ_{||} = 13k\Omega$, and it is predominantly due to a big number of RF shielded flanges assembled with RF contact spring between flanges. The frequency spectrum is changed significantly by excluding the contribution of the 739 flanges (Fig. 8, orange trace and Fig. 9 magenta trace) from the total impedance. Engineering design of the RF shielded flanges with “no gap” will be beneficial to increase the microwave instability threshold.

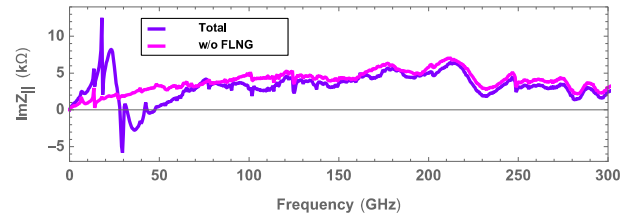
Figure 9: The imaginary part of the longitudinal impedance up to $300GHz$ frequency range. Purple trace is the total NSLS-II longitudinal impedance. Magenta trace is $ImZ_{||}$ without contribution of the RF sealed flanges.

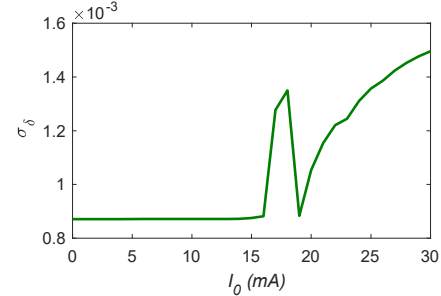
Figure 10: Numerically simulated σ_δ vs. single-bunch current for the impedance model without RF shielded flanges.

The numerical simulation of σ_δ without contribution of the RF shielded flanges to the total impedance of the storage ring, shows that the instability threshold current is increased to a value higher than $15mA$ (Fig. 10).
