High-Z Radiation Shields for X-ray Free Electron Laser Detectors

A. Tomada, S. Boutet, B. Duda, P. Hart, C. Kenney, L. Manger, M. Messerschmidt, J. Tice, G. Williams
SLAC National Accelerator Laboratory, Menlo Park, CA

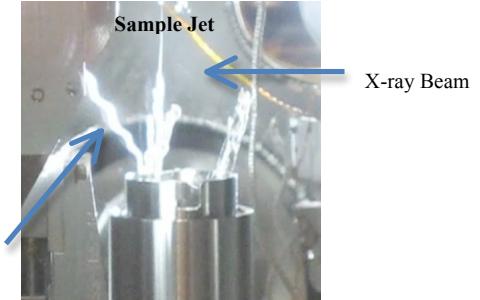
Fig. 1: In the LCLS-CXI (Coherent x-ray Imaging) chamber specimens are delivered to the x-ray beam by a water jet showed in the picture. Notice how the water crystallizes creating ice crystals.

We investigated a couple of particular events that took place in the LCLS-CXI experiments. The first event we called “the ice hit” (Fig. 1 and 7). A water jet, used to deliver the specimen, crystallized causing the beam to scatter into the camera [5][6]. In this case the module did not have any W foils installed. The detector lost at least three (3) ASICs, a full module 2x1 consisting in two ASIC and one half of a module equal to one ASIC.

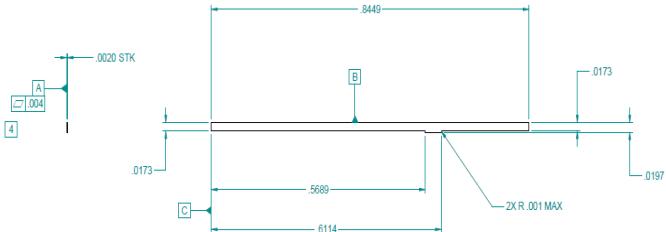
Fig. 3: Detailed drawings of the tungsten shield shape and dimensions. Notice the protruding “tab”.

To completely protect the global bias circuits the tungsten shields ended up being over 2 cm in length, 50 microns thick, and 450 microns wide. There are also tabs, as shown in Figure 3, which protruded 50 microns between the wire bonds pads. The extra piece offers more protection and additional real estate for securing the shield to the ASIC.

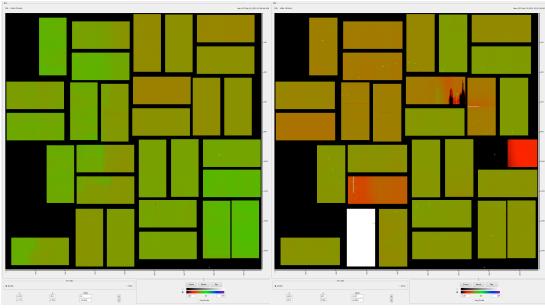
Fig. 8: This is a comparison side by side of the first and the last event of “the ice hit” run. On the picture on the right it is obvious that the lower left module is not responding, resulting in a white rectangle. On the same image another ASIC is not functioning anymore resulting in a black square.

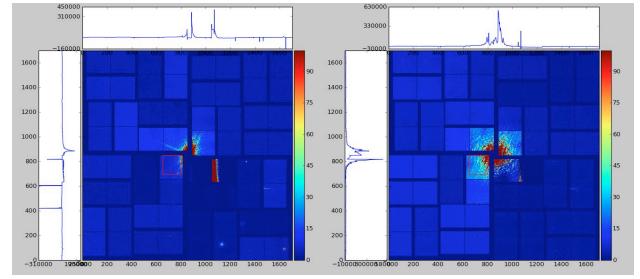
Fig 11: Screen shots of the images after “the time flight chamber” event. On the left, one soon after the hit and on the right, one seven (7) hours after.

This version of the camera had most of the modules protected by tungsten foils (Fig.11). In this incident no ASICs were lost. In subsequent experiments in the LCLS-CXI chamber we did not lose any shielded modules of the camera.

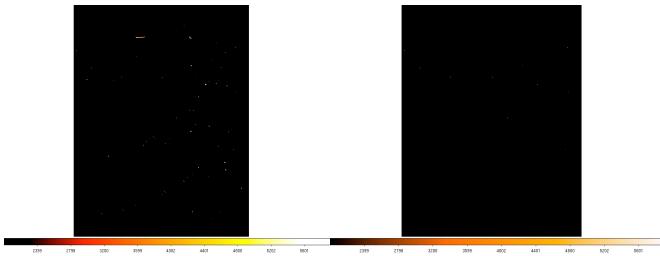
Fig. 14: Side by side comparison of the dark pedestal with input- amplifier not in reset (on the left) and in reset (on the right). Observe that the decoration of spots in the first image mostly disappears in the second image suggesting that this variety of damage is in the sensor surface.

Another study of radiation damage is shown in Figure 14, contrasting the pedestal for a damaged region with and without the input amplifier in reset. This suggested that some radiation damage is occurring on the sensor surface.
