Quality concerns caused by quality control — deformation of silicon strip detector modules in thermal cycling tests

ABSTRACT: The ATLAS experiment at the Large Hadron Collider (LHC) is currently preparing to replace its present Inner Detector (ID) with the upgraded, all-silicon Inner Tracker (ITk) for its High-Luminosity upgrade (HL-LHC). The ITk will consist of a central pixel tracker and the outer strip tracker, consisting of about 19,000 strip detector modules. Each strip module is assembled from up to two sensors, and up to five flexes (depending on its geometry) in a series of gluing, wirebonding and quality control steps. During detector operation, modules will be cooled down to temperatures of about -35°C (corresponding to the temperature of the support structures on which they will be mounted) after being initially assembled and stored at room temperature. In order to ensure compatibility with the detector's operating temperature range, modules are subjected to thermal cycling as part of their quality control process. Ten cycles between -35°C and $+40^{\circ}\text{C}$ are performed for each module, with full electrical characterisation tests at each high and low temperatur

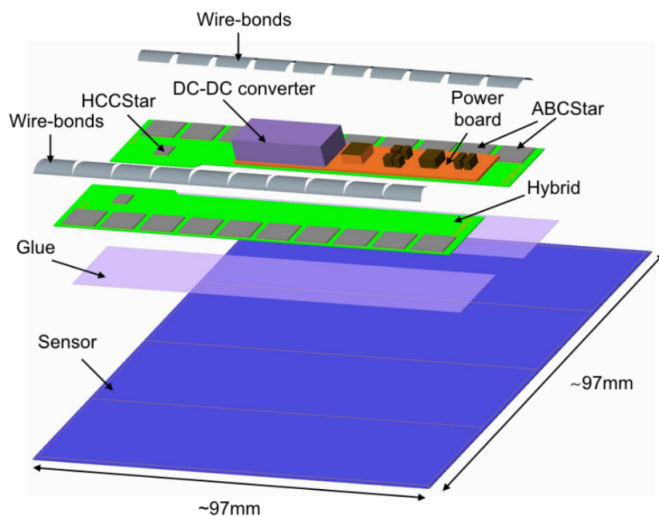
Figure 1. Exploded view of barrel module components. Reproduced from [1]. © 2024 IOP Publishing Ltd and Sissa Medialab. All rights reserved.

Modules are constructed from components in a series of manual precision assembly steps, with module component materials and thicknesses indicated in table 1. Modules in the barrel region, shown in figure 1, are square long-strip (LS) or short-strip (SS). Modules in the endcap are approximately trapezoidal, with curved edges. Hybrids are the flexible circuit boards that hold the readout chips (ASICs) responsible for registering hit signals, as well as housing thermistors for temperature monitoring. The powerboard provides the DC-DC power for the module.

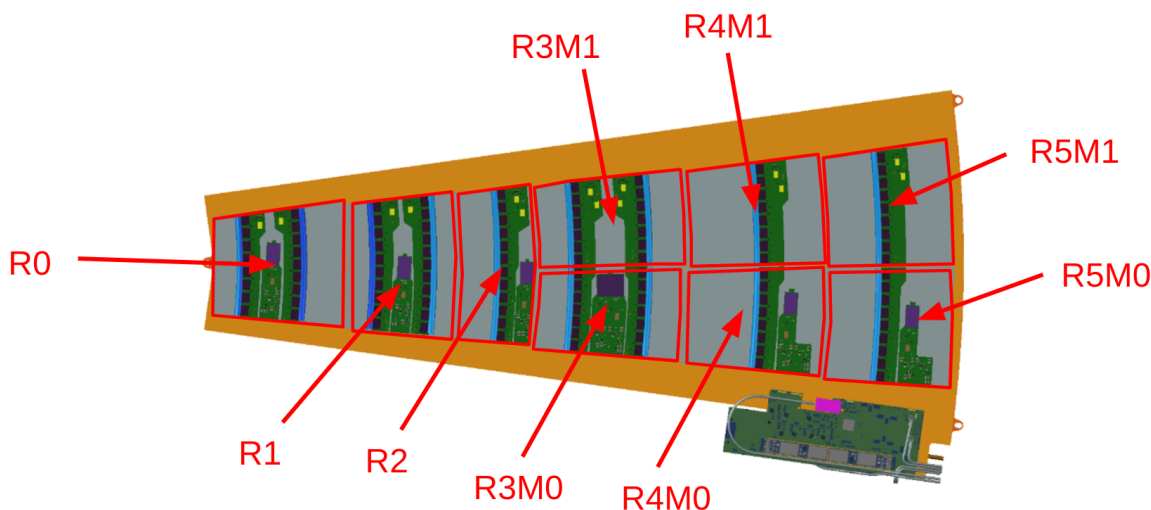
Figure 2. Schematic of a petal loaded with completed endcap modules.

Modules that pass all QC requirements are glued and wirebonded to staves or petals, shown in figure 2. The analyses presented in this study rely on measurements of the module shape (see section 2.1) and module leakage current tests (see section 2.2) in QC.

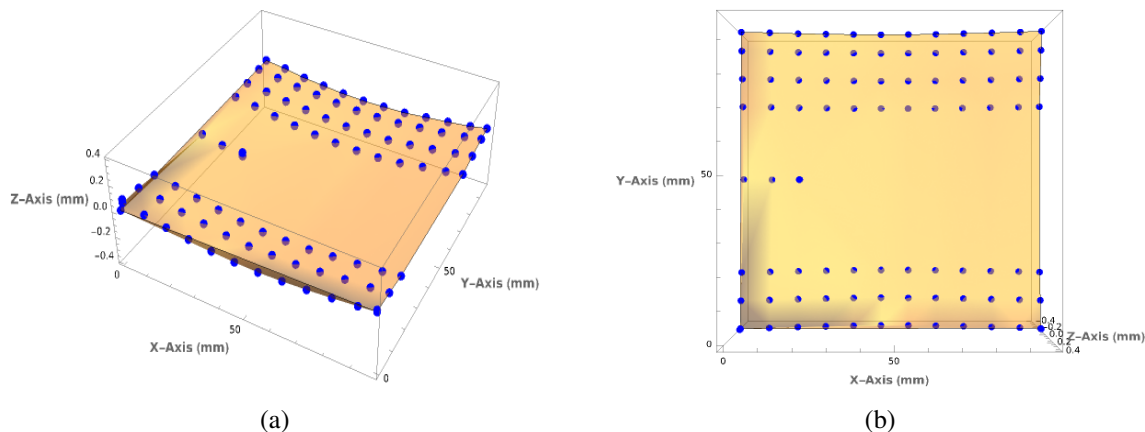
Figure 3. Measurement grid on a barrel module. The blue points represent measurements taken in the module shape test, with the full module shape interpolated in orange. The powerboard and hybrid flexes are not measured, as they are not considered in the module shape.

Module shapes are measured with the module placed on a flat surface to obtain its natural shape. Out-of-plane height measurements are taken on a grid of points across the sensor surface that are at most 1 cm apart, see figure 3. This is the general procedure for the module shape tests.

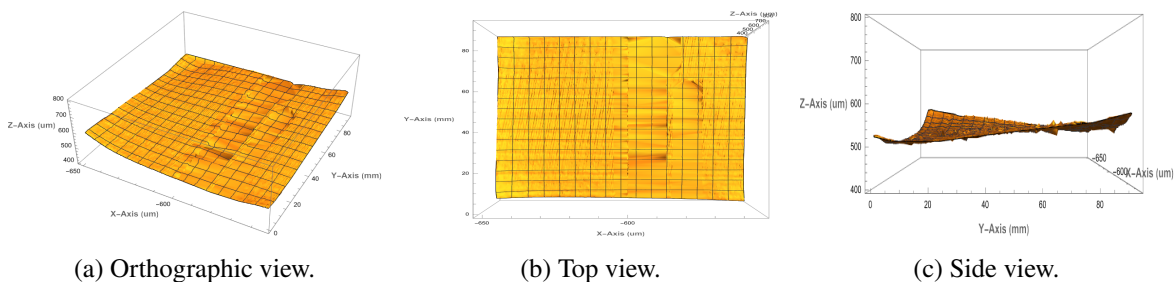
Figure 4. Tilt corrected surface map of a barrel module. The tilt corrected data yields a shape coefficient of $+51 \mu\text{m}$. The tilt correction generally has a negligible effect on the calculated shape coefficient, suggesting that the placement of the modules during measurement does not distort the calculated shape coefficients.

The shape measurements form a surface map of the measured module. To calculate the shape coefficient, only points on the sensor are considered (i.e. points measured on flexes or readout chips are not considered). Using all the sensor surface points, a tilt corrected surface map is obtained by using a plane fit, an example of which is shown in figure 4. The maximum height difference between

points on the sensor is used as the module shape coefficient. The module shown in figure 4 is a typical module that falls within the specifications for module shape coefficient. The shape of the module is consistent with the deformation introduced by the assembly process, which is acceptable for loading a module onto a support structure.

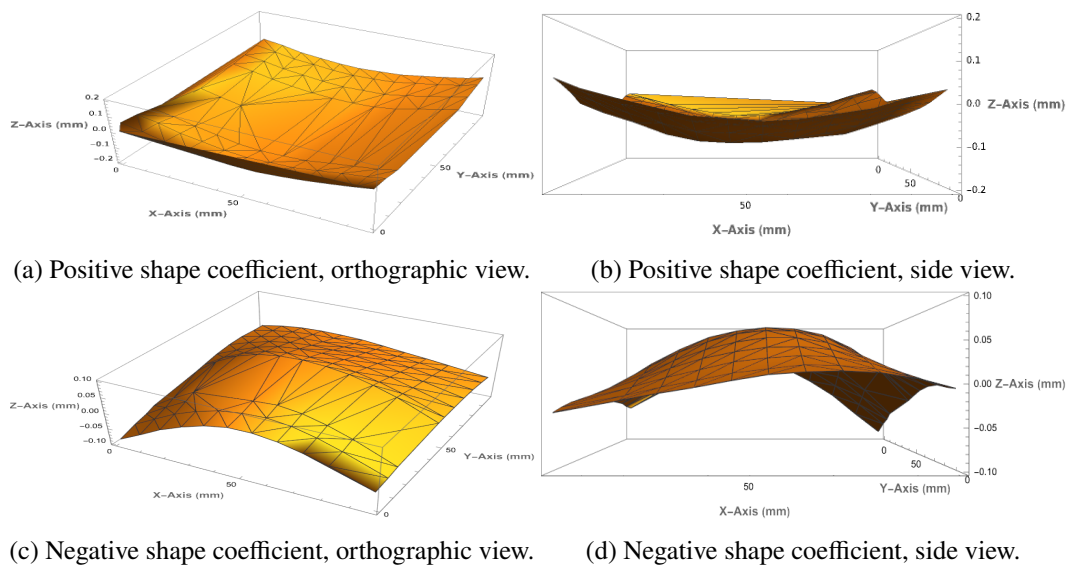
Figure 5. Barrel module exhibiting a positive module shape coefficient in (a) and (b) of $+181 \mu\text{m}$. Barrel module with a negative module shape coefficient in (c) and (d) of $-339 \mu\text{m}$. These two modules show a large bow that is outside specification for completed modules, such that they failed the shape test in QC.

A positive module shape coefficient is defined by a global minimum for a module surface with local maxima, such that the module centre is below the edges forming a bowl shape, as shown in figure 5(a) and figure 5(b). A negative module shape coefficient is defined by a global maximum for a module surface with local minima, such that the module centre is above the edges, forming a hill shape, as shown in figure 5(c) and figure 5(d).

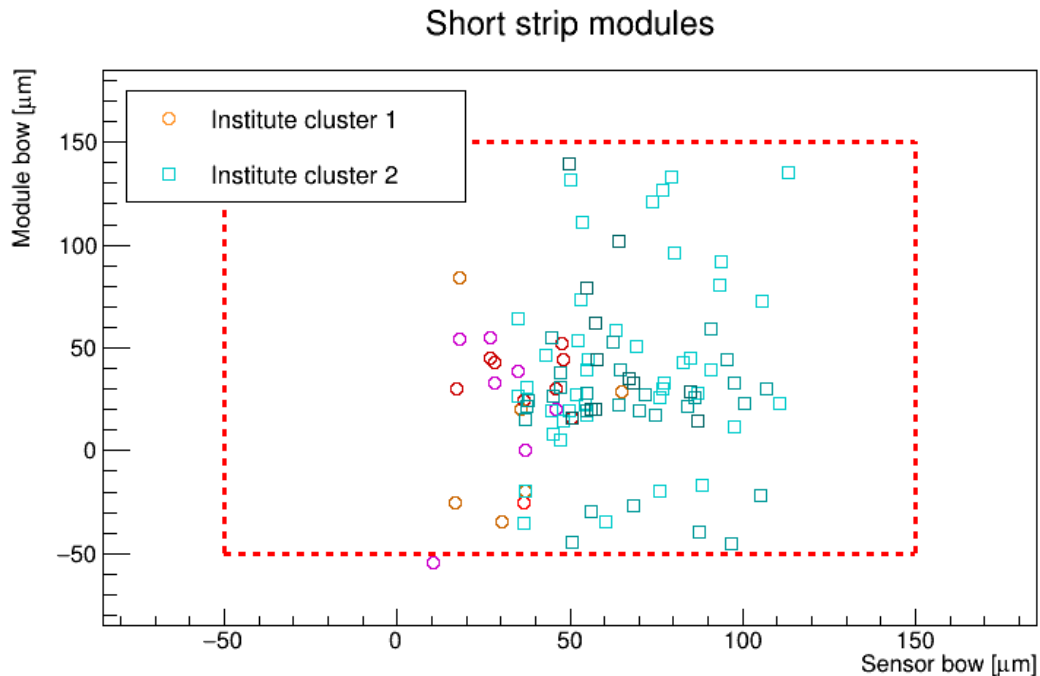
Figure 6. Sensor vs. module bow (shape coefficient) for barrel SS modules.

The typical module shape coefficient of a completed module is a small positive value, which is comparable to the intrinsic shape of an individual sensor in its free state. Sensor shapes are measured on bare sensors, prior to module assembly as part of a separate sensor QC regime. Intrinsic sensor deformation is known to be an effect of the sensor manufacturing process. Sensor deformation is not significantly affected by the module assembly process. Figure 6 shows that the sensor and module shapes are uncorrelated, but similar in value.

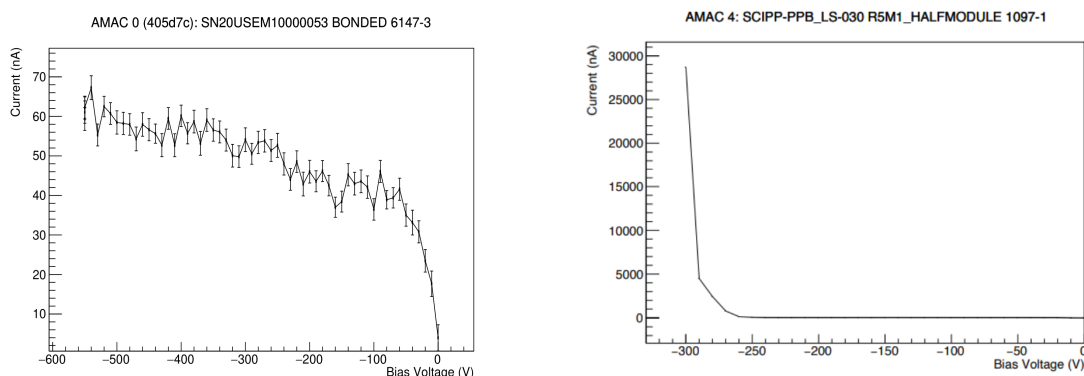
Figure 7. IV tests for ATLAS ITk strip modules.

(a) IV test that passes with no early breakdown.

(b) IV test with early breakdown at about -270 V.

Modules that exceed the limit for leakage current during IV tests may be experiencing early breakdown. Breakdown is a behaviour in which rapidly increasing leakage current is observed at a given sensor voltage. Early breakdown is defined as breakdown occurring below the nominal operating value of -500 V. An example of an IV test of a module that experienced early breakdown is shown in figure 7(b).

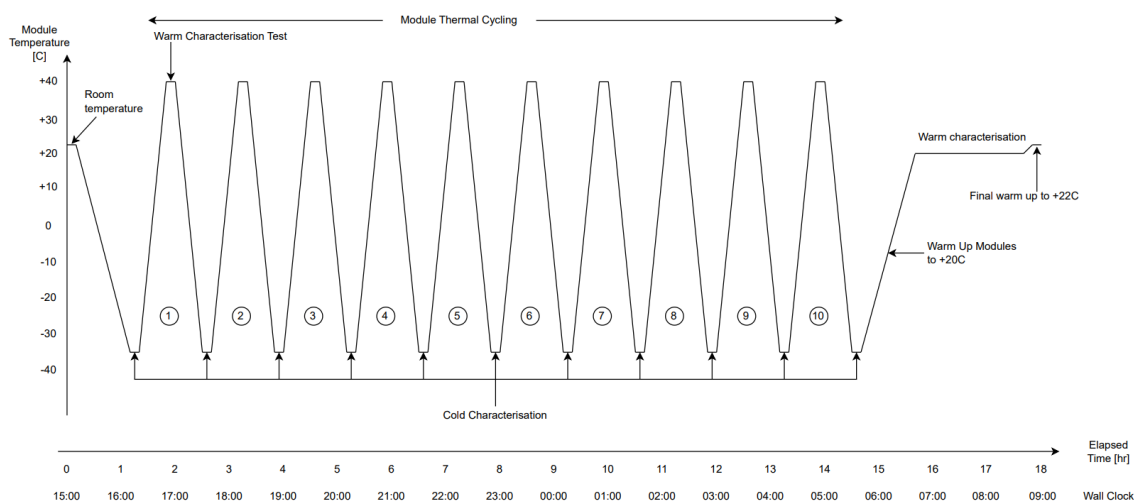
Figure 8. ATLAS ITk strips module QC thermal cycle sequence. Temperature as a function of elapsed time during a thermal cycling test, in the original cycling regime. Reproduced from [7]. The Author(s). CC BY 4.0.

Thermal cycling is done on multiple modules in parallel inside an insulated cold-box that is light- and air-tight (keeping relative humidity below 1% to avoid condensation during the cycle). The cold-box holds multiple aluminum chucks, on top of which rest the test jigs. The module is screwed into an aluminum support frame that is held by the test jig. Temperature control of the module is achieved through the jig's contact with Peltier elements mounted on the chuck, in turn connected to an external chiller. The module temperature during cycling is taken to be defined by the chuck temperature. Figure 8 displays the temperature sequence of the thermal cycling regime.

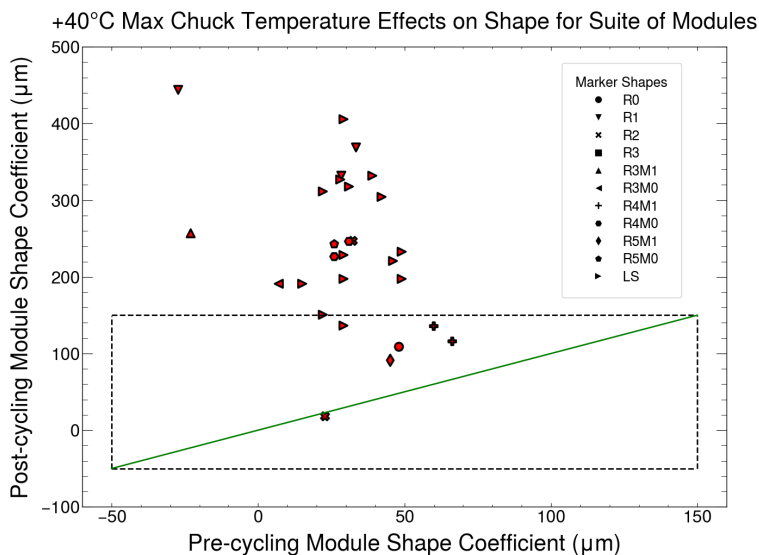
The observed increase in module deformation post-loading could not be caused by the loading process, as loading would only deform modules to within the acceptable threshold. Post-cycling shape measurements taken prior to loading revealed that the thermal cycling process had added to the original module deformation, represented by an increase in the average shape coefficient of about $+0.2\text{ mm}$ after thermal cycling, compared to a maximum allowed shape coefficient of $+150\text{ }\mu\text{m}$, see figure 10.

The plot of post-cycling shape coefficient against pre-cycling shape coefficient is shown in figure 10. Although these modules were within specifications before thermal cycling, 78% of the modules in the sample exceeded the upper threshold for acceptable shape coefficient post-cycling.

Figure 10. Post-cycling shape for modules thermally cycled to +40 °C ceiling. The dotted lines indicate the thresholds for the acceptable shape coefficient for modules to proceed to loading. Modules that fall upon the green diagonal line have their module shape unchanged before and after thermal cycling.

The thermal cycling was identified as the cause of the increased module deformation, and the mechanism behind the change in module shape was later identified to be due to the thermo-mechanical properties of the module glue (section 3.2).

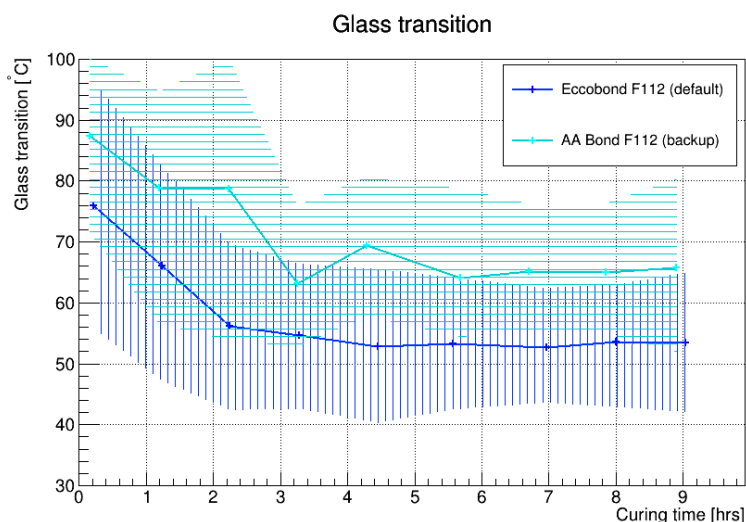
Figure 11. T_g of Eccobond F112 as cured for module assembly, measured using a Differential Scanning Calorimeter.

The quoted T_g of the glue, Eccobond F112, used in bonding the flexes to the sensor is around $+100\text{ }^\circ\text{C}$ [10] for the nominal curing procedure. However, the measured T_g was about $+55\text{ }^\circ\text{C}$, falling within the temperature range of a powered module. The lower T_g can likely be attributed to the non-standard curing process, as instead of applying the recommended post-cure at elevated temperature, module curing occurs at room temperature, which is known to affect the final thermo-mechanical glue characteristics. Figure 11 shows the T_g of the glue cured in this fashion, measured using standard techniques of Differential Scanning Calorimetry [11].

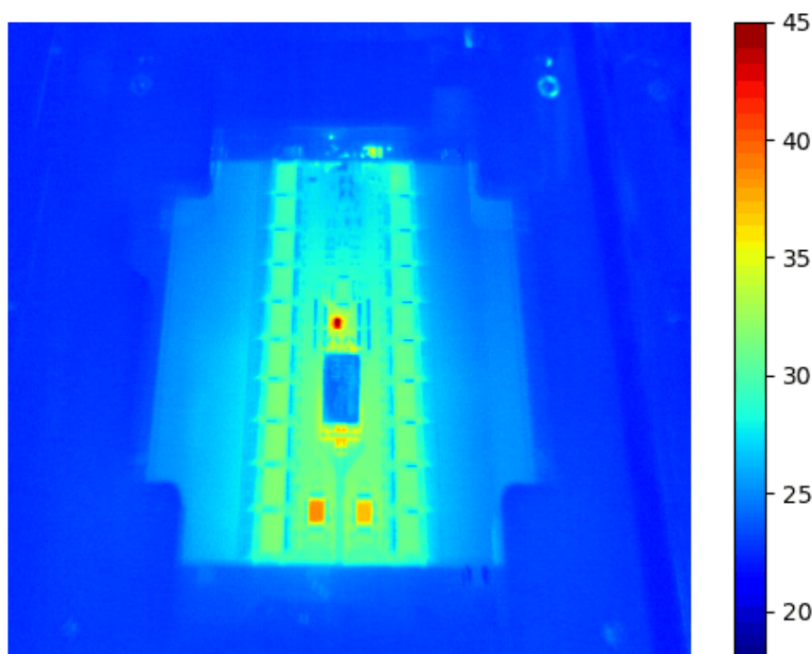
The absolute powerboard temperature was measured at more than $+45\text{ }^\circ\text{C}$ in room temperature environment operation, as shown in figure 12. This suggests that in thermal cycling to $+40\text{ }^\circ\text{C}$ chuck temperature, the absolute module temperature exceeds $+45\text{ }^\circ\text{C}$ around the powerboard.

Figure 12. Thermal image of a barrel module operated at room temperature. The temperature scale is measured in °C. The highest temperature regions are around the powerboard and hybrids, as expected, the highest temperature points in these regions are the linPOL and HCCs (small chips with high power density). The overall flex temperatures are 27 °C above the nominal chuck temperature.

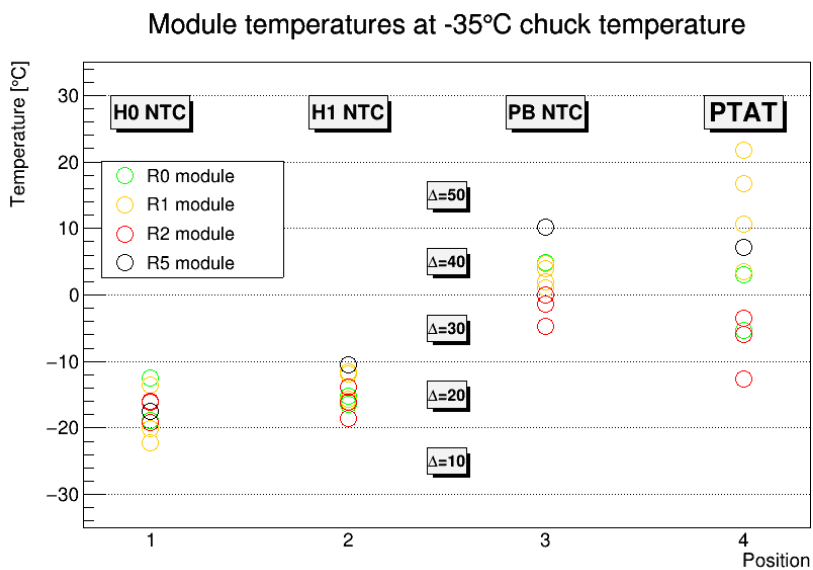
Measurements of module temperatures when in the cold stage of the thermal cycle show that the thermistor on the hybrid and powerboard flexes measures a relative temperature between $50\text{ }^\circ\text{C}$ to $70\text{ }^\circ\text{C}$ above the chuck temperature, see figure 13. The large temperature difference between the module and the chuck is what allows the module temperature to surpass the glue T_g once the chuck reaches the temperature ceiling.

Figure 13. Module temperature measured at the cold floor (chuck temperature of -35 °C) of the thermal cycle for endcap modules. The temperatures are measured at the positions of the thermistors on the hybrids (H0 and H1 NTCs) and on the powerboard (PB NTC). The temperature as measured by the proportional to absolute temperature channel (PTAT) is also reported. The y-axis measures the absolute module temperature, with the temperature deltas showing the module temperature relative to the chuck.

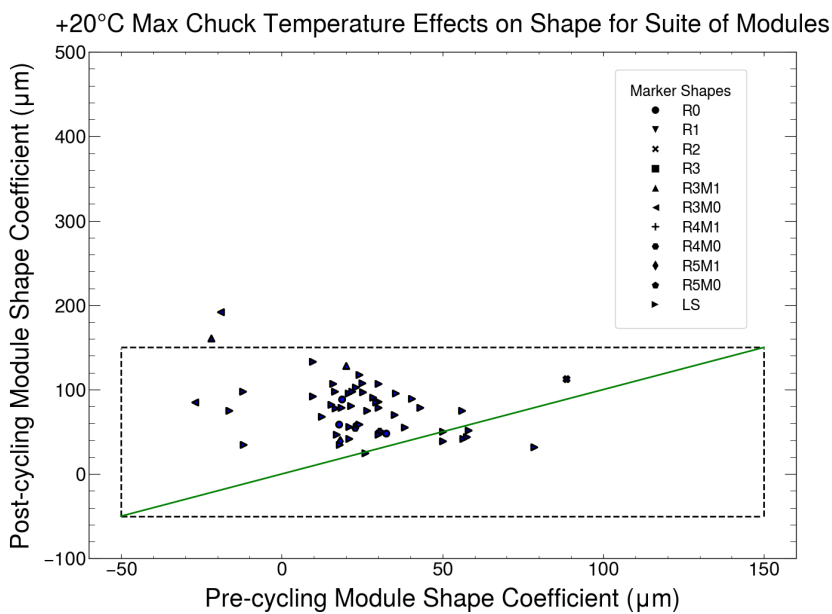
The sample of modules that were thermally cycled to +20 °C had minimal change in shape post-cycling, with 63% of modules having similar shape coefficients before and after cycling. The non-standard cure procedure for the glue had lowered the glue T_g to a temperature that could be exceeded at the thermal cycle ceiling of +40 °C. Thus, thermal cycling to +40 °C had allowed the absolute module temperature to exceed the glue T_g and caused a post-curing of the modules at an elevated temperature.

Figure 14. Post-cycling shape coefficient for modules thermally cycled to +20 °C ceiling. Most modules fall near the green line, indicating the shape coefficient is similar before and after thermal cycling.

performed with a lower ceiling temperature of +20 °C to check the impact on the module shape. The resulting plot for the modified protocol is shown in figure 14.

Modules cycled with the modified protocol lacked permanent deformation and had post-cycling shapes measured within specification. Based on this analysis, the updated thermal cycling regime brings modules to a maximum chuck temperature of +20 °C in order to prevent deforming the modules in QC. The modified ceiling temperature of +20 °C is representative of the full range of temperatures planned during detector operation.

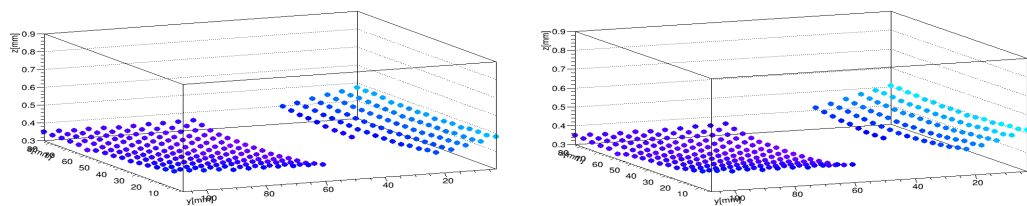
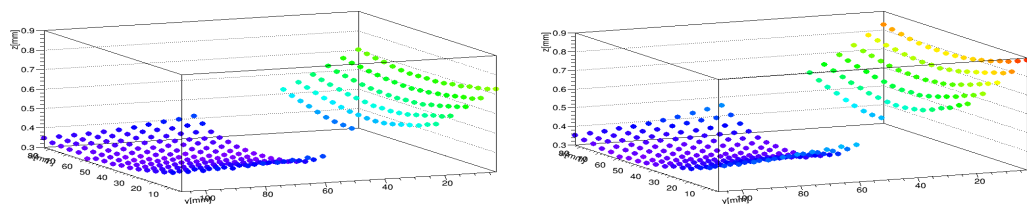
Figure 15. Module shape measurements taken following exposure to increased temperatures.

(a) Module held at +30 °C, measuring a shape coefficient of +158 μm (b) Module held at +40 °C, measuring a shape coefficient of +200 μm

(c) Module held at +50 °C, measuring a shape coefficient of +420 μm (d) Module held at +60 °C, measuring a shape coefficient of +580 μm

Monitoring the module shape over a range of increased temperatures showed that temperatures above +40 °C led to a permanent module deformation towards higher shape coefficients. This measurement confirmed that the adhesive's glass transition temperature is lower than quoted in the material data sheet and that surpassing it can lead to module deformation.

To confirm the effect of high temperatures on module deformation, a module was held at different elevated temperatures, allowed to cool to room temperature, and the module shape coefficient was measured following the temperature cycle. The module was held at the maximum temperatures for at least 30 minutes, with the module shape measurement done at +21 °C, shown in figure 15. For these tests, the module was not mechanically constrained, and remained unpowered through the whole cycle, such that the module temperature would be uniform across all components.
