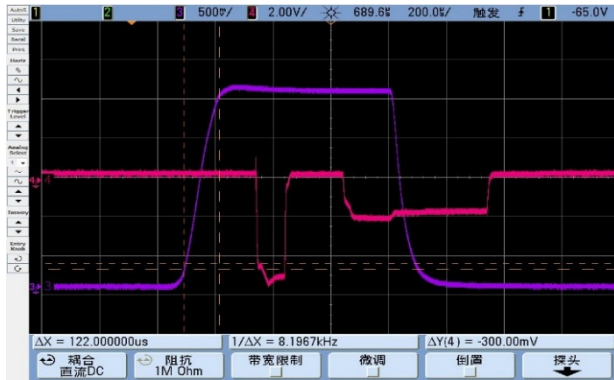
Figure 1: Two beams (red curve) are extracted with the new extraction power supply. One for the normal operation (left), another for the cesium cleaning (right).

(<8 kV) is used to clean out the cesium deposited on the extractor. The beam functioning as cleaning out cesium on extractor is lost in LEBT, and only the beam extracted by another pulse with normal voltage output (15 kV-18 kV) can transport through LEBT and into RFQ. Now the new extraction power supply is being used and works well as expected at very low beam duty factor for machine study.

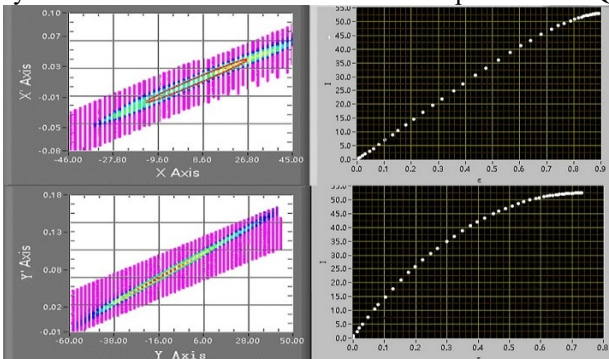
Figure 2: Results of emittance and current measurement: The left two plots show the emittance in x-x' and y-y' phase plane at the beam current of 53 mA. In the right two plots the beam current is shown as a function of the emittance in x-x' and y-y' phase plane, respectively.

Mainly three solenoids, a double slit type emittance monitor (EM), a pre-chopper and a beam collimator are adopted in LEBT. The EM is installed downstream the first solenoid. Results of emittance and beam current measurement are shown in Fig. 2. At the beam current of 53 mA, the rms. emittance is 0.892π mm·mrad in x-x' phase plane and 0.742π mm·mrad in y-y' phase plane, respectively. Within the beam rms. emittance of 0.2π mm·mrad, the beam current is 15mA in x-x' phase plane and 25 mA in y-y' phase plane, respectively.

It is proved theoretically and experimentally that, with three solenoids, the asymmetrical emittance can switch to symmetrical emittance and match the acceptance of RFQ.

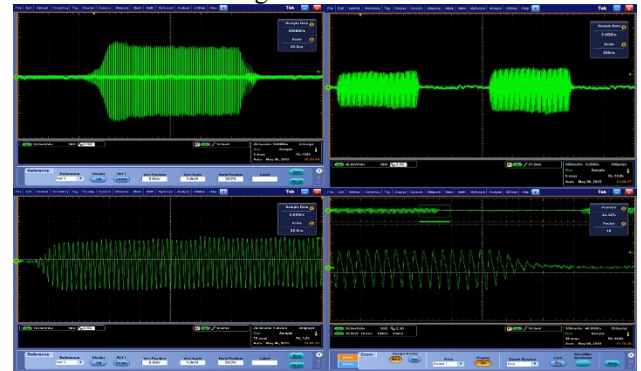
Figure 3: Beam signal of BPM after chopping. The upper plots: (left) the macro pulse of beam: 20 μs/div; (right) the micro pulse of beam: 200 ns/div. The lower plots: (left) the rising edge of beam signal; (right) the falling edge of beam signal.

For CSNS, only one electrostatic pre-chopper, which is installed at entrance of RFQ, is employed in LEBT to chop beam to the required beam structure asked for RCS. In the chopping experiment shown as in Fig. 3, the macro pulse beam with a width of 100μs and a repetition rate of 1 Hz is chopped to the micro pulse beam with a width of 500 ns and a repetition rate of 1 MHz. The chopping ratio shown here is 50%, but it is adjustable from 50% to 75% in beam commissioning.

The results shown in Fig. 3 are got from the beam position monitor (BPM) at the exit of RFQ. It can be seen that, at a applied chopping voltage of 4.5 kV, both the rise and fall time for the chopped beam are about 3 to 4 periods of the working RF (1 period time= 3.086 ns), i.e. both the rise and fall time are less than 15 ns. With a higher applied chopping voltage, the minimum rise/fall time is down to 10 ns.

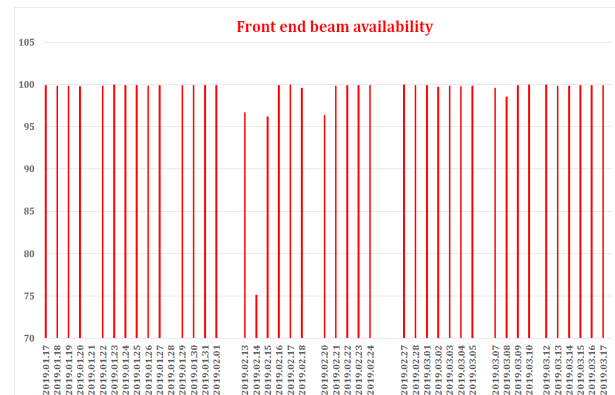
Figure 4: History of front end beam availability from January 17 to March 17, 2019.

As a whole including IS, LEPT, RFQ and MEBT, the history of CSNS front end beam availability from January 17 to March 17, 2019 is shown in Fig. 4. From the figure, one can see that the availability of the front end is about 99.9% except at February 13, 14, 15 and 20. The breakdown all comes from ion source. For February 13, 14 and 15, the breakdown is led by the cracking of the hydrogen gas transport pipe, while the breakdown at February 20 is caused by undue usage of cesium. Due to the slow and small variation of the beam current extracted from ion source, it is also variable for the target beam power. To
