DAMAGE BEHAVIOR OF TUNGSTEN TARGETS FOR 6 MeV LINEAR ACCELERATORS *

Zhihui Wang*, Hao Zha†, Zening Liu, Jiaru Shi
Department of Engineering Physics, Tsinghua University, Beijing 100084, China
also at Key Laboratory of Particle & Radiation Imaging of Ministry of Education, Tsinghua University, Beijing 100084, China

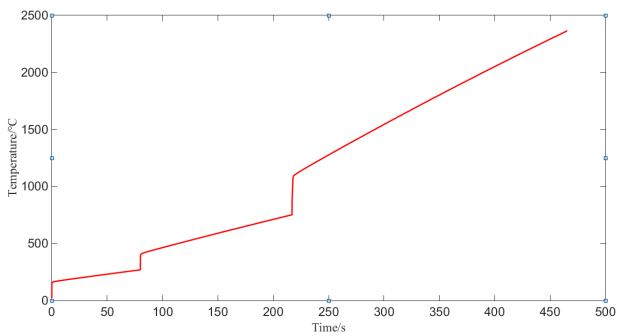
Figure 3: Maximum transient temperature within the target under average power input.

Finite element analysis software ANSYS was used to calculate the transient thermal behaviour of the target. To avoid enormous calculations, average power input was adopted to replace pulsed power input. Figure 3 shows the maximum transient temperature of the target under average power input during the course of the experiment. Due to the absence of cooling water, the maximum temperature in the target keeps rising and soars every time when increasing the average power input. The maximum temperature under average power input reaches 2365 ℃.

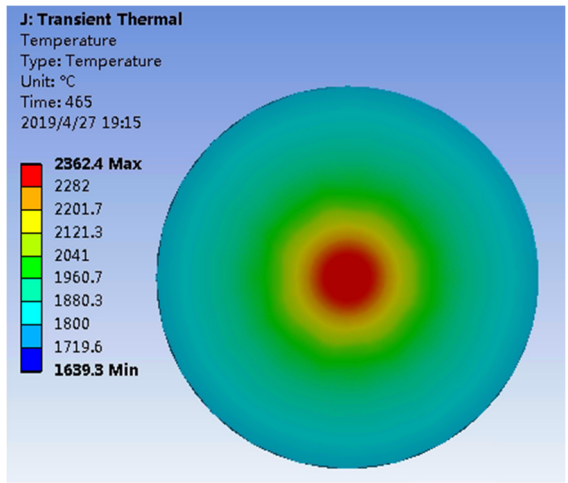
Figure 4 shows the temperature distribution of the target surface under average power input at the final state. The surface temperature reaches more than 1600 ℃ overall with a maximum of 2362.4 ℃ in the centre of the target surface. Recrystallization is assumed to occur on the target.

Figure 4: Final state temperature distribution of the target surface under average power input.

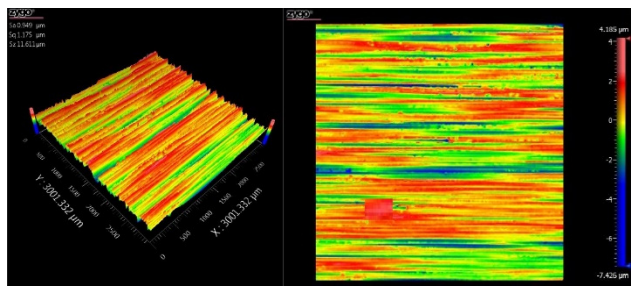
Figure 5: Surface morphology of the control group surface utilizing WLI.

Identical tungsten target that is not irradiated by electron beams or other irradiations is adopted as the control group. White light interferometer (WLI) was used to examine the surface morphology of experimental target and the control group at first. The examination results of the two targets are showed in Fig. 5 and Fig. 6, respectively. The traces of rolling are evenly distributed on the surface of the control group. A bulge with a diameter of around 1 mm is observed on the surface of the experimental target. The elevation of the highest point is measured as 56 μm. An annular depression of 5-8 μm is observed surrounding the bulge. Figure 7 shows the specific deformation data of the experimental target.

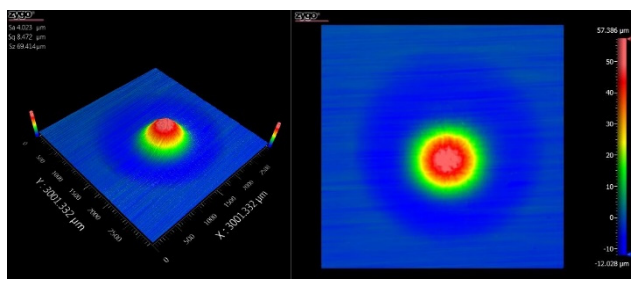
Figure 6: Surface morphology of the experimental target utilizing WLI.

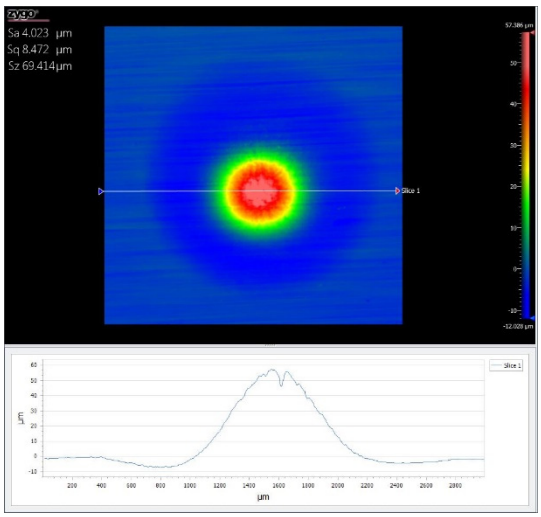
Figure 7: Specific deformation data of the experimental target surface utilizing WLI.

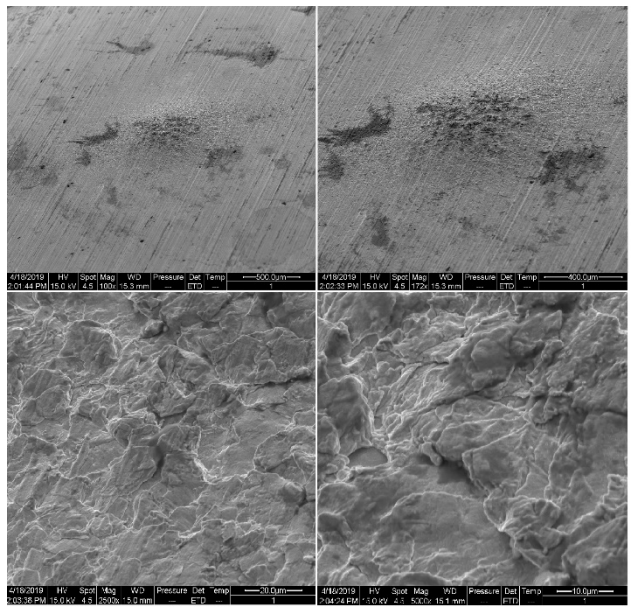
The morphology of the experimental target surface was further examined with scanning electronic microscope (SEM). Figure 8 shows the examination results of the centre of target surface utilizing SEM with different levels of magnification. The surface of the bulge appears rough, the crystal lattices expand and squeeze against each other, several cracks can be observed along the grain boundaries. Recrystallization occurs on the surface centre. Etching phenomenon causing by tungsten melting and fatigue cracking are not observed. Target surface morphology examination results show consistence with the temperature results in simulations.

Figure 8: Surface morphology of the experimental target with different levels of magnification utilizing SEM.

Recrystallization occurs on the surface of tungsten target after loading 6 MeV electron beam with repetition frequency of 220 Hz, pulse width of 4 µs and mean current of 151 µA for 248 s without cooling system. Recrystallization is a form of damage behaviour of the tungsten X-ray targets. Transient temperature calculations show high accuracy. More properties of damage behaviours of different material targets require further experiments.
