Lessons Learned from the Module Production for the First CMS Silicon Tracker

Alan Honma

Abstract: A personal view of some of the more important lessons learned from the module production for the CMS silicon tracker. This work took place from about 2002–2005. The focus is on areas where I had strong personal involvement; therefore, the tasks of hybrid production, hybrid assembly, and the wire bonding of modules and hybrids are emphasized. This article will first give a general description of the silicon tracker project and how the module production was organized. Then, there will be description of several of the key issues or problems during the production and how they were resolved. Some recommendations for future similar large-scale productions will be given.

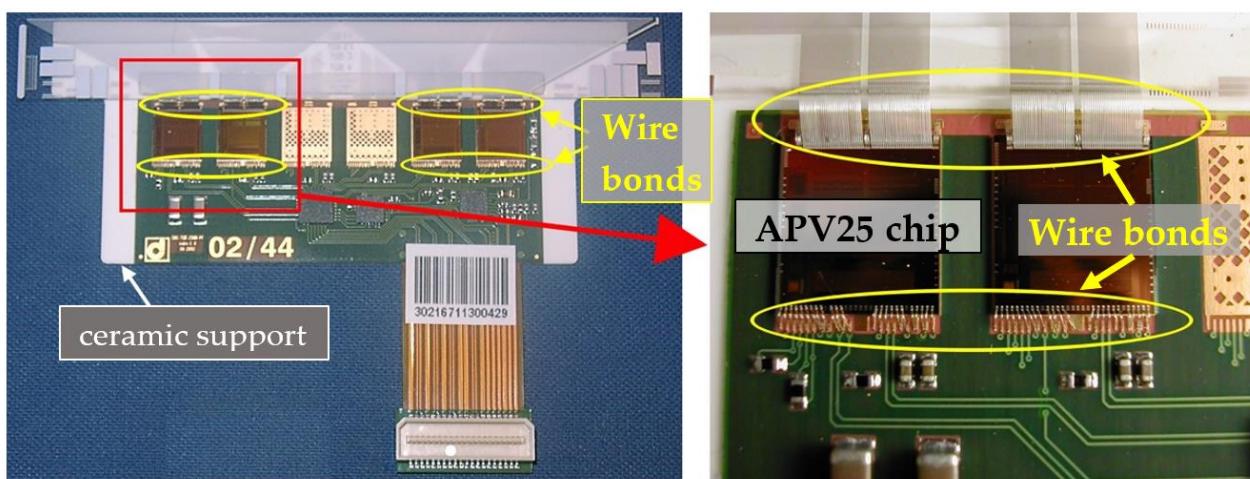
Figure 6. **Left:** Hybrid (flex PCB+pitch adapter on ceramic substrate). **Right:** Zoom on two APV chips showing wire bond connections of chip-to-flex (lower row) and chip-to-pitch adapter (upper row).

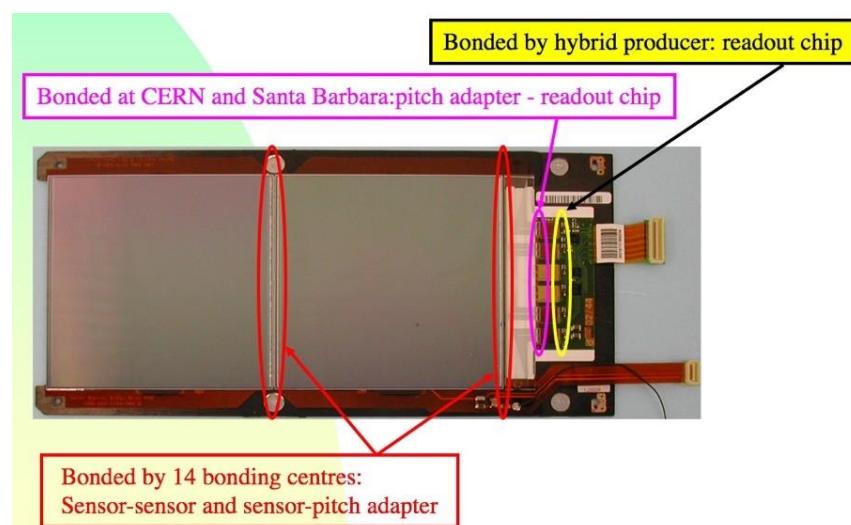
Figure 9. Location of wire bonds in a two-sensor module.
