# ELONGATION OF LED LIGHTING LIFETIME UNDER X-RAY DOMINANT RADIATION ENVIRONMENT

T. Fukui<sup>†</sup>, T. Inagaki, H. Tanaka, RIKEN SPring-8 Center, Hyogo, Japan

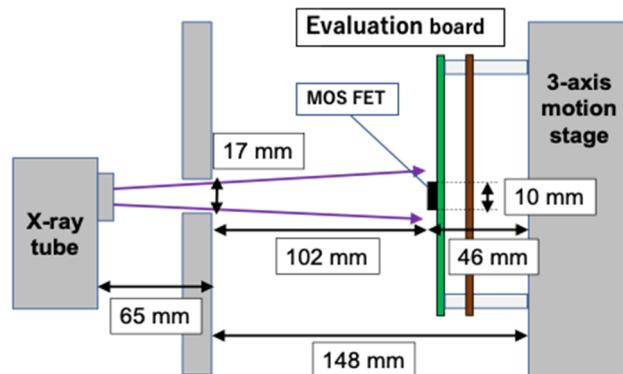
To study the process of radiation damage of MOSFET in an LED power supply, we performed in-situ measurement of a MOSFET mounted on an LED power supply circuit board under X-ray irradiation by an X-ray tube. Figure 1 shows the experimental setup. The X-ray source was an X-ray tube (Ultra18X, Rigaku) [3]. We measured the X-ray radiation dose rate on the target by using a GAFCHROMIC Film HD-V2. The critical requirements were homogeneous irradiation on a MOSFET and an appropriate dose rate of  $\sim 0.2$  Gy/s (air kerma) to make the measurement time reasonable. Figure 2 shows the schematic circuit diagram of the LED driver evaluation board (MTO-EV001, Marutsuelec). This board is a simple flyback power supply

Figure 1: Experimental setup of in-situ measurement of the radiation damage of LED power supply board.

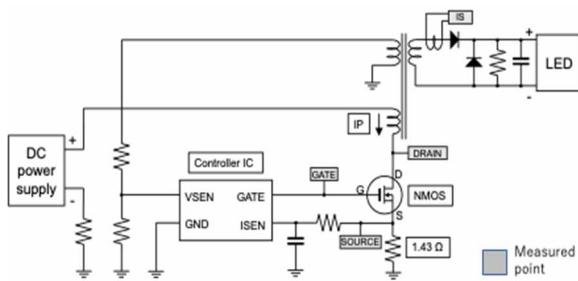
Figure 2: Schematic circuit diagram of the flyback LED driver evaluation board.
