Analysis of MQXFA07 Test Non-Conformity

US-HiLumi-doc-4293

Date: Sept. 12, 2022

US HL-LHC Accelerator Upgrade Project

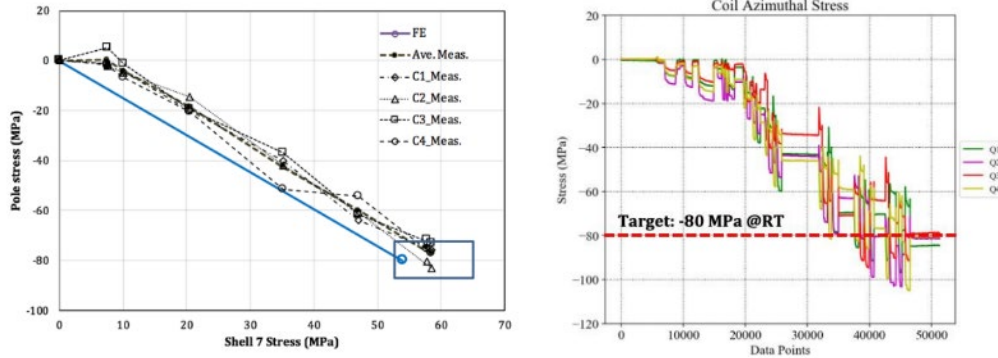
Figure 2.6: Left: coil pole vs shell stress during magnet pre-loading (the square indicates the acceptable target values). Right: details of the coil pole stress during bladder operation, with peak stress <110 MPa.

According to the strain gauge measurements taken during magnet fabrication, the coils, shells and rods were pre-loaded consistently to the target values (see Fig. 2.6 left), and the coil peak stress during bladder operation was maintained within the -110 MPa set as a limit in the magnet pre-load specifications (see Fig. 2.6 right). During test, and in particular during excitation the coil exhibited the usual unloading, indicating that the coil pre-load after cool-down was consistent with previous magnets (see Fig 2.7).

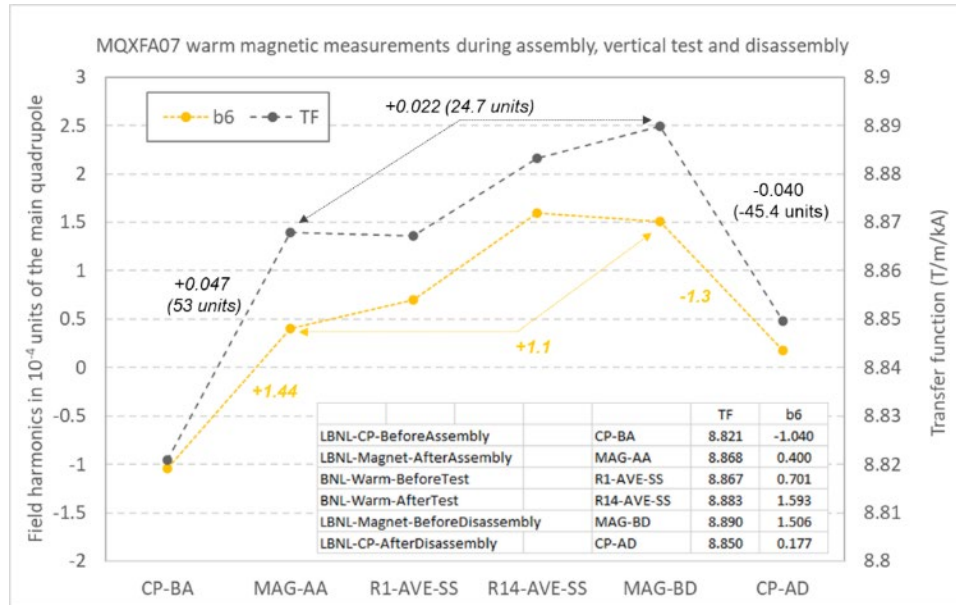
Figure 2.9: Variation of b6 and TF during assembly, test and disassembly.

- In terms of coil deformations during assembly cold test and disassembly:
 - The behaviour is consistent to other magnets
 - The coils radial deformation before/after cold test estimated by the magnetic measurements is consistent with mechanical measurement of coil pack (-0.13 mm vs. [-0.10,-0.15]) but an additional reduction of the coil arc length by 0.12 mm is required to fit both T.F. and b6 (b10)
 - Similar, but 2x larger effect, is seen from coil pack to assembled magnet
 - Assembly effect is largely reversible at disassembly while cold test causes permanent changes (see Fig. 2.9)
- In terms mechanical deformations from ANSYS (see Fig. 2.10)
 - Magnitude of calculated changes in non-allowed harmonics are roughly of the same order as found in BNL measurements from warm to nominal; however, A07/A08 measurements show different changes despite similar pole key gaps.

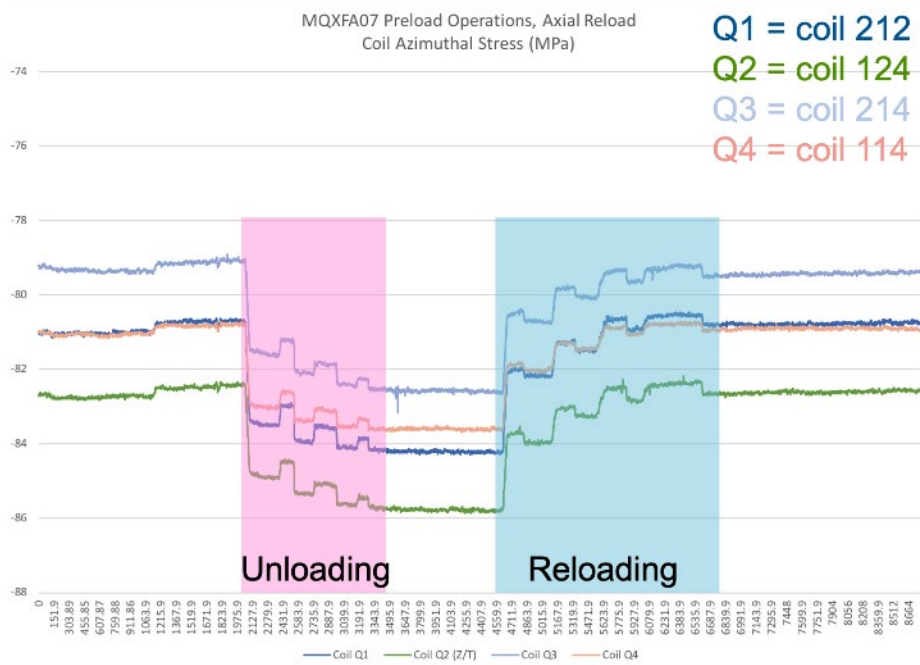
Figure 3.4: Coil azimuthal stress during off-normal work procedure for MQXFA07 NCR-220

Following preloading, it was noted that the RE axial end plate on MQXFA07 was off-center (shifted down and to the left); to correct this issue, the magnet needed to be unloaded and realigned. The off normal work procedure is documented in docDB-4210 and MQXFA-NCR-0220 and is similar to work done on MQXFA06 NCR-164. The following corrective actions were taken:

Figures 3.4 through 3.6 show the stress/strain reading before/during/after the off-normal work procedure. The coil axial strain and azimuthal stress as well as the rod strain were maintained after the work was completed.

1. Unload ~50% of the load (to ~470 $\mu\epsilon$)
2. Check strain gauges to verify repeatability
3. If numbers are proper, reduce force to light contact (~50 $\mu\epsilon$) to maintain friction
4. Move RE endplate using bracket tooling and align (same tooling as used on MQXFA06)
5. Reload to 950 $\mu\epsilon$ rod strain
6. SG readings maintained throughout process
7. Verify SG readings are ok

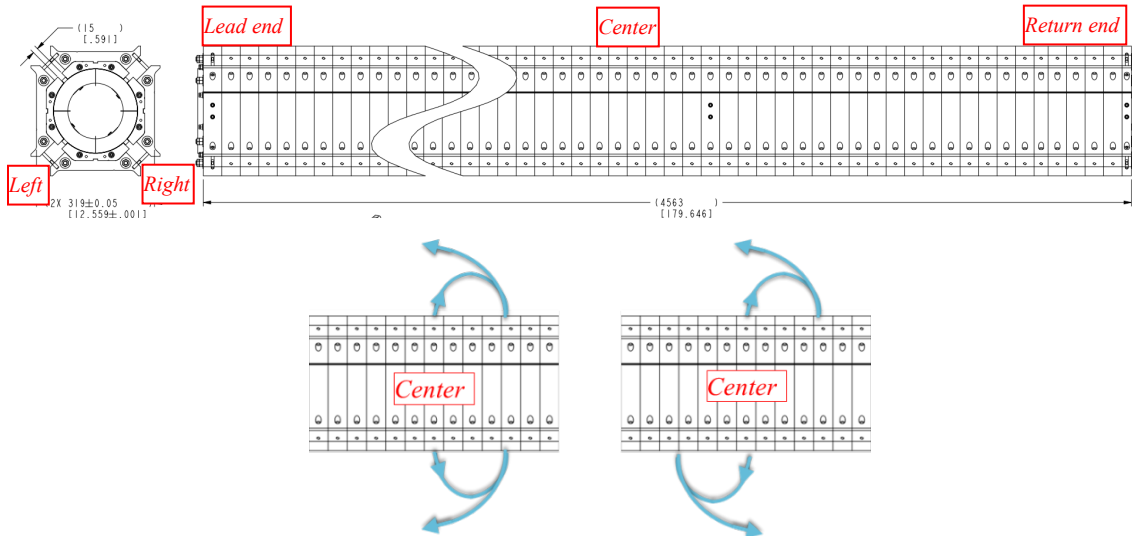
Figure 3.7: Coil pack sub-assemblies: on top, cross-section (left) and full 3D view (right) with the series of bolted pads around coil and collars. Bottom: sequence of bolting before (left) and after (right) change #1.

Two off-normal working conditions, related to the regulations implemented at LBNL to address the COVID pandemic, affected the coil-pack assembly of magnet MQXFA07. To clarify these modifications, we provide a representation of the coil-pack assembly in Fig. 3.7 (top), with on the left a cross-section of the coil-pack assembly, and on the right a 3D side view of coil-pack assembly along the longitudinal direction. The *left* and *right* side of the cross-section, and the *lead-end*, *center*, and *return-end* in longitudinal view are also indicated. The changes are:

- iii. in this process, the two technicians were moving in a simultaneous way, and were therefore always facing each other.
 - b. In the procedure adopted after the LBNL Covid shutdown (i.e. from MQXFA05 to MQXFA09) the two technicians were still starting the bolting procedure from the central pads, but they were then moving in opposite directions, still alternating the steps towards the lead and return end (see Fig. 3.7, bottom right). The purpose of this change was to minimize the time when the technicians were in close proximity (i.e. facing each other).

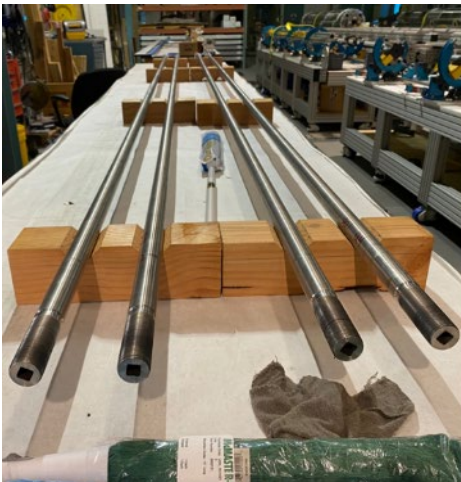
Figure 4.9: Rods after disassembly.

The rods length was not measured prior to the assembly, so a comparison was not possible with the length post-test. Relative lengths after disassembly appears to show that rods 1, 2, 4 each were $\sim 1 \text{ mm}$ longer than rod 3 (Fig. 4.9). However, some variations are expected from the unchamfered rolled threads ends. Therefore, these observations are inconclusive.

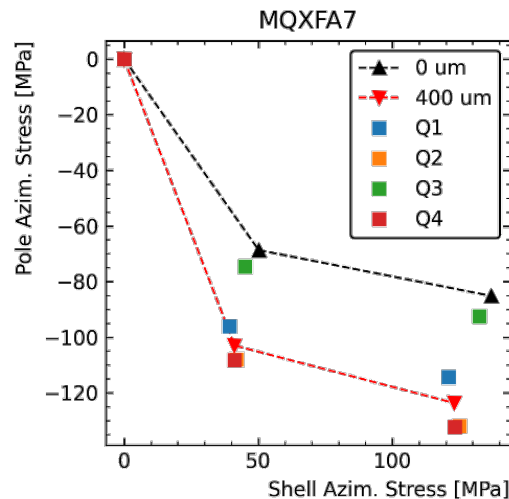
Figure 5.2: Coil pre-stress vs shell stress in the straight section assuming a closed pole key gap in quadrant 3.

According to the 2D model (which analyzes the magnet straight section), no ‘special’ stress singularity is observed in any of the quadrants. Nonetheless, the azimuthal pre-stress is significantly lower (~30 MPa reduction) in the quadrant with a closed pole-key gap (quadrant 3), ‘medium’ on the opposite side (quadrant 1), and maximum on the two remaining quadrants (see coil and shell computed stress in Fig. 5.2). It is important to point out that this reduction is not measured by the strain gauges mounted on the MQXFA07 coil in quadrant 3, in one axial location at 3.9 m from the lead end.

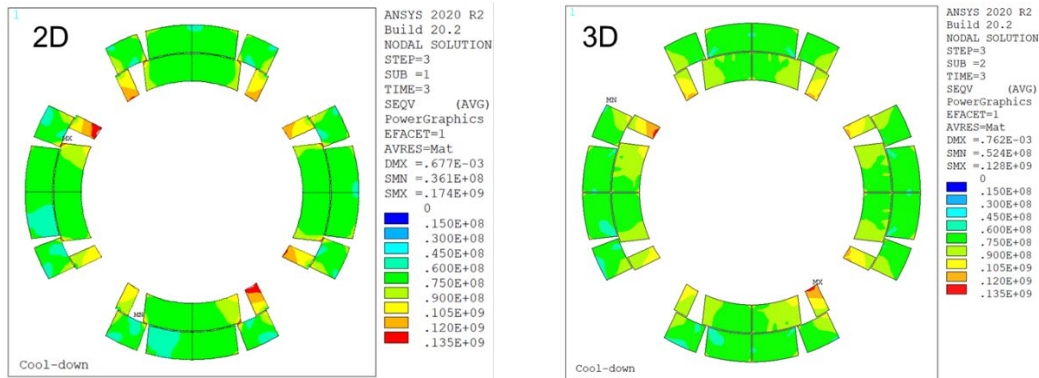
Figure 5.3: Comparison between coil azimuthal stress after cool-down computed by the 2D and 3D models (360 degrees).

A 3D finite element model (360 degrees) confirms that the quadrant with the pole key gap closed has lower pre-stress than the quadrants with the open pole key gap, as can be seen in Fig. 5.3, where the coil azimuthal stress after cool-down computed by the 2D and 3D models (360 degrees) are compared.

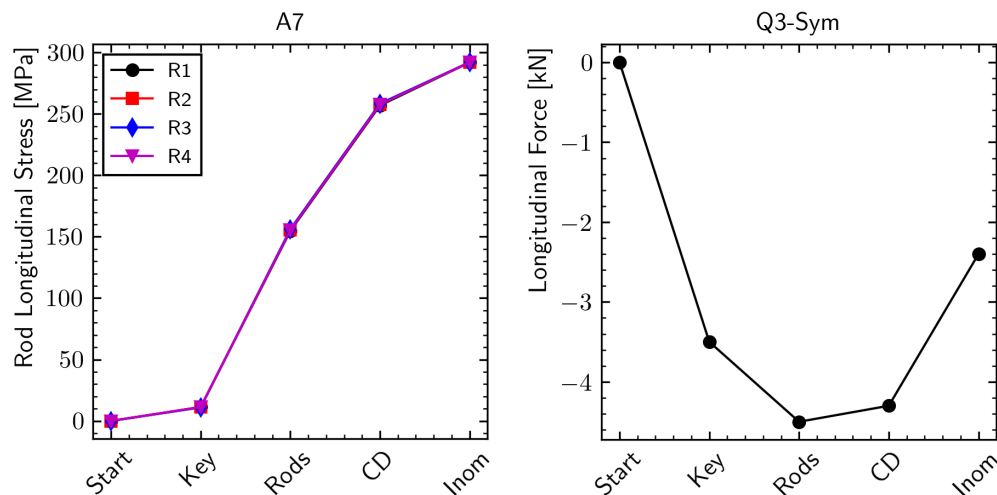
Figure 5.4: Left: axial rod stress in the MQXFA7 scenario. Right: difference between axial force delivered by the end-plate in quadrant 3 and in the other quadrants, in the MQXFA7 scenario.

In addition to the azimuthal stress in the straight section, the 3D model (360 degrees) allows to investigate the behavior of the four quadrants in the end region considering the MQXFA07 scenario. If we focus on the axial pre-load system, we notice that the computed stress is identical in the 4 rods (see Fig. 5.4, left): this indicates that the four rods have the same displacement. However, the axial force delivered by the end plate to the coil in quadrant 3 is smaller compared to the other quadrants (Fig. 5.4, right). This phenomenon can be explained as follows: the lower azimuthal pre-load in quadrant 3 results in a lower friction between the coil and the structure. Therefore, when compressed by the end plate, the quadrant 3 coil contracts axially more than the other coils, which are better axially constrained by the higher frictional contact with the support structure.

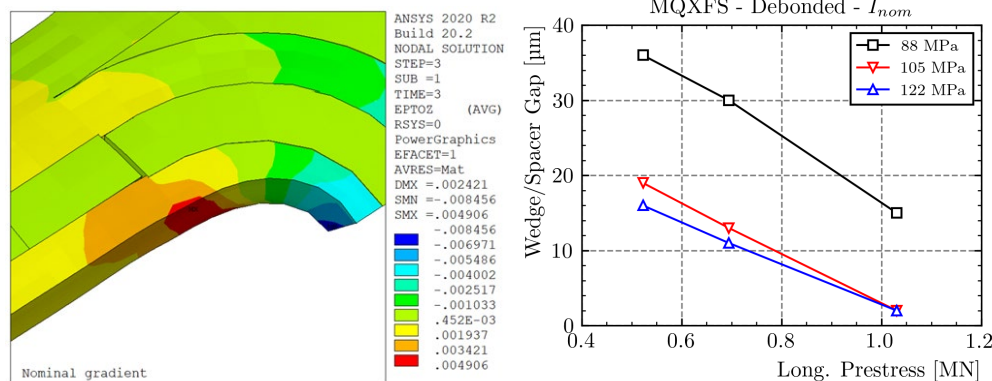
Figure 5.6: Left: View of the gap between wedge and end-spacer in the no-bonded case. Right: variation of the gap as a function of the azimuthal and axial pre-load.

The impact of a possible separation between the wedge and the end-spacer on the coil strain was studied with an octant model, which allows a more refined mesh compared to the 360 degrees model. Under the assumption that the coil surfaces are not bonded, i.e. that epoxy cracking has occurred, the gap between wedge and end-spacer, showed in Fig. 5.6 (left), increases with progressively lower azimuthal and axial pre-load, i.e. the conditions of Q3 in the MQXFA07 scenario according to the 360 degrees 3D model. The gap induces a spike in axial strain in the coil, which can reach the 0.4% level (see Fig. 5.7, left). As can be seen in Fig. 5.7, right, a larger increase is computed in the turn towards the pole.

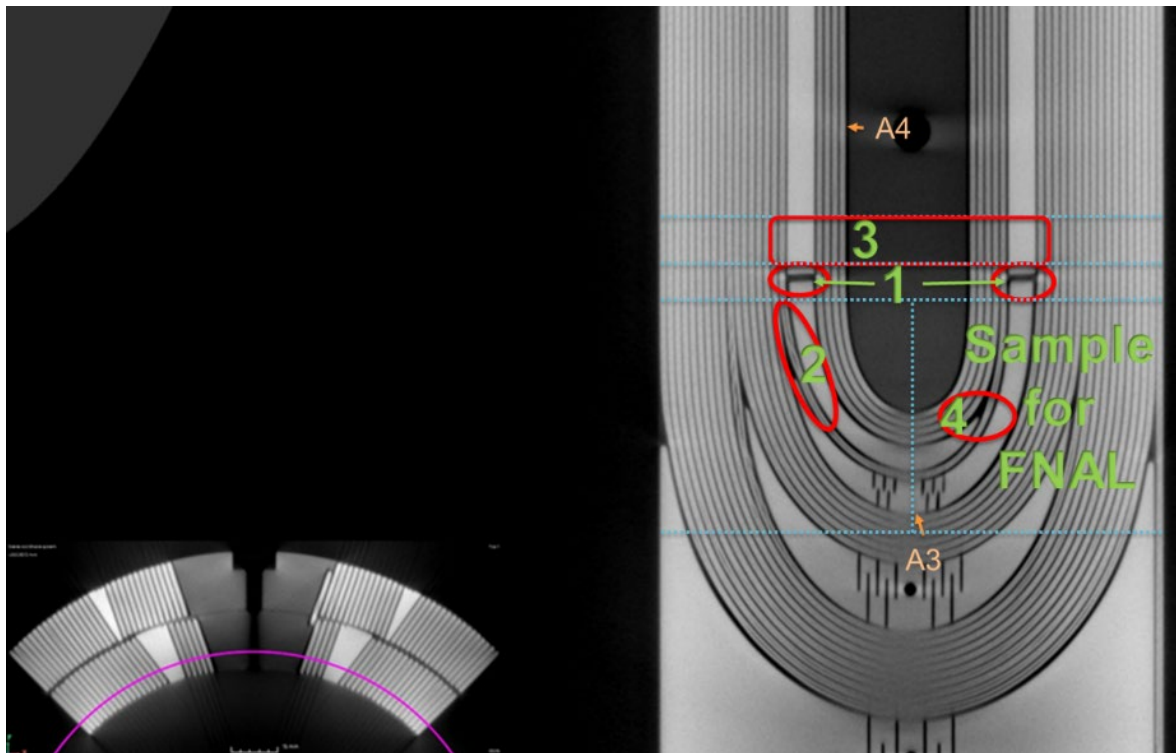
Figure 6.7. Areas in coil 214 Inner Layer Lead End selected for micrographic analysis.

Based on CT-scan results it was decided to perform macrographic analysis of 4 regions of the Inner Layer of coil 214 lead end. These regions are shown in Figure 6.7 and described below:

1. This is the wedge to end-part transition on both coil sides. The FE analysis described in section 5 has shown the possibility of strain concentration in this region due to the unusual elongation of coil 214 because of the closed gaps. Both visual inspection (Fig. 6.2) and die penetrant tests (fig. 6.6) showed signs of strain concentration in these regions. According to FE analysis, the cables most affected by this mechanism should be those on both side of each wedge to end-spacer transition.

2. This is the area where tomography showed a turn affected by popped strand(s) within the limiting segment (A3-A4). Micrographic analysis of this area is particularly challenging because the cable is not straight.
3. This is the area where the last collar lamination in contact with the pole-key ends. In case of sliding between this collar lamination and the next one (not supported by the pole-key) there could be a stress gradient in this region.
4. This is the tip of the end-spacer allowing turn 5 to move from the pole block to the mid-plane block. It is the other transition within the limiting segment (A3-A4). This sample was sent to Fermilab.

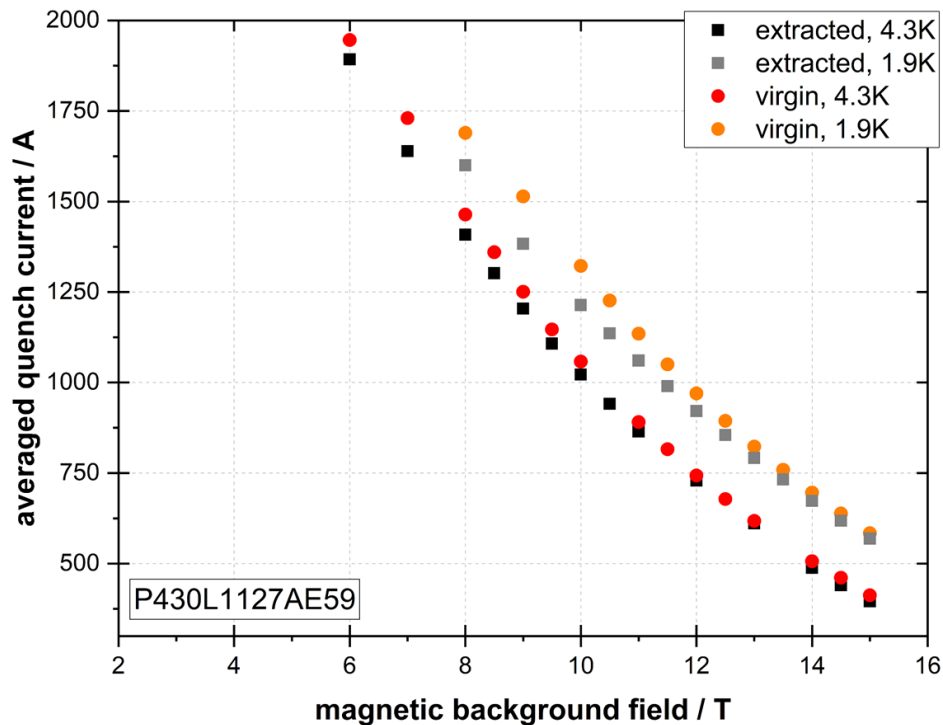
The figures below show measurement results. No sample showed sign of stability issued up to 2 kA.

Figure 9.1. Samples: P430L1127AE59 extracted & virgin

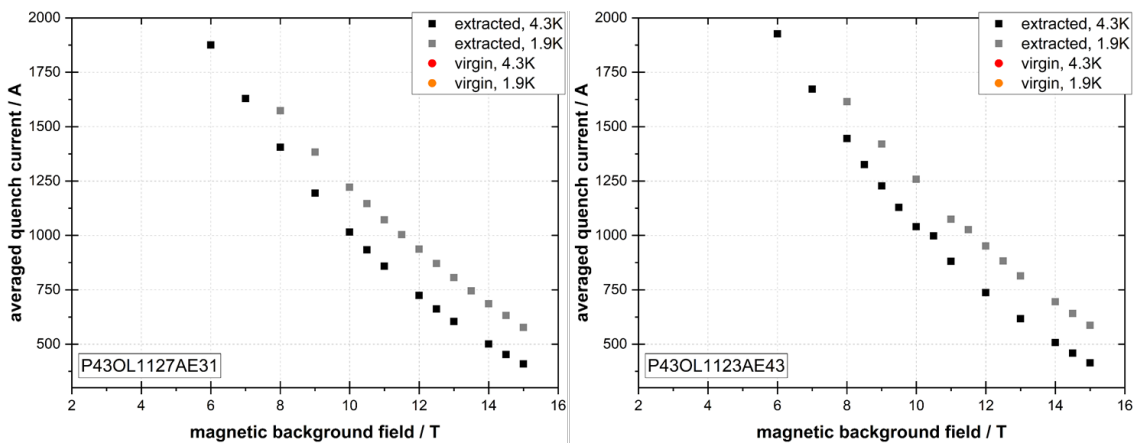
Figure 9.3. Samples: P43OL1127AE31 extracted (left) & P43OL1123AE43 extracted (right)

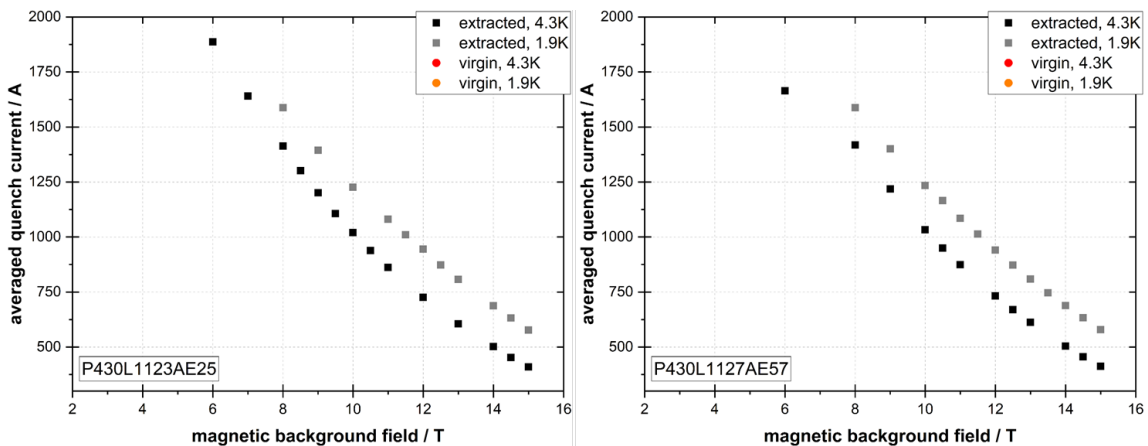
Figure 9.4. Samples: P43OL1123AE25 extracted (left) & P43OL1127AE57 extracted (rights)
