RHIC Au-Au OPERATION AT 100 GeV IN RUN 23*

Abstract

The Relativistic Heavy Ion Collider (RHIC) Run 23 program consisted of collisions of 100 GeV gold beams at two collision points for the first time since 2016; the sPHENIX collaboration used the beam to commission their new detector systems while the STAR detector took physics data. Completion of sPHENIX construction pushed the start of the run to May, forcing the collider complex to operate over the summer months and incurring lower than normal availability due to heat and power dip related problems. Issues with dynamic pressure rise during acceleration through transition resulted in a slower ramp up of intensity compared to prior years. Finally, a failure of a warm-to-cold current lead interface in the valve box for the Main Magnet power supply forced the run to end. This paper will discuss the progress made by each experiment and the failure mode, repair and mitigation efforts in preparation for Run 24.

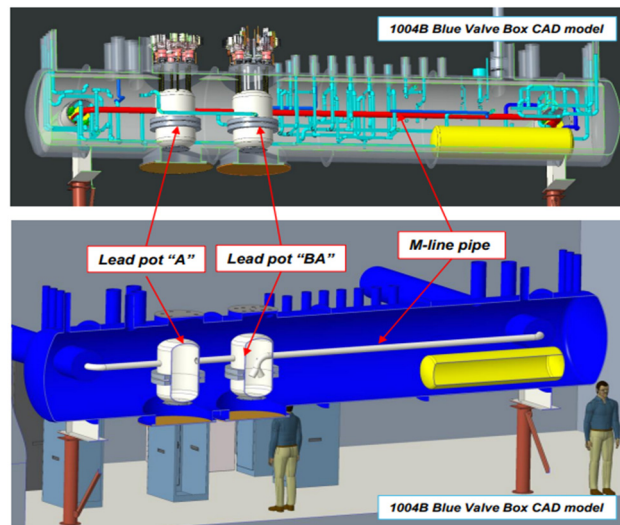
Figure 6: Valve box cutaway

A valve box is a 10m x 3m cylinder with most of the volume filled with insulation and vacuum. Within each valve box are 2 'lead pots' where liquid helium and superconducting wiring from the ring enters the bottom of the pot and transitions into copper bars soldered into cups on a ceramic break at the top of the pot.

Each lead pot contains several groups of connections referred to as 'terminal boards'. The failure occurred in terminal board D (TBD) that contained 12 connections each rated up to 150 amps. An arc developed across two of the gas-cooled leads which then expanded to engulf 10 of the 12 pins, destroying them and rupturing both the TBD feed-through wall and the bellows that separate the insulating vacuum from atmosphere.

The 4 o'clock DX magnet was replaced with a spare since the time needed to check for damage within the original magnet would exceed the shutdown time between runs. A spare terminal board was installed into the failed location and the ruptured bellows were replaced.
