# TWENTY YEARS OF OPERATION OF THE ELETTRA RF SYSTEM

C. Pasotti, M. Boccai, P. Pittana, M. Rinaldi,  
Elettra - Sincrotrone Trieste, 34149 Basovizza, Trieste, Italy

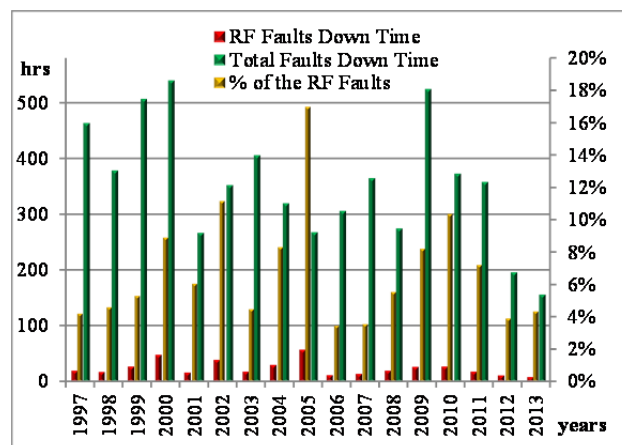
The reliability of the Elettra RF system is shown from the down time caused by RF in comparison with the total machine down time, see Fig. 1. Every RF failure is fatal meaning machine downtime for the users.

Figure 1: Total and RF down time in hours, vertical axis on the left, and percentage of RF downtime with respect to the total downtime, vertical axis on the right.

to the data shown in Fig. 1, the RF down time is not significantly decreased. The absence of a significant improvement of the reliability is mainly due to the obsolescence of the RF equipment and to the lack of qualifications of the Thales IOT tubes.

Therefore the contribution to the RF downtime of Fig. 1 comes entirely from the storage ring RF stations.
