# TWO YEARS EXPERIENCE WITH THE UPGRADED ELBE RF-SYSTEM DRIVEN BY 20 kW SOLID STATE AMPLIFIER BLOCKS (SSPA)

H. Büttig, A. Arnold, A. Büchner, M. Justus, M. Kuntzsch, U. Lehnert, P. Michel, R. Schurig, G. Staats, J. Teichert, Helmholtz Zentrum Dresden- Rossendorf, Germany

Since January 2012 the Superconducting 1.3 GHz CW Linac ELBE is equipped and in permanent operation with four 20 kW Solid State Amplifier Blocks (SSPA). The project and the design of the new RF system have been described in the papers [1] and [2]. The experience gained within the first two years of operation is encouraging.

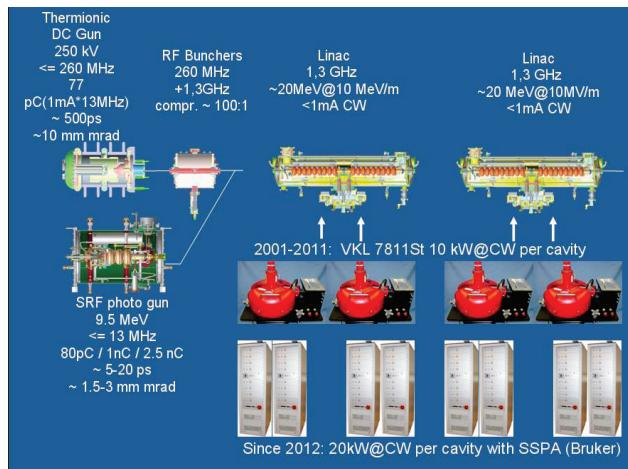
Figure 1: Layout of the upgraded ELBE RF-system.

The replacement of the klystrons by SSPA is illustrated in Fig. 1. 20 kW SSPA modules are used per cavity and one SSPA is used to operate the SRF photo gun. The RF related activities before the upgrade project are described in the papers [2] and [3]. Fig. 2 shows the new SSPA gallery at ELBE. In general the ELBE operation is now much smoother than with klystrons used before.

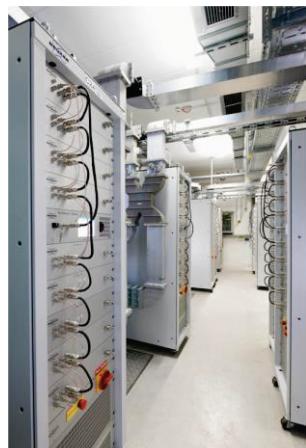
Figure 2: The new SSPA gallery at ELBE.

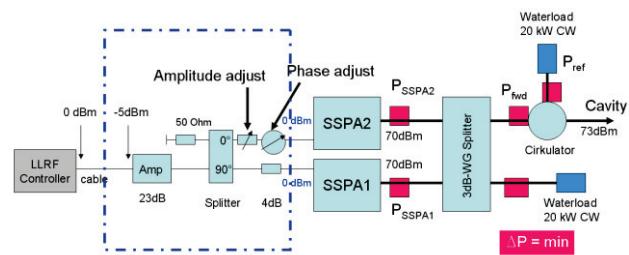
Figure 3: Block diagram of the 20 kW SSPA module.

The block diagram of the driver is shown in Fig. 3. Two 10 kW SSPA are operated in parallel using hybrid waveguide couplers at the output and also 3 dB hybrid couplers (SMA-type) at the input.

Tuning criterion is RF power minimum at the isolated port of the 3 dB-waveguide coupler using the variable amplitude and phase adjusts in the driver box.
