**Search for Mechanically-Induced Grain Morphology Changes in
Oxygen Free Electrolytic (OFE) Copper**

Search for Mechanically-Induced Grain Morphology Changes in Oxygen Free Electrolytic (OFE) Copper. JENNIFER E. SANDERS (Westminster College, Fulton, MO 65251) ROBERT KIRBY (Stanford Linear Accelerator Center, Menlo Park, CA, 94025).

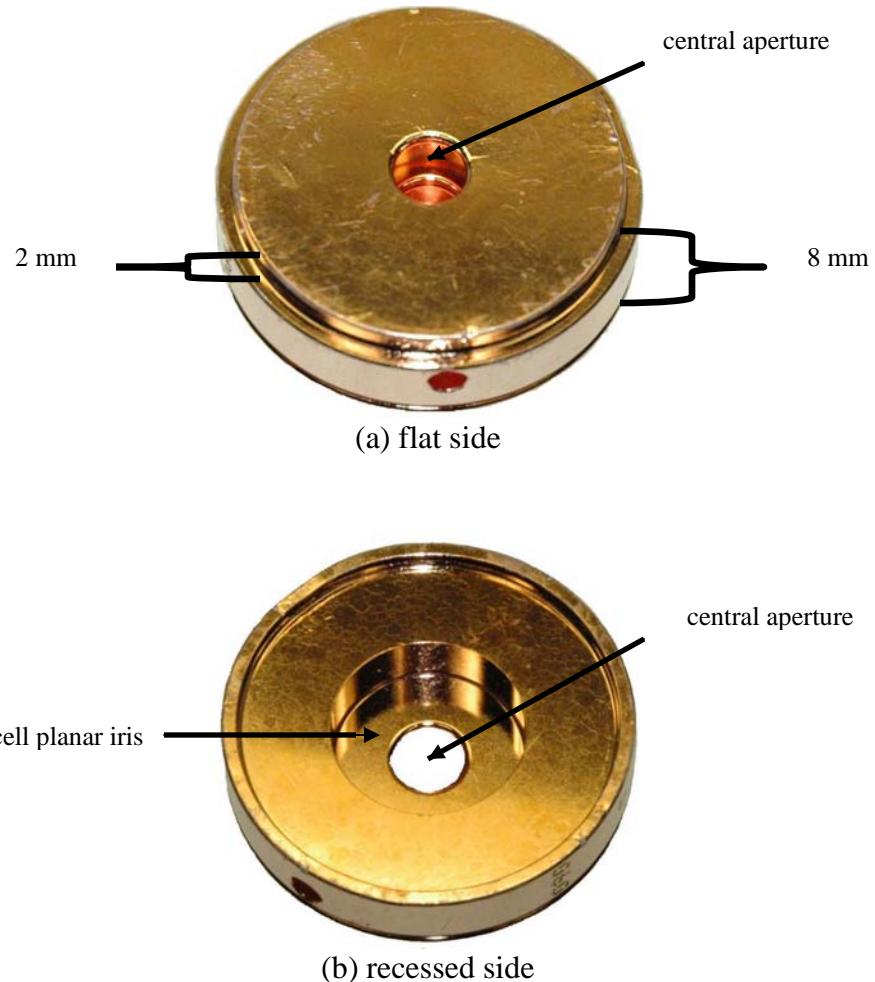
Figure 1 Flat side and recessed side of an OFE copper accelerator structure cell.

structure of the cell planar iris, within several millimeters of the central aperture, where the electric field is highest and most breakdowns occur and deformed grains are formed. The irises are 2 mm thick and the overall thickness is 10 mm (Figure 1).

Six OFE copper cells numbered 60 through 65 were bonded as a small test stack for this study (Figure 1). These cells are of the type used for fabricating the accelerator structure of the NLCTA, but for various reasons were not used for that purpose. In an accelerator structure, cell numbers reference cell location within the larger accelerator structure. This study uses the numbers solely for identification and comparison purposes. The individual cells were from a lot of cells rejected for previous use because of incidental handling artifacts, e.g. scratches and dents.

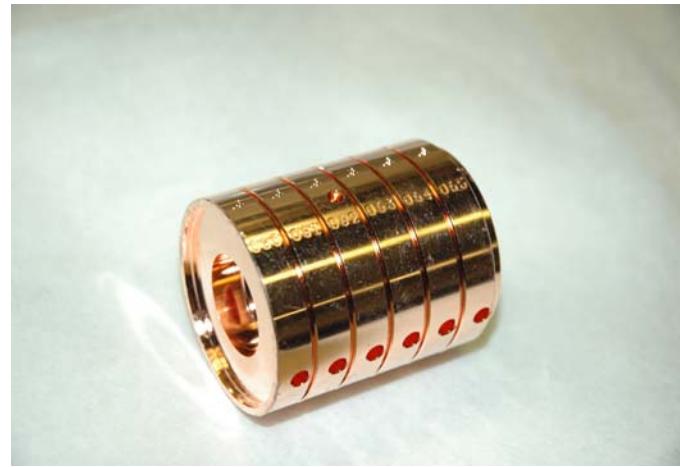
Figure 2 OFE Copper small test stack, cell numbers 60 through 65, used for this study before the manual twisting. The bottom of the stack, cell 60, shows the recessed cup of the cell. Notice the cell numbers and lower holes are perfectly aligned.

Each individual cell went through the annealing furnace and chemical cleaning before being diffusion bonded at 1015 – 1020°C for an hour. Chemical etching on individual cells, lasting 60 seconds, effectively removed unwanted debris from the surface of the sample before bonding while the hydrogen furnace removes oxide from the surface area between the cells (which encourages atomic inter-diffusion between mating cell surfaces during the very high temperature bonding). After bonding, the stack of accelerating cells was vacuum-baked (to remove the excess hydrogen from the copper bulk) and then sealed in N₂ to maintain the clean surface. The bonded stack of accelerating cells measures approximately 52mm in length with cell 60 on the bottom of the stack, the recessed cup down (Figure 2).

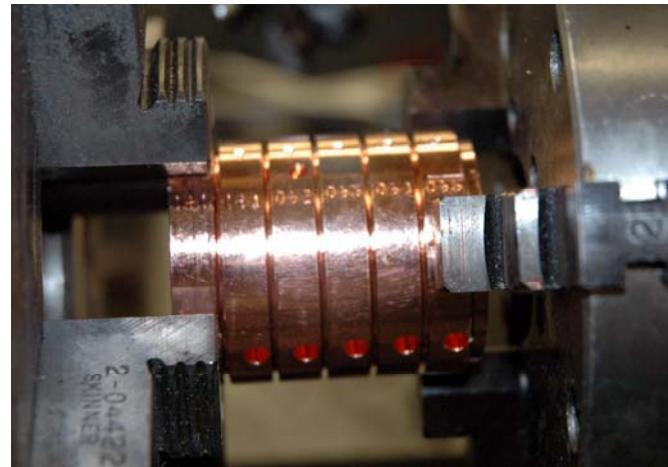
Figure 3 OFE Copper small test stack, cell numbers 60 through 65, locked in the lathe after the manual twisting. Notice the slight misalignment of the cell numbers as well as the lower holes.

To simulate the rotational damage done to the NLCTA accelerator structure during mechanical fabrication, the test stack was placed in a lathe (Figure 3), anchored on one end, and manually twisted 1.5° from the free end, severely damaging both end cells held by the lathe. The degree of twist was measured by the displacement of the number on the bottom cell from the centered number of the anchored cell. The rotated cell was displaced 1.25 mm—the desired amount of twist (2° – 3°).

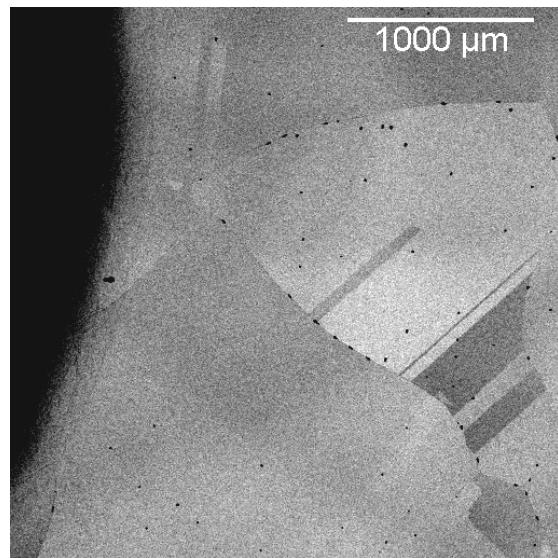
Figure 4 SEM image of copper grains in surface of cell 60 at magnification of 30X before twisting damage.

SEM imaging was done on cell 60 (recessed end) of the bonded stack before the manual twist and cells 60 through 64 (recessed end) after the manual twisting of the test stack. Images of cell 60 before the twist generally appeared as in Figure 4: many grains varying in size, shape, and brightness. Figure 5 shows an image of the same location on the cell after the twisting. Though cell 60 underwent enormous exterior damage during twisting, comparisons with the images of this cell (Figure 4) taken before twisting at each magnification (30, 100, and 1000), show similarity in appearance and grain consistency.

Cells 61 – 64 lack evidence of rotational deformation from the twist performed on the stack. Figures 6 and 7 of the cells at magnifications of 30 and 100 resemble the previously discussed figures of cell 60 (Figures 4, 5).

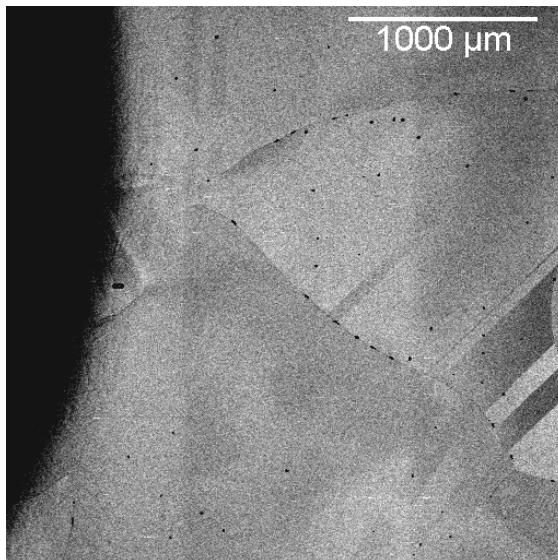
Figure 5 SEM image of copper grains in surface of cell 60 at magnification of 30X after twisting damage.

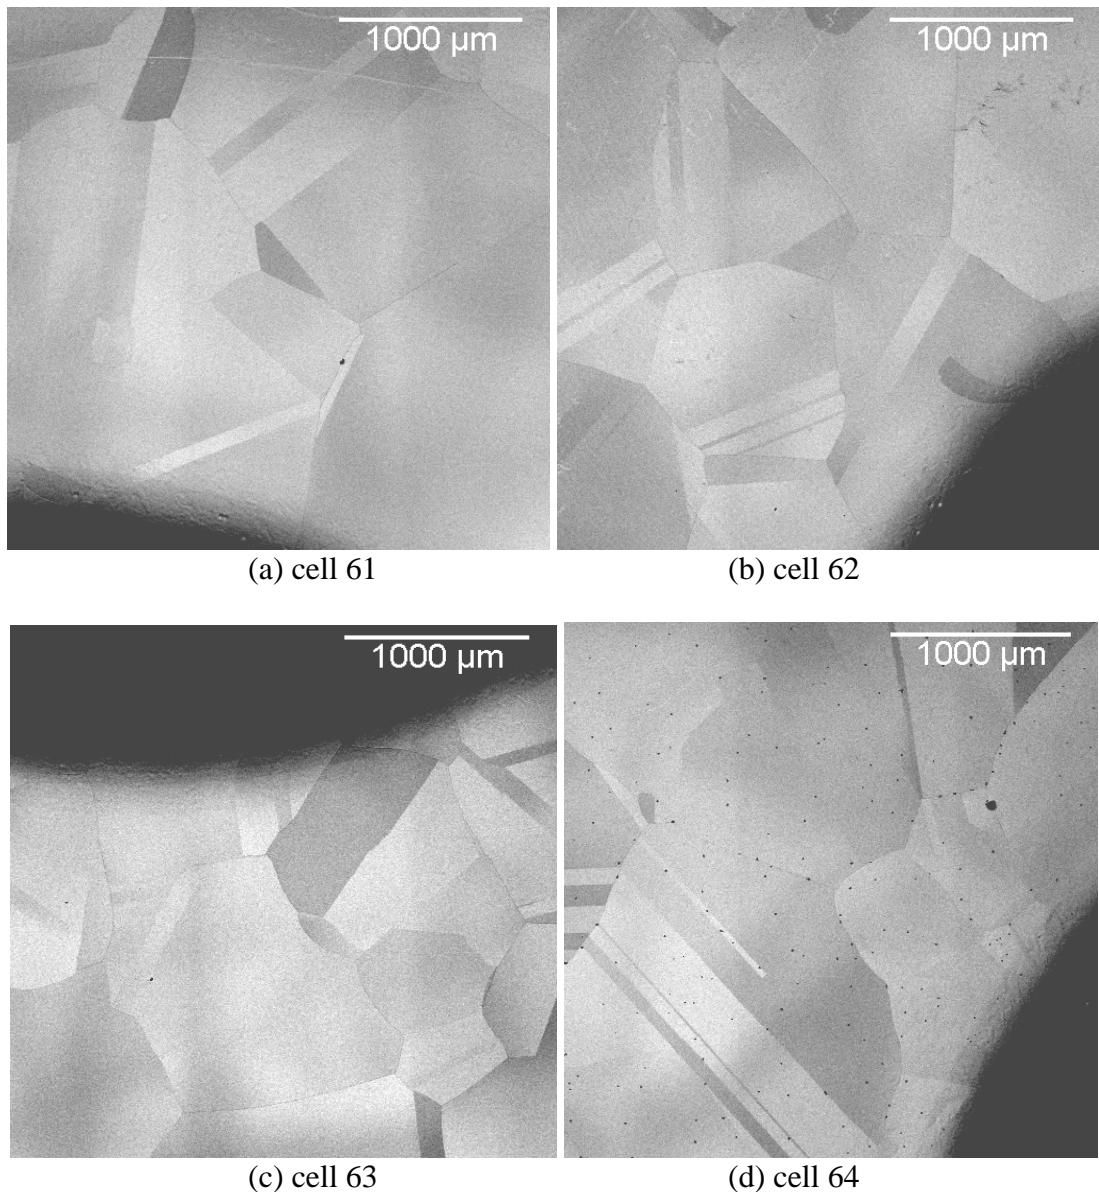
Figure 6 SEM images of copper grains in the surface of cells 61 – 64 at magnification of 30 after twisting. There are no signs of grain deformation.

Cells 61 – 64 were examined for changed morphology due to the manual twisting of the test stack. Figure 6 and Figure 7 show images of the grains in cells 61 – 64 on the scale of 1000 μm and 100 μm . The grain morphology is comparatively similar to the grains of cell 60 in which changes were not seen, even after extreme surface pressure. At the highest magnification used in examining the cells (1000X), multiple grains are observed to have high-angle grain boundaries, as in Figure 8. This type of boundary effects grains of different sizes, shapes and brightness throughout cells 61 through 64. Although the high-angle boundaries vary in severity, the deformation is only seen at the magnification of 1000 (10 μm scale) and therefore is not related to the macroscopic deformation searched for in this study.

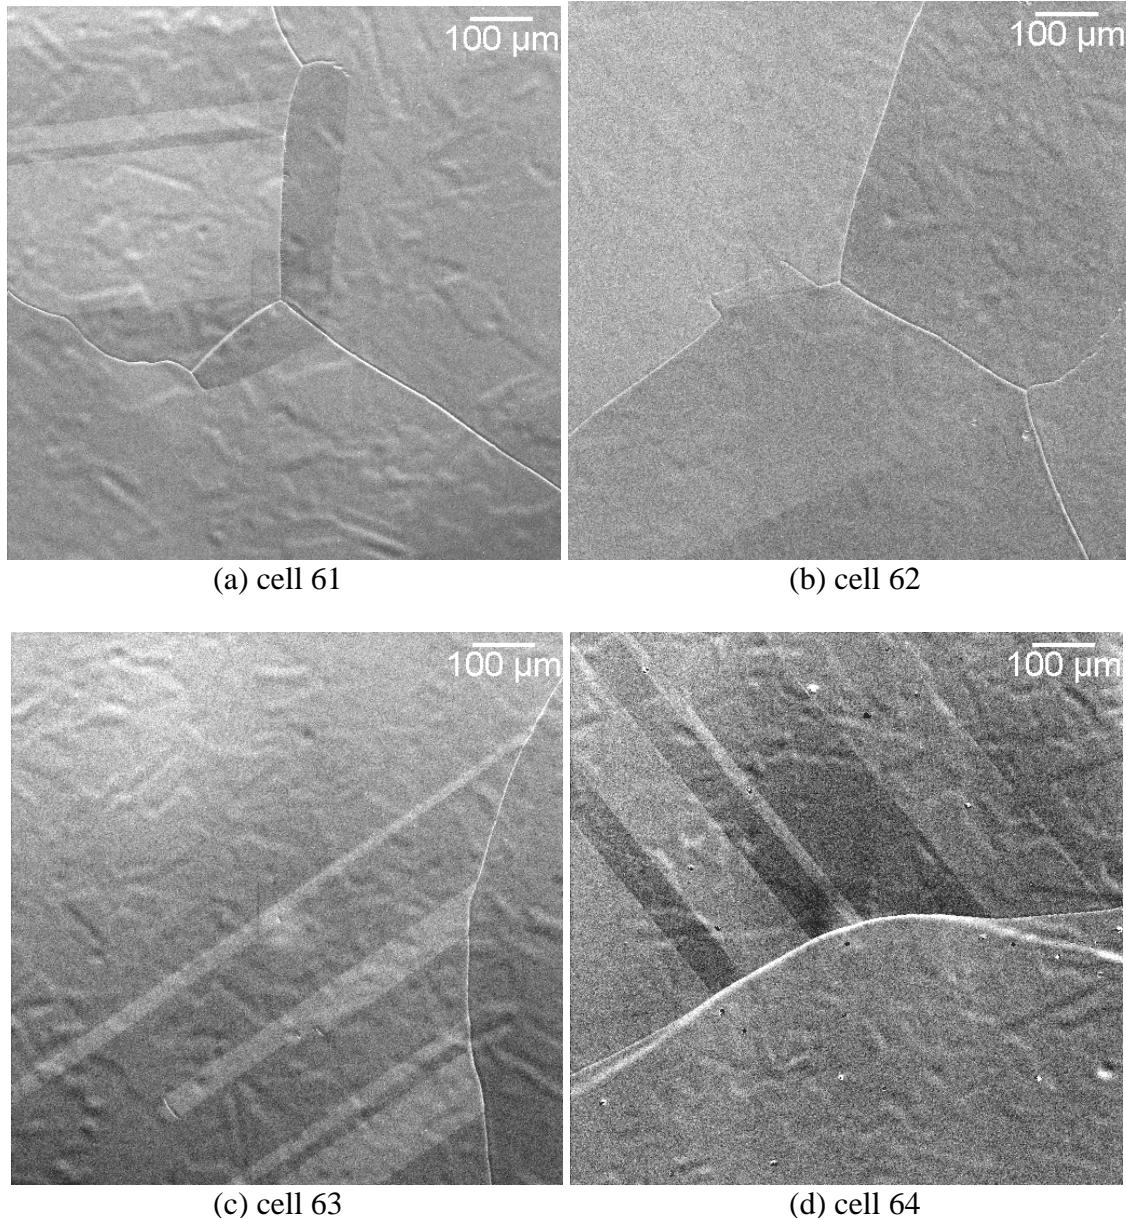
Figure 7 SEM images of copper grains in surface of cells 61 – 64 at magnification of 100 after twisting. There are no signs of grain deformation.

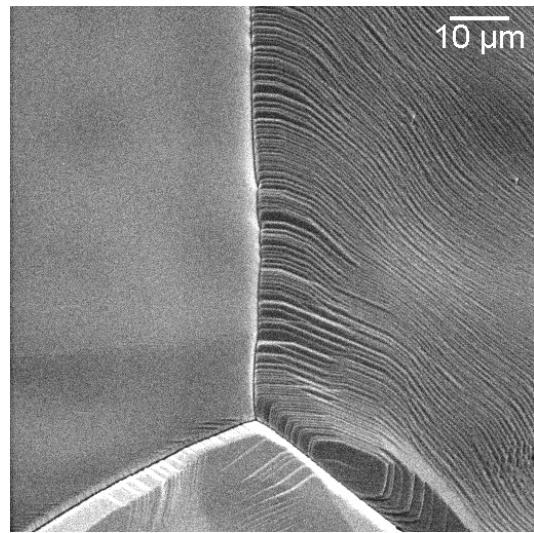
Figure 8 SEM image of high-angle grain boundary in cell 61 at magnification of 1000 after twisting.
