TCAD Analysis of Leakage Current and Breakdown Voltage in Small Pitch 3D Pixel Sensors

Jixing Ye, Abderrezak Boughedda, D M S Sultan and Gian-Franco Dalla Betta

Abstract: Small-pitch 3D pixel sensors have been developed to equip the innermost layers of the ATLAS and CMS tracker upgrades at the High Luminosity LHC. They feature 50×50 and $25 \times 100 \mu\text{m}^2$ geometries and are fabricated on p-type Si-Si Direct Wafer Bonded substrates of $150 \mu\text{m}$ active thickness with a single-sided process. Due to the short inter-electrode distance, charge trapping effects are strongly mitigated, making these sensors extremely radiation hard. Results from beam test measurements of 3D pixel modules irradiated at large fluences ($10^{16} n_{eq}/\text{cm}^2$) indeed demonstrated high efficiency at maximum bias voltages of the order of 150 V. However, the downscaled sensor structure also lends itself to high electric fields as the bias voltage is increased, meaning that premature electrical breakdown due to impact ionization is a concern. In this study, TCAD simulations incorporating advanced surface and bulk damage models are used to investigate the leakage current and breakdown beh

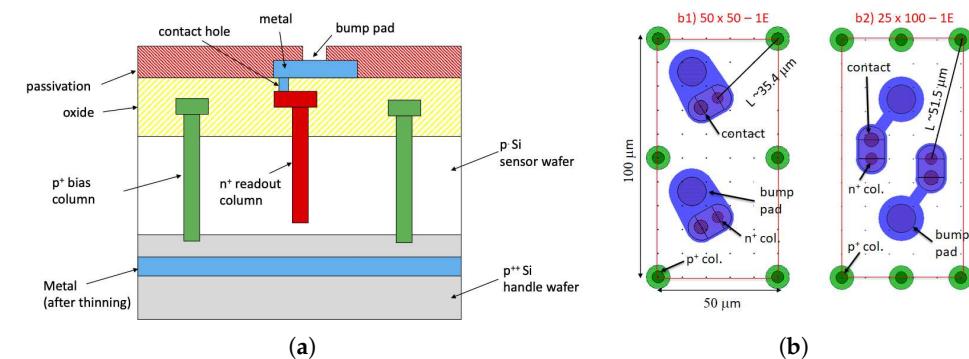
A cross-section of the devices is shown in Figure 1a. A 500- μm thick p^{++} handle wafer is directly bonded to a thin p^- sensor wafer to ensure a high mechanical stability [4]. Vertical electrodes are etched by Deep Reactive Ion Etching (DRIE) from the front side. The p^+ electrodes penetrate into the handle wafer to allow for bias from the backside (the handle wafer is thinned as a post-processing step, and a metal layer is deposited to ease wire bonding). On the contrary, the etching of the n^+ electrodes stops at a safety distance (gap = 30 μm) from the handle wafer to prevent early breakdown. A p-spray layer prevents the front surface from inversion, thus isolating the n^+ electrodes. Thorough evaluations based on the signal amplitude, the sensor capacitance, and the characteristics of the readout chips have been carried out to optimize the thickness of the active volume, for which a value of 150 μm was finally chosen [9].

Figure 1. Description of the devices under study: (a) schematic cross-section, and (b) layouts of different designs (two adjacent pixels are shown).

Figure 1b shows the layouts of the two pixel designs that will equip the ATLAS Inner Tracker (ITk), namely $50 \times 50 - 1E$ and $25 \times 100 - 1E$. These two layouts have a relatively low density and are not critical from a lithographical point of view. However, while in the $50 \times 50 - 1E$ pixel, the inter-electrode distance $L \sim 35 \mu\text{m}$ is small enough to make it very radiation hard, in the $25 \times 100 - 1E$ pixel, $L \sim 51 \mu\text{m}$ was initially considered to be not small enough to ensure a high radiation tolerance. This motivated the parallel development of a more aggressive layout for the 25×100 pixel with two readout electrodes,

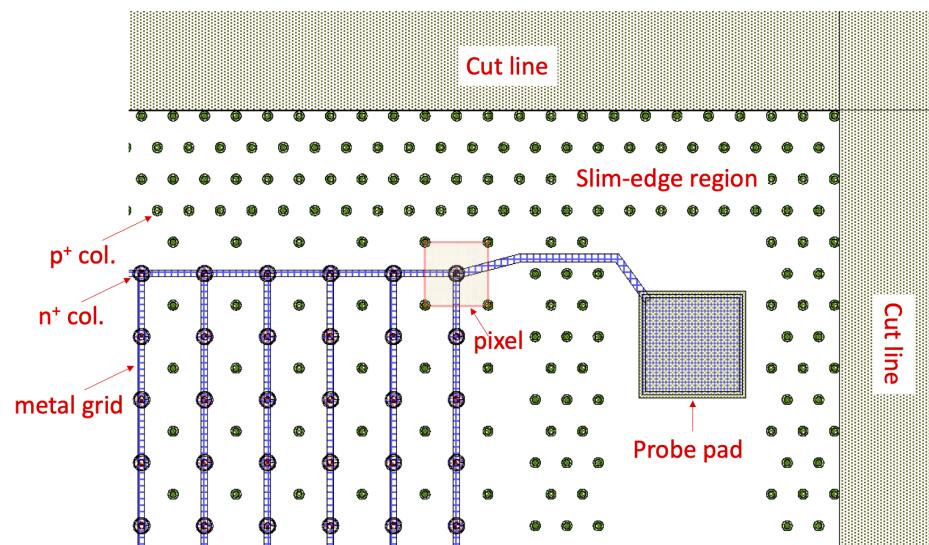
Since the ultimate purpose of this paper is the analysis of the leakage current and the breakdown voltage, we mainly focused on the I-V characteristics. As test structures, we used 3D diodes, which reproduce the electrode configurations and layout details (including the edge region) of their parent pixel sensors. As an example, Figure 2 shows a layout detail of a 3D diode of $50 \times 50 - 1E$ geometry. The diode includes an array of pixels with all n^+ electrodes shorted by a metal grid to a probe pad on the frontside, whereas the bias is applied from the backside. The device is terminated at the periphery by a slim edge, which consists of a multiple fence of ohmic columns extending from the active area toward the cut line. This structure limits the lateral extension of the depletion region spreading from the outermost pixels before it reaches the highly damaged cut region [14]. Due to their small size ($\sim 2 \text{ mm}^2$), 3D diodes are often free from process-related defects, making it possible to investigate the intrinsic properties of the different structures.

Figure 2. Layout of a 3D diode of $50 \times 50 - 1E$ geometry: detail of a corner.

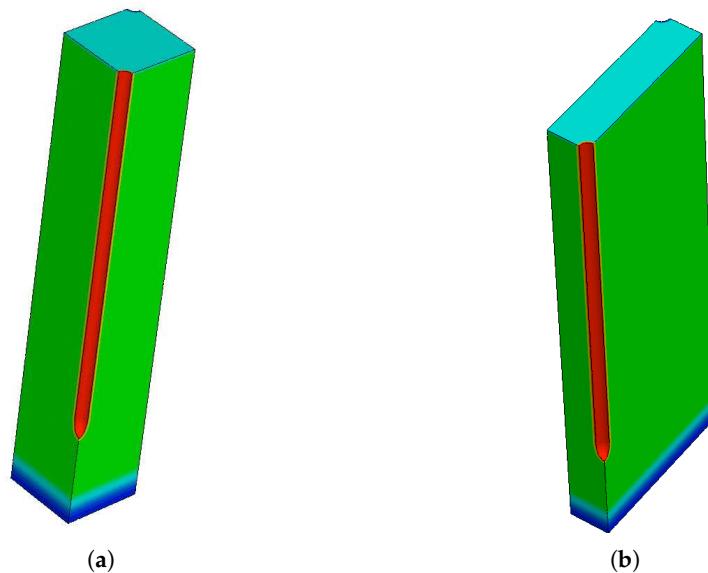
In our previous studies, it has been shown that similar breakdown voltages are measured for small-pitch 3D pixel sensors before irradiation and after X-ray/γ-ray irradiation, i.e., in the presence of surface damage only [5,12]. These findings suggest that the n⁺ column tip is the cause of the breakdown, instead of the junction between the n⁺ column and the p-spray on the front-side surface. Therefore, it is important to locate the origin of the breakdown using TCAD simulations so as to face the problem accordingly. For this purpose, TCAD simulations based on 3D domains of the exact layouts were carried out using Synopsys Sentaurus [15]. Exploiting the inherent 3D cell symmetry, the simulated structures represent only one quarter of the pixels of the two layouts, in order to reduce the number of grid points (hence simulation time). The simulation domains for the two geometries are shown in Figure 3. The red region on the front side represents the n⁺ electrode, while the p⁺ electrode is on the opposite corner. The frontside surface layers (oxide, polySilicon, contact and metal) are not shown in the figures. It is worth mentioning that the back diffusion of boron from the p⁺⁺ handle wafer (in blue at the bottom of the figures) is also considered, with a depth of 10 μm as estimated from SIMS and C-V measurements.

Figure 3. Simulation domain of different layouts: (a) 50 × 50 – 1E, and (b) 25 × 100 – 1E.

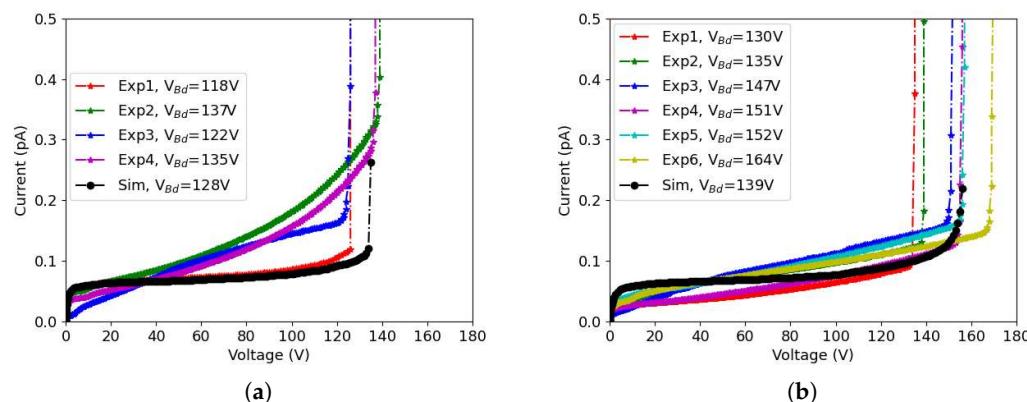
The comparison between experiments and simulations of the $50 \times 50 - 1E$ and the $25 \times 100 - 1E$ structures are shown in Figure 4a,b, respectively. The measurements were done on different devices of the same structures (Exp1, ..., Exp4), and the results were normalized to the same active volume used in the simulations (a quarter of a pixel). The breakdown voltage, denoted as V_{bd} in the legends of the plots, was calculated based on the parameter

Figure 4. Measured (Sim) I-V curves before irradiation at room temperature, with breakdown voltages V_{bd} reported in the legend: (a) $50 \times 50 - 1E$, and (b) $25 \times 100 - 1E$.

We can see that the simulations accurately predict the magnitude of leakage current and breakdown voltage, although the shape of the simulated curves does not perfectly match the experimental ones. This can be attributed to the simplified simulation domain, which adequately represents the core of the 3D diodes (array of pixels) but does not account for edge effects raising from the diode periphery. In fact, when the bias voltage is increased, the depletion region spreading from the peripheral pixels extends into the slim-edge region, so the leakage current increases. This is the main reason why the experimental I-V curves exhibit a non-negligible slope, whereas the simulated ones are almost flat before the onset of impact ionization effects. In addition, there is a non-negligible dispersion in the experimental curves, which can be ascribed to spatial fluctuations in several parameters such as bulk doping concentration, generation lifetimes, oxide charge density, interface state density, etc., and also to the presence of defects, in some devices. Simulations have been performed using nominal values for process-related parameters, aiming at the prediction of a general trend rather than fitting the individual curves. In this respect, the overall agreement between simulation and measurements can be considered good enough, indicating that TCAD simulations are reliable.

Comparing Figure 4a,b, it can be seen that the leakage currents are slightly lower and the breakdown voltages are slightly larger in $25 \times 100 - 1E$ devices—a fact that can be attributed to the larger inter-electrode distance, leading to smaller electric fields. Besides the different breakdown voltages observed in the two designs, the origins of the breakdown before irradiation are also different. For $50 \times 50 - 1E$, the main contribution of the breakdown comes from the n^+ column tip. This can be understood looking at Figure 5a, where the region with the highest impact ionization rate at voltage of 135 V (after the onset of the breakdown) is depicted; on the contrary, for $25 \times 100 - 1E$, the breakdown takes

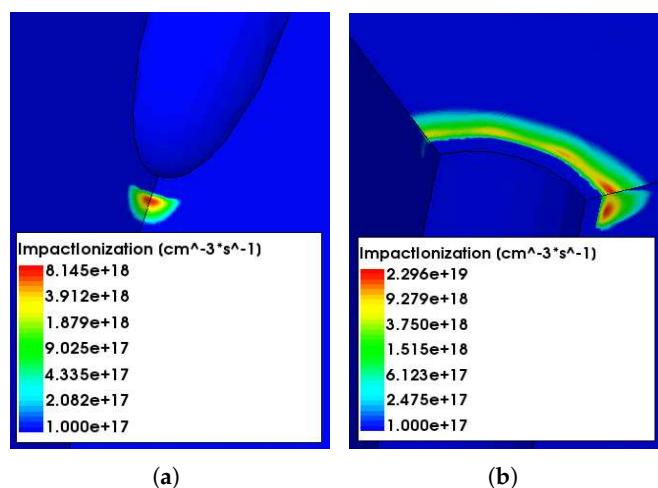
place at the junction between the n^+ column and the p-spray on the front-side surface, as shown in Figure 5b, which was extracted at 146 V.

Figure 5. Impact Ionization map of different layouts before irradiation: (a) 50 × 50 – 1E at 135 V, and (b) 25 × 100 – 1E at 146 V. Results point to a different origin of the breakdown in the two structures before irradiation.

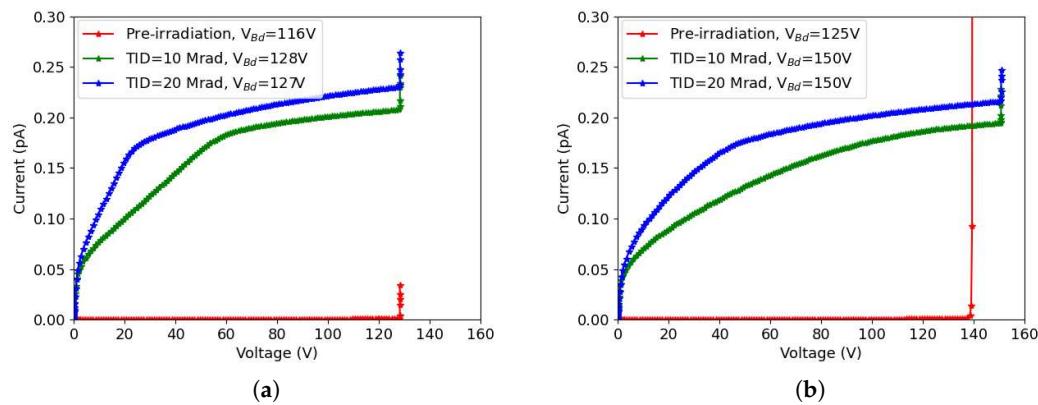
Due to the fact that the breakdown shifts from the front-side surface to the tip in 25 × 100 – 1E after the introduction of surface damage, the breakdown voltage increases by ~ 20 V, and it remains the same for both doses, as shown in Figure 6b. The shift of the simulated curve of the non-irradiated device toward a lower breakdown value observed in Figure 6b as compared to Figure 4b is due to the lower temperature.

Figure 6. Simulated I-V curves of different layouts both before and after surface damage at $-25\text{ }^{\circ}\text{C}$: (a) $50 \times 50 - 1E$, and (b) $25 \times 100 - 1E$.

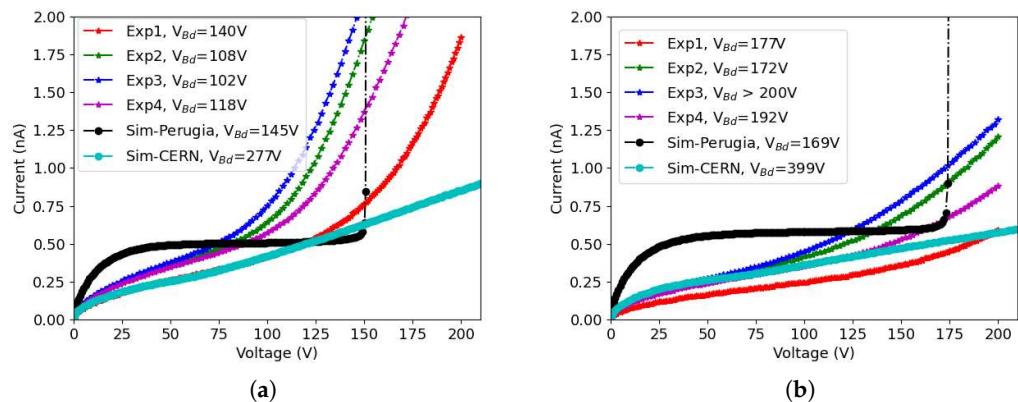
Figure 7a shows the results of 50 × 50 – 1E after irradiation up to $1 \times 10^{16} n_{eq}/\text{cm}^2$, while the results of 25 × 100 – 1E are shown in Figure 7b. The measurements were done at $T = -25\text{ }^\circ\text{C}$, the same temperature used for the simulations with the Perugia model. The temperature adopted with the CERN model was $-38\text{ }^\circ\text{C}$. The leakage current was then normalized to the value that corresponds to $-25\text{ }^\circ\text{C}$ using the Shockley-Read-Hall (SRH) model [22].

We can see that the CERN model reproduces the leakage current with good accuracy when the bias voltage is low. However, when the bias voltage is increased, the model fails to predict the onset of impact ionization effects, thus underestimating the leakage current and overestimating the breakdown voltage. The Perugia model predicts the magnitude of the leakage current and of the breakdown voltage, but the shape of the I-V curve is different from the measured ones. In particular, a plateau in the I-V curve is soon reached due to the fact that the model underestimates the full depletion voltage, as was also found in a previous study [23]. Moreover, an abrupt increase in the current is observed at breakdown, whereas the measured curves exhibit a smooth rise.

Figure 7. Comparison between measured (Exp) and simulated (Sim) I-V curves of different layouts after irradiation at a fluence of $1 \times 10^{16} n_{eq}/\text{cm}^2$, with breakdown voltages V_{bd} reported in the legend: (a) $50 \times 50 - 1E$, and (b) $25 \times 100 - 1E$.

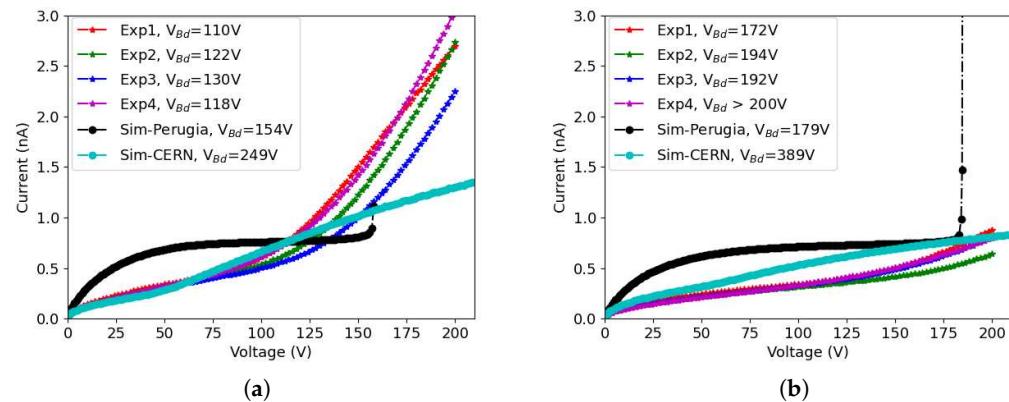
Similar considerations apply to results for the other considered fluences. Figure 8a shows the results of $50 \times 50 - 1E$ after irradiation up to $1.5 \times 10^{16} n_{eq}/\text{cm}^2$, while the results of $25 \times 100 - 1E$ are shown in Figure 8b. In this case, the I-V curves obtained with the CERN model start to deviate from the measured ones at lower voltage: the agreement is good enough until ~ 50 V, but then the shape of the simulated curves show a different concavity from the measured ones, overestimating the current in the intermediate voltage range, and finally underestimating it at large voltage. Impact ionization effects have an impact only at a very large voltage, leading to non-realistic breakdown voltage values. The Perugia model, on the other hand, yields results affected by the same type of inaccuracies

observed at the lower fluence, with a shape of the I-V curves that differs significantly from the measured ones.

Figure 8. Comparison between measured (Exp) and simulated (Sim) I-V curves of different layouts after irradiation at a fluence of $1.5 \times 10^{16} n_{eq}/cm^2$, with breakdown voltages V_{bd} reported in the legend: (a) $50 \times 50 - 1E$, and (b) $25 \times 100 - 1E$.

The reasons for the observed discrepancies between simulations and measurements are manifold, among which are the following:

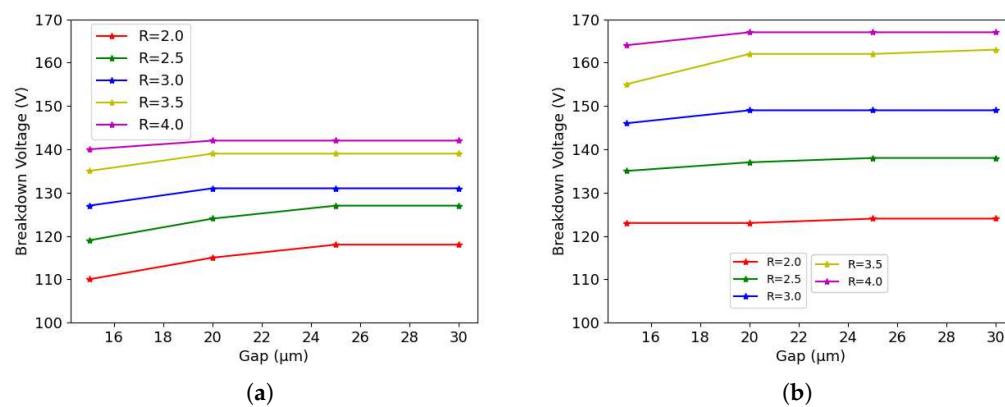
Figure 9a shows the simulation results of 50 \times 50 – 1E before irradiation. We can see that the breakdown voltage increases as the gap and radius increase. The increase with

the gap is more pronounced at small values; then, saturation is reached at larger gaps, since the surface becomes more and more critical. The radius impacts on the breakdown voltage both when it is originated at the tip and at the surface, but its effect also shows a saturation trend.

A similar trend is observed in $25 \times 100 - 1E$, as can be seen on Figure 9b, with slightly larger breakdown values. Here, the saturation of the gap effect is anticipated to $20 \mu\text{m}$ (i.e., the same value applying to the existing devices), which is reasonable, considering that the origin of the breakdown is on the front-side surface at that point.

Figure 9. Breakdown voltage acquired using different geometrical parameters before irradiation: (a) $50 \times 50 - 1E$, and (b) $25 \times 100 - 1E$.

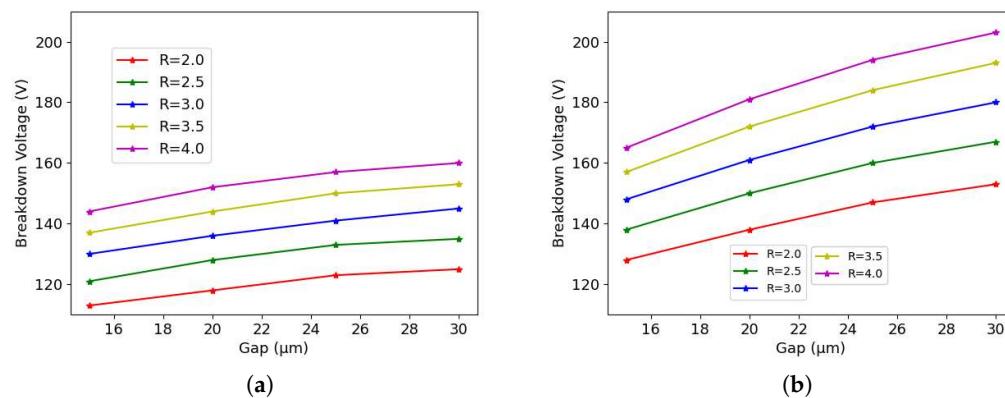
Although 3D detectors are normally not used in applications involving only surface damage, it is still interesting to observe the breakdown behavior in this condition. In fact, it makes it possible to study the dependence of the breakdown originating at the column tip on the geometrical parameters without the effects of the bulk damage. Figure 10a shows the simulation results of $50 \times 50 - 1E$ after surface damage. We can see a clear dependence of the breakdown voltage on the radius and on the gap. A larger radius/gap corresponds to a higher breakdown voltage. Moreover, both doses used in the simulations gave the same breakdown voltage, which further proves that the breakdown is at the tip after surface damage.

The same conclusion can be drawn for $25 \times 100 - 1E$, as can be seen from Figure 10b. Moreover, because of larger inter-electrode distance, $25 \times 100 - 1E$ has higher breakdown voltages than $50 \times 50 - 1E$.

Figure 10. Breakdown voltage acquired with TID = 10/20 Mard: (a) $50 \times 50 - 1E$, and (b) $25 \times 100 - 1E$.

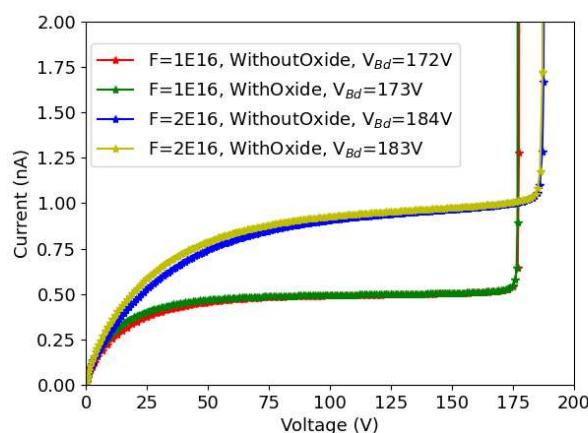
TCAD simulation can be very time consuming for 3D structures, and it scales with the number of mesh points. Most importantly, it is necessary to use a very dense mesh on the front-side surface in order to have a precise description of it; this contributes more than one third of the total mesh points. Therefore, it is worthwhile to explore if the surface would cause a big difference on the breakdown voltage after radiation damage. Figure 11 shows the results for $25 \times 100 - 1E$, with reference to the nominal values of radius ($2.5 \mu\text{m}$) and gap ($20 \mu\text{m}$). Simulations were performed using the Perugia bulk damage model, which proved to yield a more accurate estimate of the breakdown voltage. The temperature was set to -25°C , and the TID was adjusted according to the fluence (10 Mrad when the fluence is $1 \times 10^{16} n_{eq}/\text{cm}^2$, and 20 Mrad when the fluence is $2 \times 10^{16} n_{eq}/\text{cm}^2$). Other key parameters are shown in the legend.

It can be seen that the oxide does not have any influence on the breakdown voltage under all simulated conditions and indeed has a very limited influence on the leakage current. It was also checked that the same trend applies to different geometrical parameters (e.g., radius = $2 \mu\text{m}$) and layouts, namely $50 \times 50 - 1E$. Simulations were also repeated using the CERN bulk damage model, leading to the same conclusion. Therefore, it was deemed appropriate to remove the surface layers (p-spray, oxide) to study the breakdown prediction after radiation damage, as a way to boost the whole simulation process. Hence, we re-built the simulation structures without the surface and ran the simulation using different geometric parameters and different fluences.

Figure 11. The effect of the oxide and p-spray have on the breakdown voltage, $25 \times 100 - 1E$.

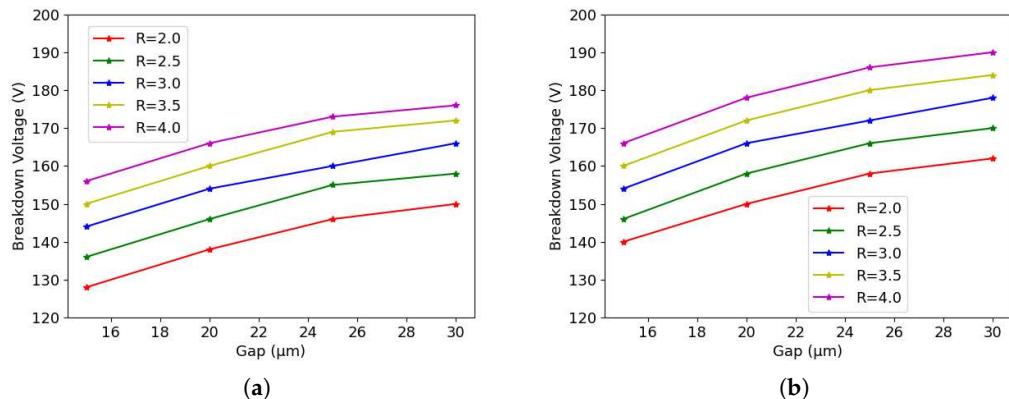
Figure 12a shows the results for $50 \times 50 - 1E$ when the fluence is $1 \times 10^{16} n_{eq}/\text{cm}^2$, while Figure 12b shows the results when the fluence is $2 \times 10^{16} n_{eq}/\text{cm}^2$. It can be seen that the breakdown voltage increases with the radius and the gap; higher fluence leads to higher breakdown voltage. As an example, it is possible to improve the breakdown voltage of the current design (gap = $20 \mu\text{m}$) by more than 10 V, by increasing the column radius by one micron, from $2.5 \mu\text{m}$ to $3.5 \mu\text{m}$. Indeed, this would slightly increase the capacitance and the dead volume, but it would still be within the ITk specification.

Figure 12. Influence of different geometrical parameters for $50 \times 50 - 1E$ after bulk damage: (a) $1 \times 10^{16} n_{eq}/cm^2$, and (b) $2 \times 10^{16} n_{eq}/cm^2$.

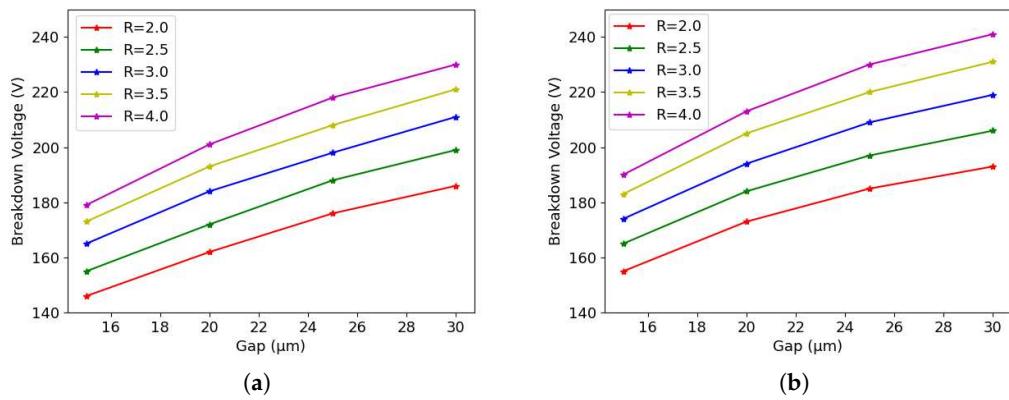
Figure 13a shows the results for $25 \times 100 - 1E$ when the fluence is $1 \times 10^{16} n_{eq}/\text{cm}^2$, while Figure 13b shows the results when the fluence is $2 \times 10^{16} n_{eq}/\text{cm}^2$. The behavior is very similar to the one observed for the $50 \times 50 - 1E$: a larger radius and gap corresponds to a larger breakdown voltage. As an example, keeping the gap at $20 \mu\text{m}$, the breakdown voltage increases by 20 V after raising the column radius by $1 \mu\text{m}$ from $2.5 \mu\text{m}$ to $3.5 \mu\text{m}$.

Figure 13. Influence of different geometrical parameters for $25 \times 100 - 1E$ after bulk damage: (a) $1 \times 10^{16} n_{eq}/cm^2$, and (b) $2 \times 10^{16} n_{eq}/cm^2$.
