# RADIATION DAMAGE MONITORING AT PAL-XFEL

Sojeong Lee\*, Jang-Hui Han, YoungGyu Jung, Dong Eon Kim and Geonyeong Mun  
Pohang Accelerator Laboratory, Pohang, Korea

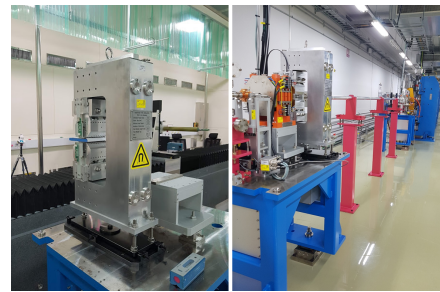
Figure 4: RTU in field measurement bench (left) and installation in front of hard X-ray undulator beamline (right).

As shown in Fig. 4, the RTU was installed at the intersection upstream of U104, before the first undulator, HXU105. This U104 space is preserved as drift space now. One additional undulator will be installed at this position in 2020 summer maintenance. Two radFET sensors at the top and bottom positions of magnet structure's upstream face of RTU. Before the installation of the RTU, the B-field was measured by using the Hall probe. Figure 5 shows the measured field. The B-field measurement of the RTU is planned during every winter maintenance to monitor the demagnetization of the magnets. This result together with accumulated radiation dose level will be used as a guide of hard X-ray undulator's re-tuning.
