DEVELOPMENT OF ALUMINIUM VACUUM CHAMBERS FOR THE LHC EXPERIMENTS AT CERN

M. Gallilee, P Chiggiato, P Costa-Pinto, P Lepeule, J. Perez-Espinosa
 Leonel Marques Antunes Ferreira, Laurent Prever-Loiri, Antonios Sapountzis
 CERN, Geneva, Switzerland

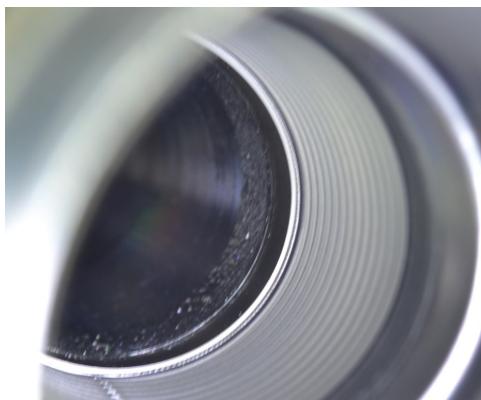
Figure 1: Peel-off.

Adhesion was also good for most of the chambers, being the VA type the only exception. For the three VA chambers treated, in independent runs, peel-off was observed at exactly the same place: after a weld between bellows and a short sleeve, around 2 cm in length, and on the flanges to a lesser extent. The outcome from an optical inspection with an endoscope (see Figure 1) has supported evidence for variation of the mechanical inner surface texture in the sleeve that coincides with the peel-off area. X-ray photoelectron spectroscopy was used to analyse the back of the coating that was in contact with the aluminium surface but no relevant contamination was found that could explain the poor adhesion. Since no wet chemical etching could be applied in order to remove the NEG in the whole chamber, due to the risk of trapping corrosion active elements in the bellow, the coating on the zones with peel-off was removed mechanically. The chamber was then bombarded with Krypton ions at approximately 400 eV at a dose of 2.8×10^{-3} C/mm², and then recoated with NEG without air exposure in between. The peel-off persisted, indicating the origin of the problem is not related with last layers of the aluminium surface. Since both the short sleeve and the flanges have the same turned mechanical surface finish, and the other parts are honed, except the bellow, we suspect this surface finish may be linked to the lack of adhesion.

A previously qualified manufacturing method for aluminium UHV chambers was successful in trials and initial chamber production. In one set of chambers for ATLAS, NEG peel-off was observed in certain internal zones which were machined by turning. Etching modified the internal surface finish to resolve this issue. The new manufacturing method for these chambers has shown promise even on turned machined zones, and the pre-annealing has yielded vacuum chambers that adhere to, or exceed, the necessary mechanical tolerances. A further challenge was observed with porosity between aluminium grades 5083 used to manufacture aluminium bellows to 2219 used for the chamber bodies. This issue was resolved by using a TIG method of welding which doesn't allow the magnesium vapour in the 5083 aluminium to expand and create a void.

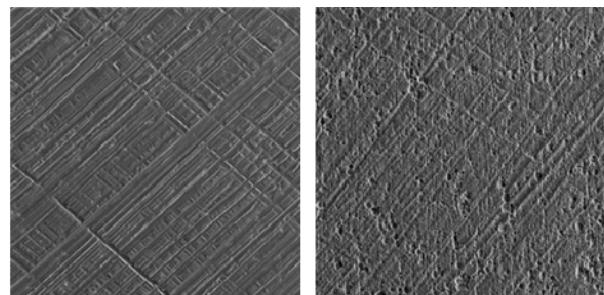
In order to achieve a good surface condition for NEG deposition, several studies were made. After an optimization process, a new procedure was devised for individual components before welding, and an additional cleaning step added for chambers after welding assembly. Concerning the first step for the individual components, except for the bellows, the components were etched in a solution of H₃PO₄ and HNO₃, for 2 hours at room temperature [5]. The objectives were to modify the surface finish of the components, machined by turning, to overcome the lack of adhesion for NEG coating ensuring the vacuum compatibility of the surfaces of the honed components. Material removal of 7 μm ± 1 μm was expected in all the cases. Figure 2 shows a magnified image before and after etching. Where bellows formed part of a chamber, no change was made to the surface preparation procedure before integration.

Figure 2: Image of honed surface finish before and after the etching process.

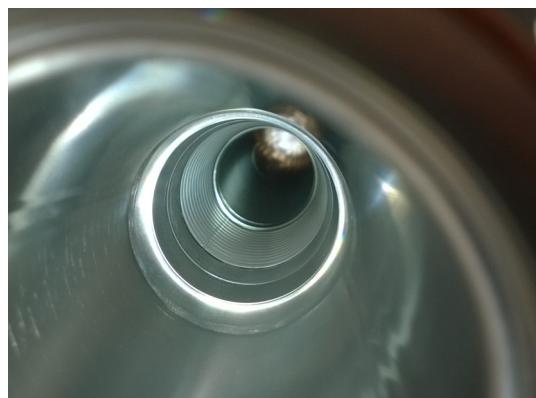
Figure 3 shows the NEG coating on the second set of chambers after implementation of the new etching and cleaning methods as mentioned above. Peel-off is not observed, and a constant surface finish can be seen.

Figure 3: NEG coating of second series chamber with new surface treatments.

After welding of components, a second surface treatment procedure was applied. This followed three main steps: a first immersion degreasing with NGL 17.40 for 30 minutes at 50°C, a second degreasing with P3-almeco®, and finally a flush pickling with CrO₃ and H₂SO₄. This is the same treatment applied to the VT chambers in the first series to guarantee the local surface condition in the welding areas and UHV compatibility of the chamber.
