METALLOGRAPHIC POLISHING PATHWAY TO THE FUTURE OF LARGE SCALE SRF FACILITIES*

O. Hryhorenko^{†1}, C.Z. Antoine², M. Chabot¹, D. Longuevergne¹

Abstract

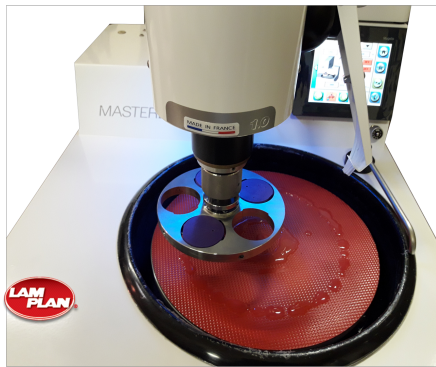
Metallographic polishing has been performed on a machine MasterLAM 1.0, see Fig. 1, manufactured by a French company LAM PLAN [7]. Polishing disks may be charged with various type of abrasives (diamonds, silica carbide, aluminium oxide and etc.) with different size (from 100s microns down to nanometers scales. Abrasives could be embedded in the polishing disk or added as a liquid suspension between the disk and the specimen.

Figure 1: Metallographic polishing (MP) device (LAM PLAN company).

Nb and is controlled by a pneumatic adjuster on the centre of sample holder. The tangential force creates a cutting effect and results in the material removal. The efficiency of material removal (removal rate) depends on: hardness of used abrasives, carrier of the abrasives (metal, resin or cloth), applied pressure, rotational speeds of holder and polishing disk.

The rotational speeds of the sample holder and the polishing disk were 150 and 300 rotations per minute (RPM). Working pressure is typically set to 305 g/cm^2 corresponding to a pressure of 30 kPa for 3 samples (10 x 40 mm). The polishing procedure was optimized on small flat specimens (10 mm x 40 mm) and then the recipe has been transferred to Nb disks of diameters of 50 and 126 mm.

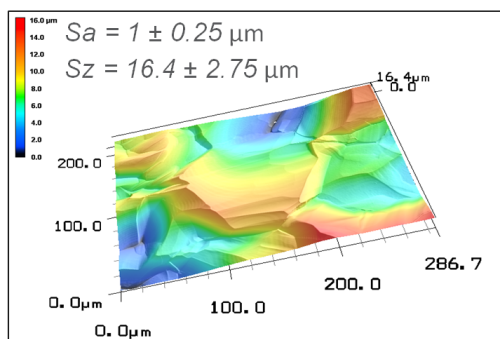
In order to remove the influence of the specimen preparation history all specimens before MP were etched by BCP mixture to 1:1:2.4 ($\text{HF}:\text{HNO}_3:\text{H}_3\text{PO}_4$) to remove about of 200 μm of the surface layer. Fig. 2 shows topography of Nb surface after BCP treatment with $S_a = 1 \pm 0.25 \mu\text{m}$ and $S_z = 16.4 \pm 2.75 \mu\text{m}$.

Figure 2: 3D reconstruction of Nb surface state after BCP treatment.

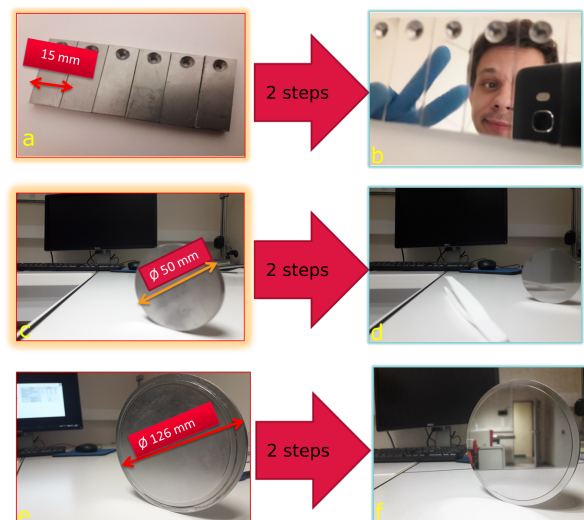
As shown in Fig. 3, mirror finished surfaces have been obtained for all Nb samples by using 2 steps polishing recipe.

Figure 3: Raw Nb specimens before metallographic polishing (a-rectangle sample, c-disk of 50 mm diameter, e-disk of 126 mm diameter). Mirror finished specimens after 2 steps polishing recipe (b-rectangle sample, d-disk of 50 mm diameter, f-disk of 126 mm diameter).

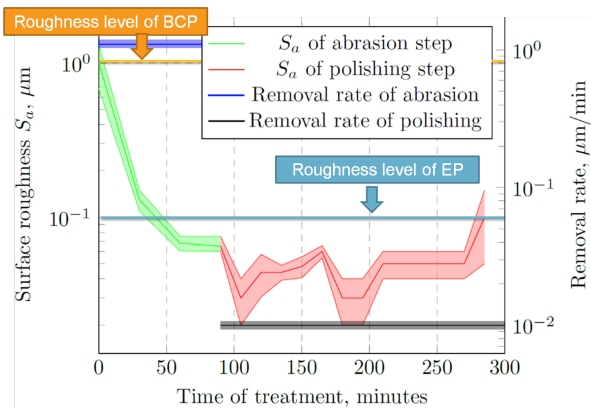
Figure 4 depicts the evolution of the average surface roughness after each abrasion and polishing step. The abrasion step (first 90 minutes in Fig. 4) removes the polycrystalline structure created by BCP, planarizes the surface, creates amorphous structure that will increase the efficiency of the following polishing step. Unfortunately this step leaves embedded particles all over the surface.

Figure 4: Evolution of the average surface roughness as a function of time.

The best average surface roughness is achieved after 1 hour of abrasion and remains constant if processed for a longer time. Average surface roughness has been saturated after 1 hour of abrasion. Fig. 5 shows final topography of Nb surface after the abrasion step with $S_a = 68 \pm 11 \text{ nm}$ and $S_z = 3.27 \pm 1.09 \mu\text{m}$.

The polishing step reduces the roughness down to 30 nm after 20 minutes, but tends to reveal some roughness of the surface with time due to reappearance of grains because of the combined chemical-mechanical (CMP) action. However polishing step can't be stopped because of embedded abrasives remaining in the material. For this reason polishing step has to be extended at least up to 200 minutes. Fig. 6 shows the final topography of Nb surface after 200 minutes polishing step with $S_a = 100 \pm 50 \text{ nm}$ and $S_z = 2.58 \pm 0.426 \mu\text{m}$. As seen in Figure 7, all surface damages and embedded abrasives are removed.

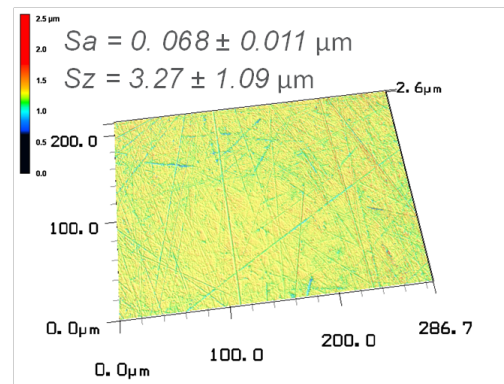
Figure 5: 3D reconstruction of Nb surface state after abrasion step of MP.

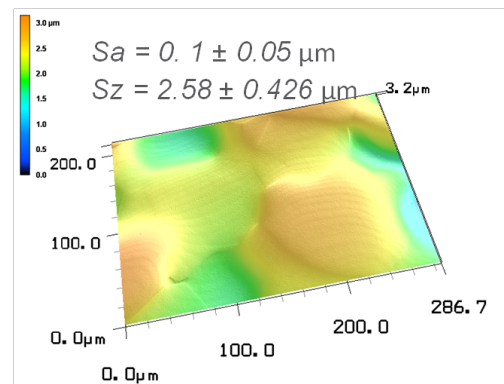
Figure 6: 3D reconstruction of Nb surface state after polishing step of MP.

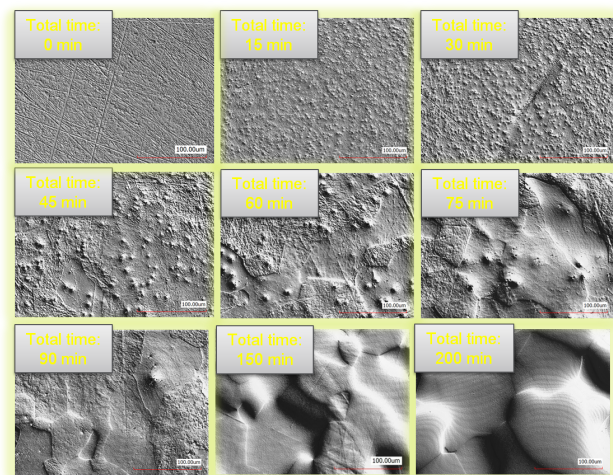
Figure 7: DIC images of Nb surface state during MP polishing in different periods of time. Note: figure shows also the de-pollution effect, grain formation and grain growing with time.

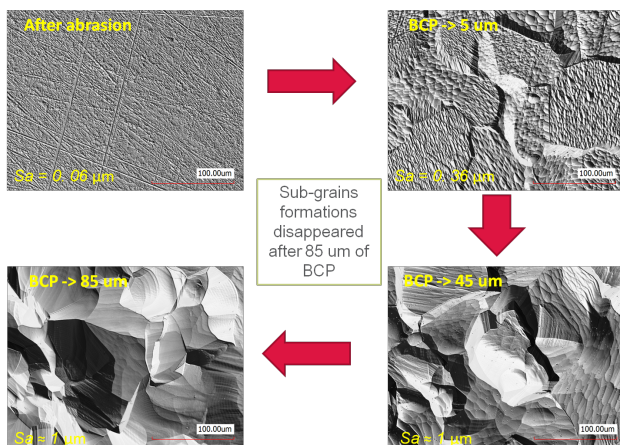
Etching process during the BCP treatment tends to reveal not only the grain structure, but also subgrain damages caused by mechanical processes. In order to estimate the depth of affected layer (high density of dislocations), the surface has been observed after multiple BCP etching of 5 μm (confocal imaging in DIC mode). Sub-grain structures are visible and presented in Fig. 8. Sub-grain patterns present in the affected layer, disappear approximately after 85 μm of BCP.

Figure 8: Etching figures of Nb surface after abrasion step.

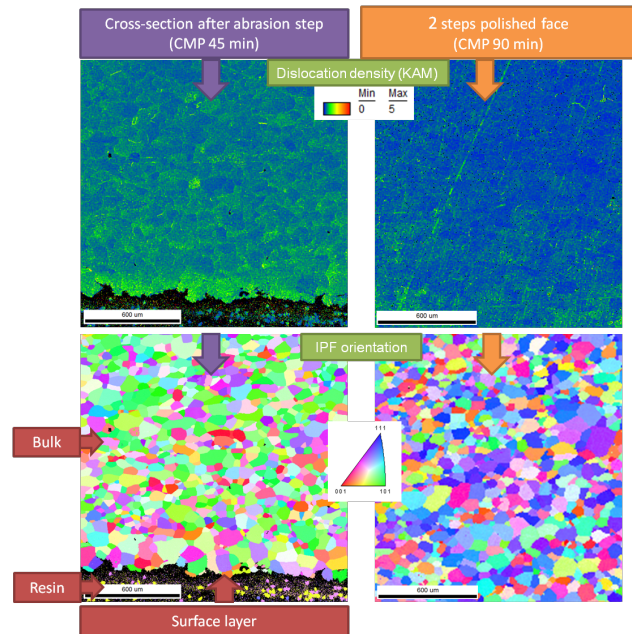
Evaluation of affected layer has been done thanks to another method. This one involves EBSD analysis performed on the cross-section of the sample. In that sense this requires some additional surface preparation (cutting, mounting in resin and cross-section polishing). Figure 9 shows kernel average misorientation (KAM) and inverse pole figures (IPF) of polished face after 2 steps polishing procedure (right) as described before and secondly cross-section after abrasion step (left).

As EBSD analysis is typically sensitive to the first hundred of nanometers under the surface, we can conclude that 2 steps polishing procedure is causing very limited residual crystal damages. Indeed this IPF image (right) is showing crystallized surface comparable to bulk unaltered crystal. On the other side, the cross-section analysis tends to show some surface damages (higher dislocation density at the edge of sample). However, these damages have been more likely created during the preparation of the cross-section (cutting procedure) rather than from 2 step polishing procedure of the face. Additional analysis will be carried out to confirm this statement.

Figure 9: Kernel Average Misorientation (KAM) and Inverse Pole Figures (IPF) of cross-section after abrasion step (left, CMP 45 minutes) and polished face after 2 steps polishing (right, CMP 90 minutes).

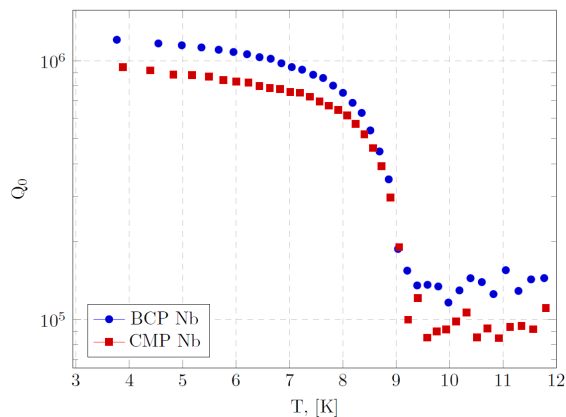
The quality factors of both samples (CMP and BCP) are shown in Fig. 10. At 9.2 K both samples show a sharp increase of quality factor as a consequence of the transition of Nb material from normal to the superconducting state. However, a lower quality factor is observed below 4 K after CMP process, indicating the presence of surface pollution or damages.

Figure 10: The quality factors of the BCP (blue curve) and the CMP (red curve) polished disks as a function of temperature.

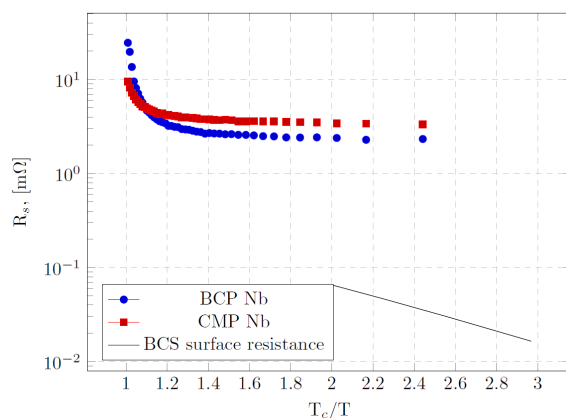
Fig. 11 shows the behaviour of extracted surface resistance versus T_c/T ratio. Measured surface resistance consists of the sum of the BCS surface resistance (ideal Nb) and the residual resistance (presence of the impurities in Nb). As shown in Fig. 11, the BCS model predicts that the surface resistance should be well below measured values (at 4 K and at frequency 11.4 GHz the BCS resistance would be typically of the order of 80 $\mu\Omega$). However the tested samples, even the BCP treated Nb shows a very early saturation of the surface resistance caused by a very high residual resistance (2 m Ω). These early stabilizations of the surface resistance for both samples may be the sign of the Q-disease (as samples were

not degassed in a furnace before RF test) or the existence of anomalous dissipation (RF contacts, lossy contacts...).

Figure 11: The surface resistance of the BCP and CMP samples versus T_c/T .

This test performed at SLAC showed very promising results. Unfortunately, because of technical limitations inducing a very early saturation of the surface resistance, the decay of superconducting BCS resistance with T_c/T ratio couldn't be measured properly. A way to mitigate these "high frequency" limitations would be to test a sample at a lower frequency, as on IPNO test bench as soon as this one would be available (the sample disk is ready to be tested).
