MANUFACTURING AND INSPECTING SUPPORTING TABLES FOR FRONT END IN TAIWAN PHOTON SOURCE

Abstract

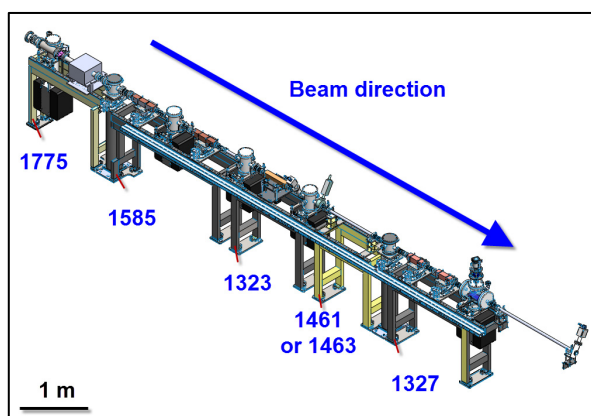
The Taiwan Photon Source (TPS) is the second accelerator in Taiwan, with a circumference of 518 m. It is located in Hsinchu, Taiwan. This study describes the stand in the front end of TPS to support a variety of components assembled in the front end area, such as X-ray Beam Position Monitor (XBPM), High Heat Load Components (HHLC), vacuum pump and cavity. The figure below shows the design of the front end, with a total length of approximately 10.242 meters.

Figure 1: Design Prototype Newly Built on the Front End Area.

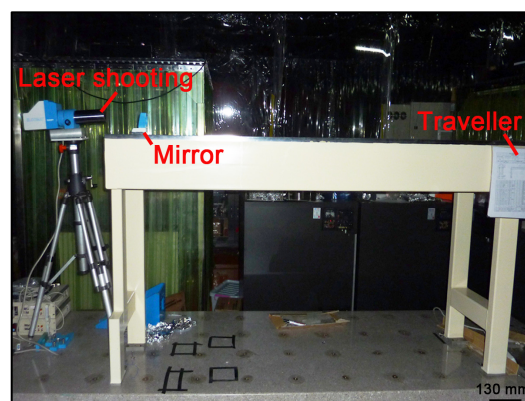
The measuring instruments in Figure 2 in this study are employed to check the mechanical dimensions of stands, such as mechanical arm [1] and laser alignment tool [2] for mechanical geometry, shape and surface roughness, with the measurement benchmark erected on the top of a marble.

Figure 2: Measurement and erection of laser alignment tool.

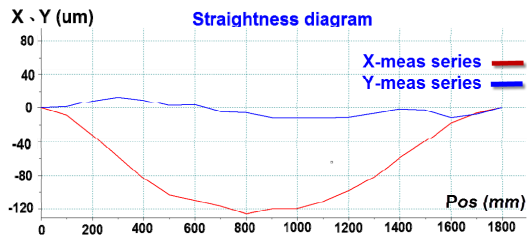
This chapter shows the measurement results of stand via a laser alignment tool. The direction of X in Figure 3 is represented by red and that of Y by blue.

Figure 3: Measurement results of Stand 2FE-1-SUP-0A-1323-4 on side A.

As for the measurement results after manufacture, we have successfully controlled the amount of deformation of the steel strip within 150 μm , but that of some stands longer than 2 meters may exceed the standard. And the

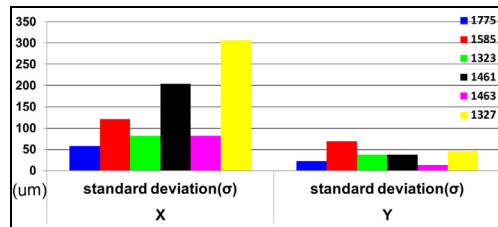
Figure 4: Statistical results on the standard deviation of the front end stands.

Due to the large number of stand measurements, a statistical method is employed in this paper to present the measurement results. For example, among the standard deviation results in Figure 4, a slightly high error of Stand 1327 resulted in an increase in the overall standard deviation. In addition, the stand data distribution can be obtained through the standard deviation and mean value according to the 68-95-99.7 rule in statistics, and will not be described further in this paper.

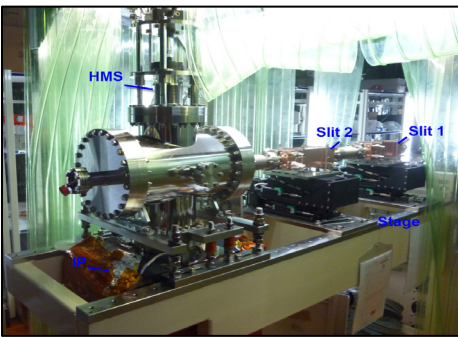
In the Figure 5, a simulation for Stand No. 1327 involves components such as two slits, fixtures, HMS and IP, as shown in Figure 5 Table 2 shows the load parameters and deformation results.

Figure 5: Components mounted on Stand 1327.

Deformation	Gravity	Gravity +slit*1	Gravity +slit*2	Gravity +slit*2+ HMS
load (kg)	159.91	207.61	255.31	451.31
Max (um)	3.571	4.293	7.982	8.390
Min (um)	0.001	0.001	1.545	0.847

amount of deformation of a stand in the static simulation is within an acceptable range of about 8 μm .

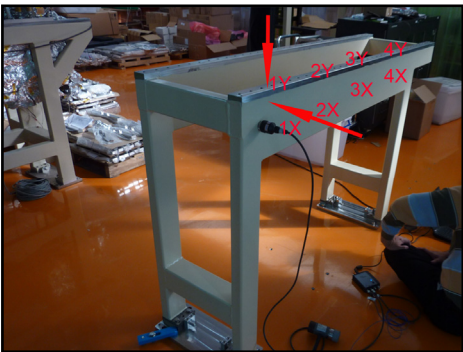
The 1X, 2X... in Figure 6 mark the location of accelerometers which are distributed evenly in X and Y directions to generate four stimuli each, which are averaged and presented in X and Y direction in Table 3 and 4. Due to limited space, a schematic diagram of the X and Y test results is presented respectively.

Figure 6: Erection of vibration test of stand 1327.

mode	Natural Frequency(Hz)	Damping ratio (%)
1	16.84	7.95
2	35.88	4.34
3	73.97	1.7

mode	Natural Frequency(Hz)	Damping ratio (%)
1	16.11	8.97
2	32.95	4.33
3	98.14	3.74

The vibration test results will help future installation of stands in the storage ring of TPS. Considering the synchrotron radiation ambient excitation bandwidth of about 6-30 Hz range, the first mode of the stand natural frequency will appear in the excitation bandwidth before the components are mounted, and then exceed it after mounting the components according to our expectation.
